MAINTENANCE AND REPAIRS ON THE WATER INTAKE OF JAGUARI HYDROPOWERPLANT AFFECTED BY AAR.

¹CESP – Cia. Energética de São Paulo, São Paulo, SP, BRAZIL

This paper presents the procedures, methodologies and results obtained after cracks repairs caused by AAR on the water intake, on the foundation block and columns that support the steel catwalk.

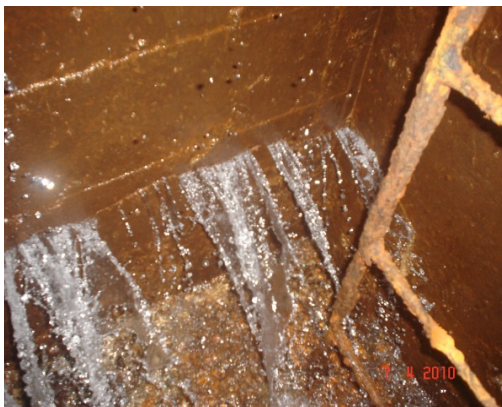
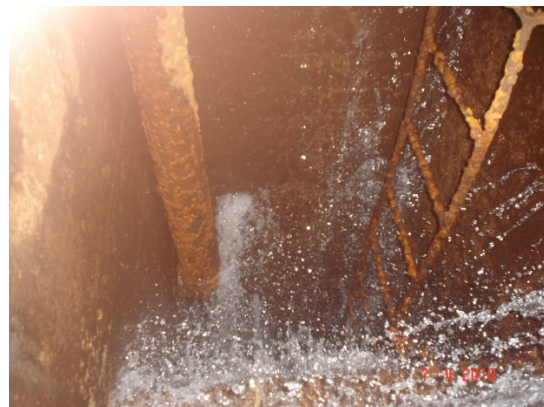
With the aim of improving the tunnel access conditions, divers conducted the first services of slant joints and some cavities in the water intake of the ventilation tunnel structure, with application of epoxy. However, the result of applying, didn't answer the objective of reducing significantly the infiltrations, depending on the water pressure of the reservoir to the inner side of the tunnel.

FIGURE 4
FIGURES 4 and 5: Infiltration through cracks of wall ventilation tunnel.

The exhaustion of the supply aqueduct, allowed access to the inner walls of the tunnel, and repairs were started in the joints, cracks and cavities with higher water percolations at the level 615. 00 m. In this way this leak was controlled in the joints next to the slab.

To achieve satisfactory results within the structure, the services were performed, by associating the jobs of quick picks, cements for caulk and products for grouting such as polyurethane and acrylic resin.

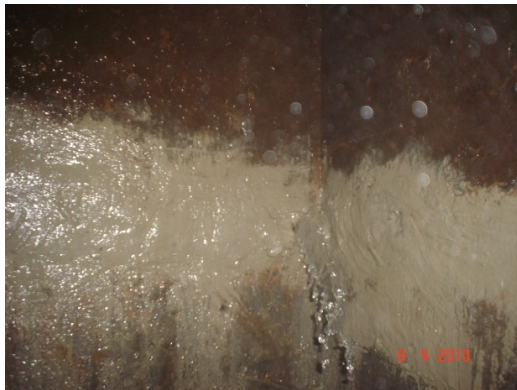
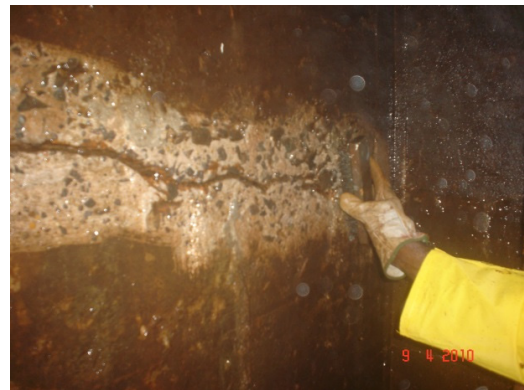
FIGURES 6 and 7: Cleaning the area to be repaired and use of quick set cement, to stop the infiltration.

There was also the need to eliminate the water infiltrations affecting the work of the team of mechanical maintenance at level 608. 00 m. The activities to stop the water infiltration were performed by the careful drilling of concrete, with special procedures depending on the thickness of the wall, cleaning the area to be repaired with hydro jet and steel brush, caulk the joints with quick set cement and grouting with the products mentioned above, see Figures 6 to 8.

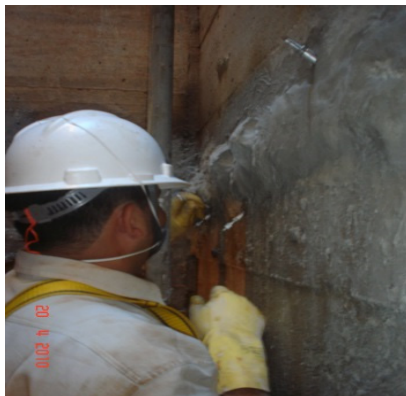
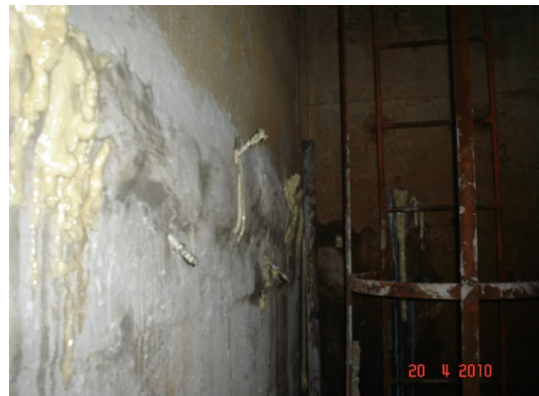
FIGURES 8 and 9: Installation of nozzles and injection with polyurethane and acrylic resin.

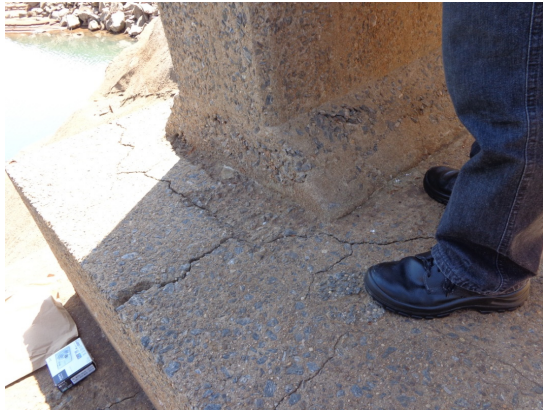
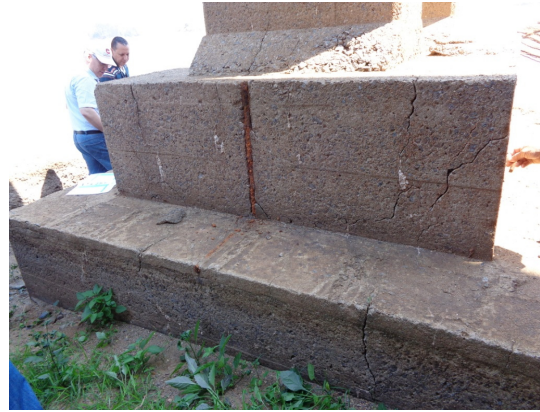
In the technical visit, performed by the technicians of CESP, appeared the necessity to repair the blocks and concrete columns, which were heavily cracked with openings above 10.0 mm, which compromised the concrete strength, elasticity and durability. Figures 12 to 15 show the Foundation blocks and concrete columns of the steel catwalk, water intake access and highlighting the more pronounced cracks, with gaps between 1.0 mm to 4.0 mm. There were also points of aggregate segregation on the basis of the concrete columns surface, and on the surface of the Foundation block.

FIGURES 12 and 13: View of foundation blocks and concrete columns of steel catwalk, and highlighting the sharp cracks, with top opening up to 1.0 mm.

It was decided to inject a structural epoxy based adhesive because, despite blocks and concrete columns presented cracks due to AAR, they required repairs in order to restore structural integrity and monolithicity. The structural epoxy has high compressive and tensile strength, and was used to bond the structure. To make the injections with resin, it was necessary to caulk the cracks with structural epoxy - adhesive - bi-component.

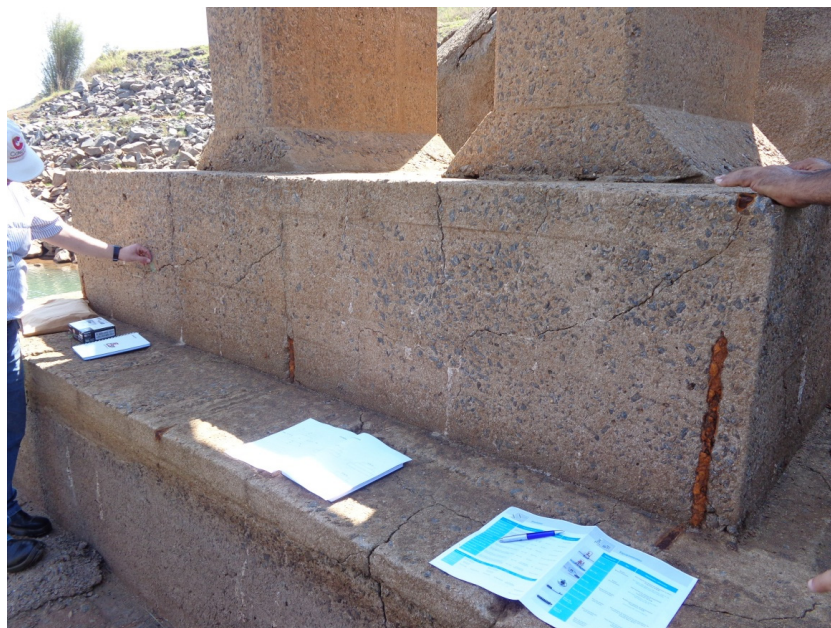
FIGURE 14: View from the block of the concrete columns, highlighting the cracks, with top opening up to 1.0 mm. Presence of leaching and segregation on the concrete surface.

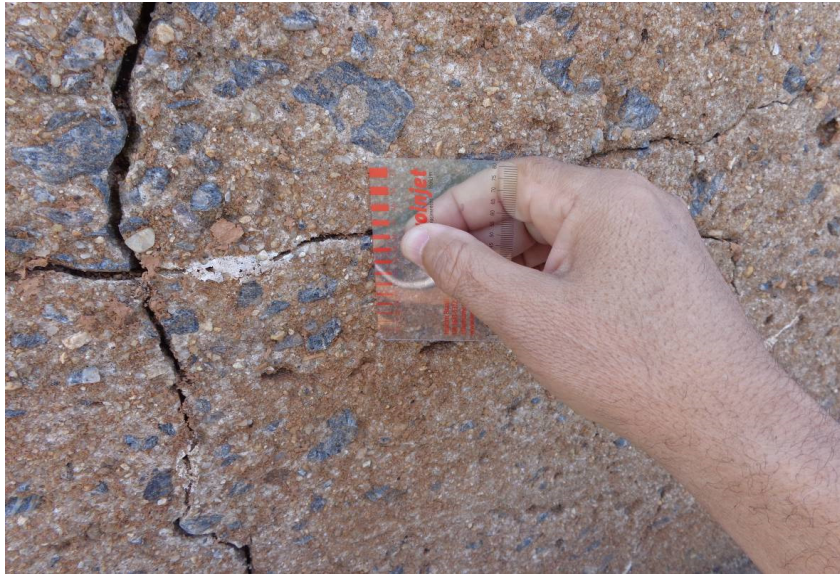
FIGURE 15: Detailed view of the Foundation blocks, measuring the opening of cracks on the order of 2.0 mm. Observe the resulting gel of the AAR.

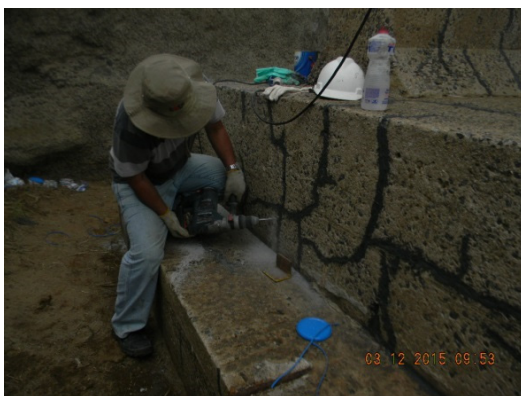
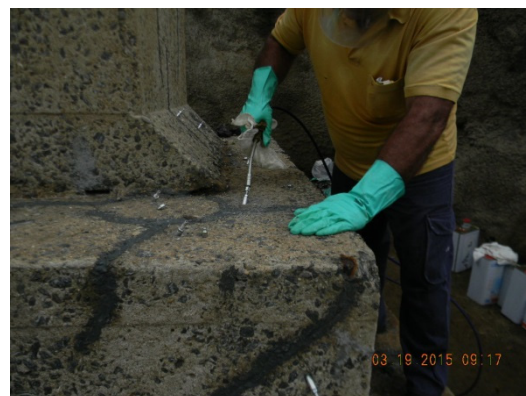
FIGURES 16 and 17: Holes for the insertion of nozzles and implementation of the injection process.

To insert the injection nozzles, holes were made on the diagonal of the crack (45°), each one with 15 cm maximum, in such a way that there was longitudinal cut between cracks at a depth of 12.00 to 30.00 cm. After drilling, nozzles were inserted, Figure 16. After cleaning and drying, injections were initiated with epoxy resin, Figure 17. After applying the resin injection nozzles were removed.

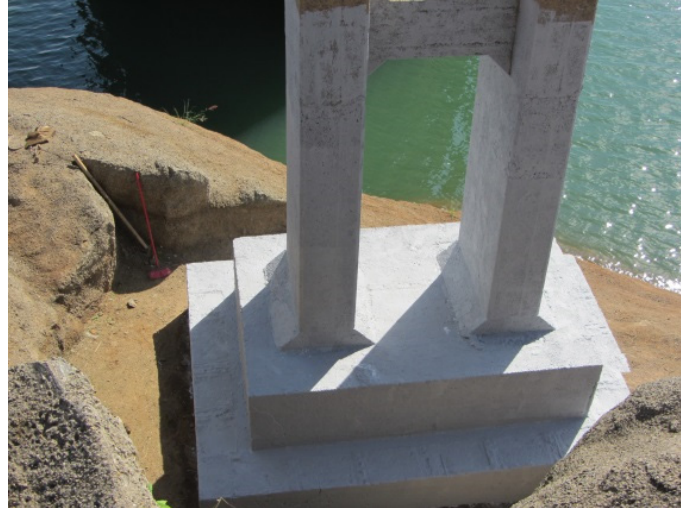
FIGURE 18: View from the set blocks and concrete columns, texture coating, after the injection job.

Finally, as the presence of water is the factor that triggers the alkali-aggregate reactions, texture coating (highly flexible liquid-pure acrylate dispersion) was used as waterproofing agent on the blocks and part of the concrete columns, avoiding the contact of the concrete structure retrieved with the reservoir water and rainfall. This waterproof process was chosen because the possibility of remaining AAR activity, see Figure 18. In this period the quantities of materials indicated in table 2 were applied.
