# EXPANSION SLOT CUTTING TO COUNTERACT ALKALI AGGREGATE REACTION AT PEDRA DAM

## Abstract

The Pedra Dam, located in River de Contas, Bahia state in Brazil, was built between 1964 and 1968. In 1991 the presence of alkali-aggregate reaction (AAR) in concrete structures was detected by means of petrographic and electron microscopic analysis. The concrete expansion caused an internal tension on the end piers of the spillway transmitted by the adjoining blocks; this resulted in operating problems of the left end gate. In order to reduce the effects of the concrete expansion, four expansion slots were cut with diamond coated steel wires. A monitoring system – consisting of 24 joint meters was installed at eight joints between the concrete blocks, including the four expansion slots and the four slots next to them. The displacements measured during the cutting operations showed different behaviors at the left and the right abutments.

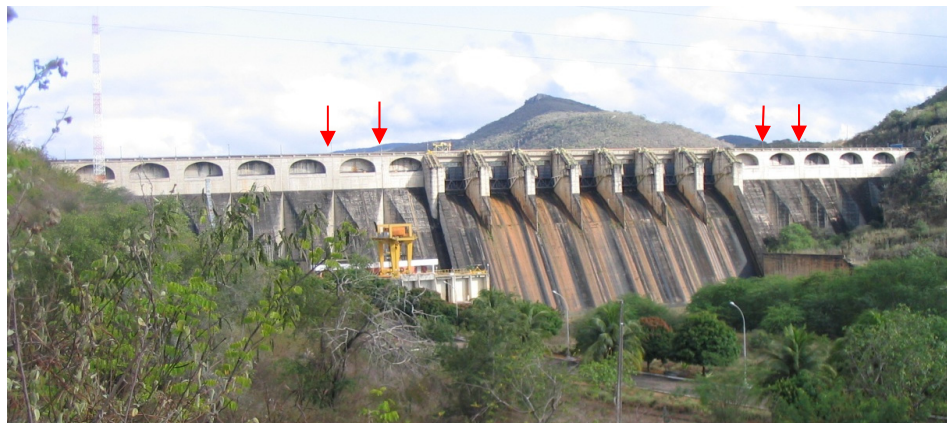
The dam is made of 24 - 17 meters- wide blocks. In the excerpt from the right margin there are eleven blocks, with a total length of 187 m. The left margin has six blocks with a total length of 102 m., between these two portions there are seven spillway blocks with total length of 119 m (see figure 1) equipped with radial gates 9.0 m high and 12.50 m wide. The gates spans are separated by double 2.25 m-wide piers. The spillway flow capacity is 8,000 m<sup>3</sup> with the reservoir level at 231.30 m.

FIGURE 1: Downstream view of Pedra Dam and slots location.

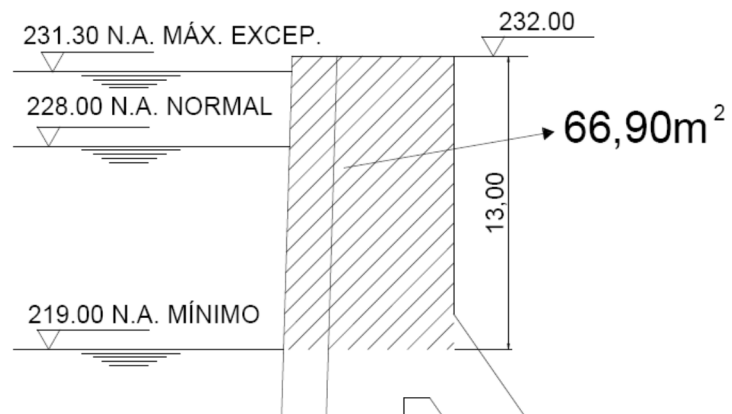
Four expansion slots on the contraction joints at the left and right sides of spillway were part of this project. These expansion slots were located on the contraction joints between blocks B9/B10, B10/B11, B19/B20 and B20/B21 at the left and right sides of the spillway. The slots between the concrete buttresses have an upstream-downstream extension of 5.75 m. They are 13 m deep, 10 mm wide and an area of 66.90 square meters (See figures 3 and 4).

FIGURE 3: Slot cutting area.

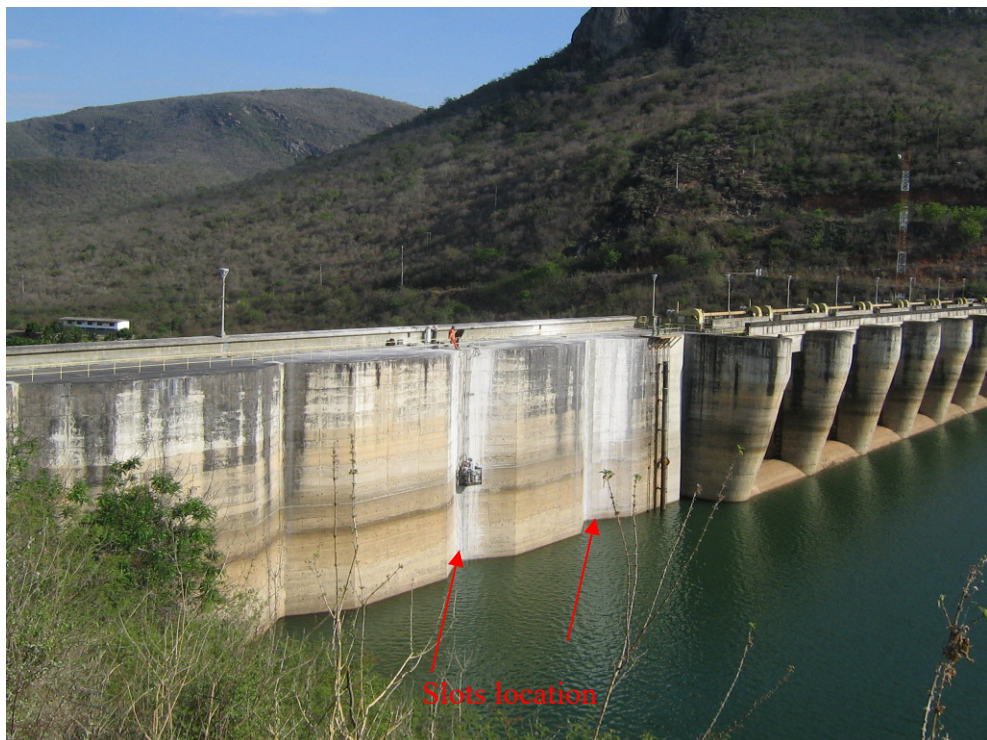
FIGURE 4: Upstream view of left abutment blocks (B19, B20, B21 and B22).

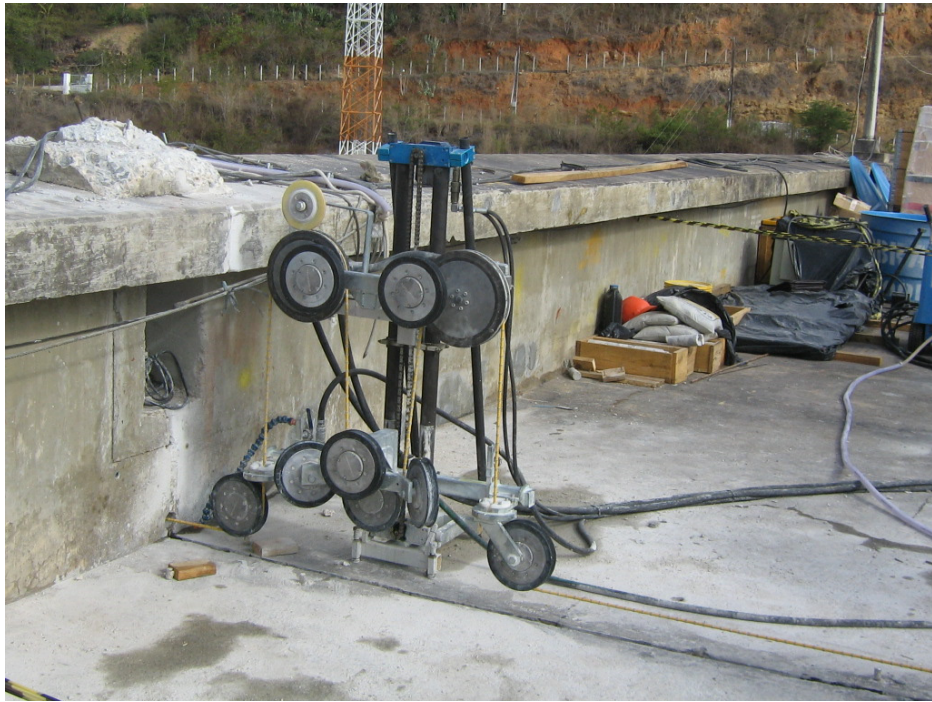
The slots were cut with a 10 mm diameter diamond coated steel wire. The equipment used was the Wire Saw, SK-SD model, Hydrostress (Tyrolit) brand, driven by a hydraulic PPH20 unit (see figures 5 and 6). Depending on the characteristics of crop area as described above, the first slice of cross section was trimmed with the “diving” cutting method, where the wire cuts from top to bottom. For rest of the slices, the “loop” method was used, with the wire passing through the relief holes and running toward the upper bound.

FIGURE 5: Cutting equipment at dam crest near downstream parapet wall.

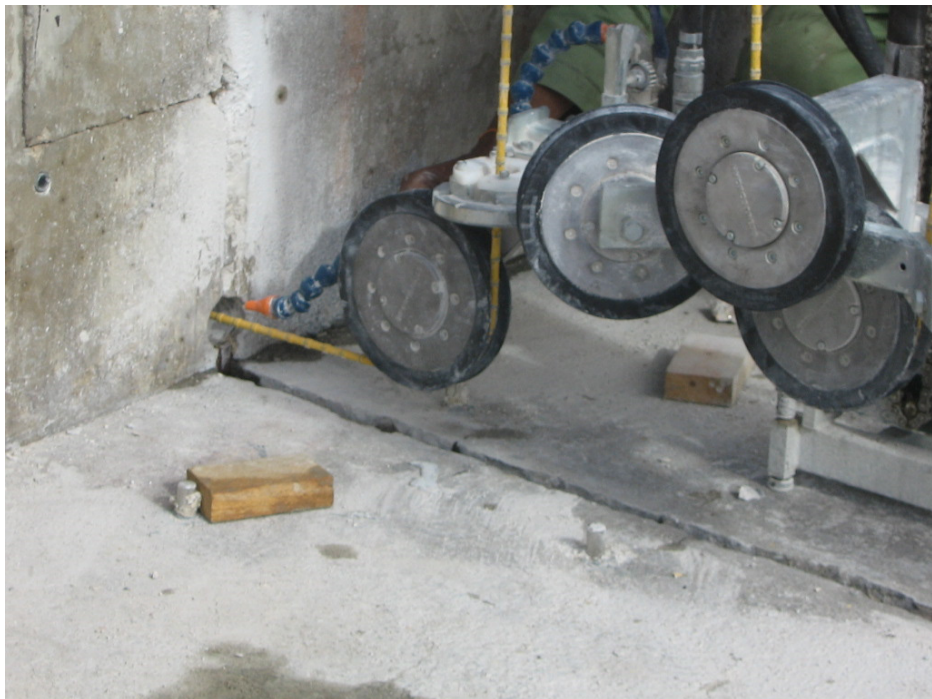
FIGURE 6: Detail of diamond coated cable and water cooling system.

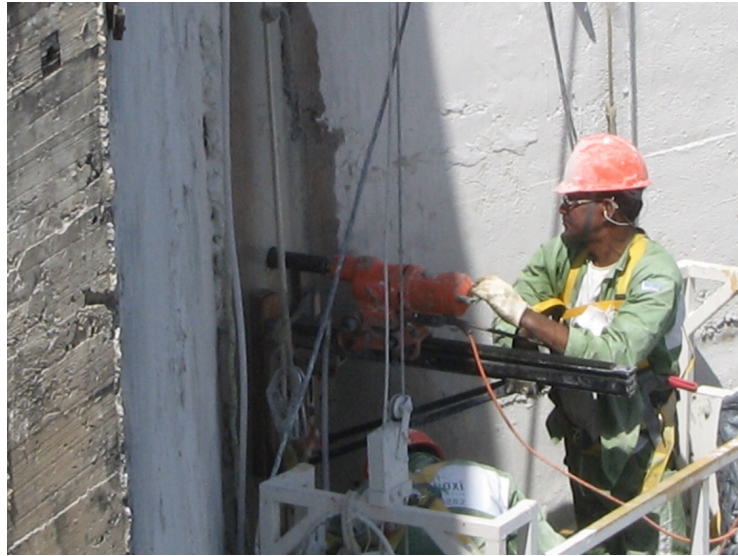
The expansion slots cutting at Pedra dam was performed in October of 2009. Because of its overall length, each cut was broken down into segments made in sequence. Each segment had a maximum height of 3m. It was necessary to drill horizontal relief holes across the massif to prevent the wire from getting stuck during the cutting operation. The wire can seize due to the high internal compressive stresses caused by the alkali aggregate reaction. The holes were drilled with 5 cm diamond drill bits.

FIGURE 7: Relief hole horizontal drilling.

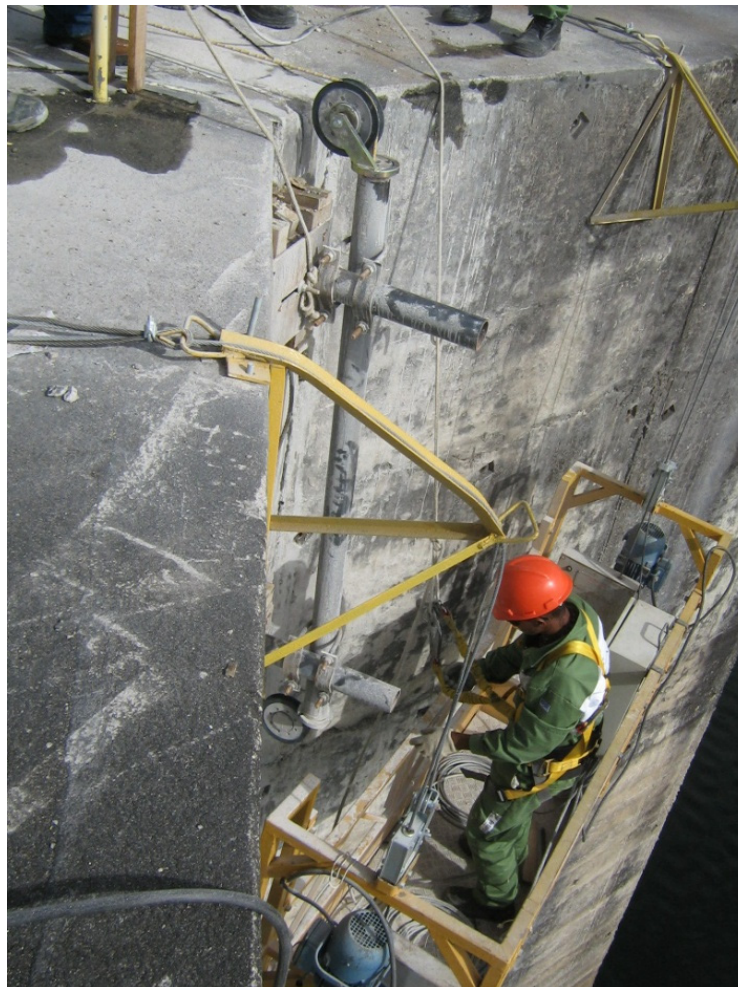
FIGURE 8: Cable guiding system and suspended working platform.

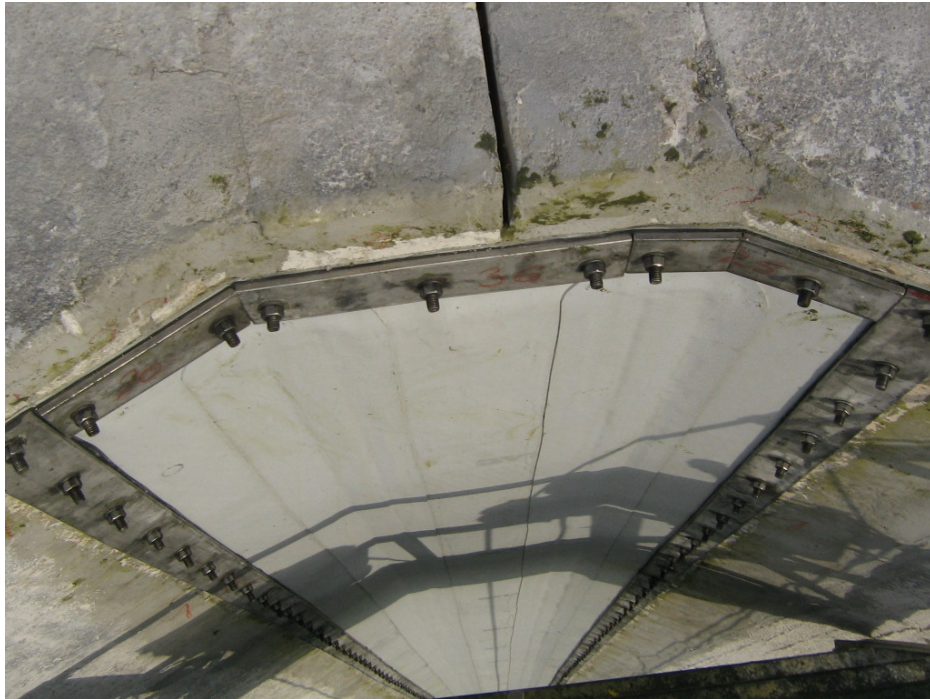
FIGURE 9: Slot and geomembrane sealing system after completion.

The waterproofing of the expansion slots was designed through a exposed geomembrane drain system supplied and installed by Carpi Brasil Ltda. The system is composed of a polyvinyl chloride (PVC) geocomposite laid over a flexible PVC geomembrane antipuncturing double layer, fixed along the perimeter with stainless steel batten strips and chemically anchored bolts. Each geomembrane system covers 1 m wide by 14 m high surface on the upstream face of the expansion slots.

This installation was performed in four weeks. The work was done over an area of 56.0 m<sup>2</sup> (14.0 m high, between the elevations levels of 218 and 232m. The antipuncturing flexible PVC geomembrane support layers are fixed to the concrete along both sides with stainless steel profiles and impact bolts (see figure 9).

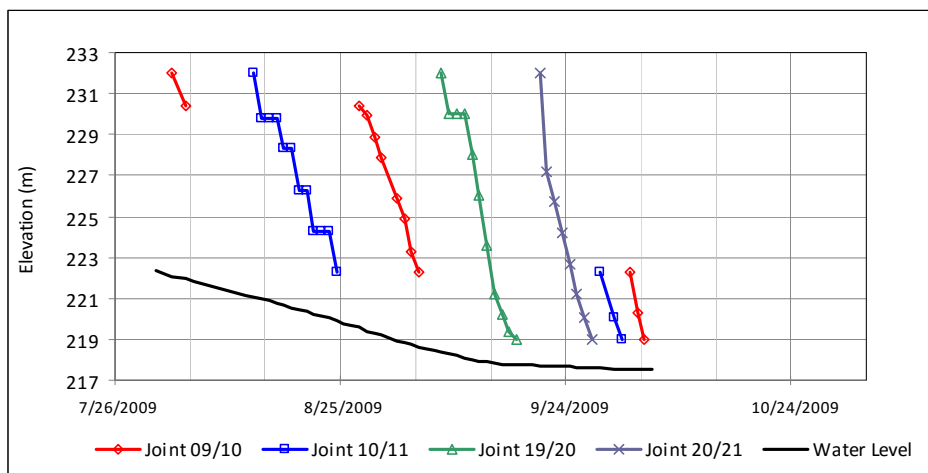
To make the cuts between the elevations of 219 m and 232 m, the reservoir was drawn down to El 217.5 m. The joint B9/B10 was cut into 3 steps and the joint B10/B11 in 2 steps due to interference with the reservoir water level (see Table 1 and Figure 10).

FIGURE 10: Slot cutting and reservoir drawdown chronology.

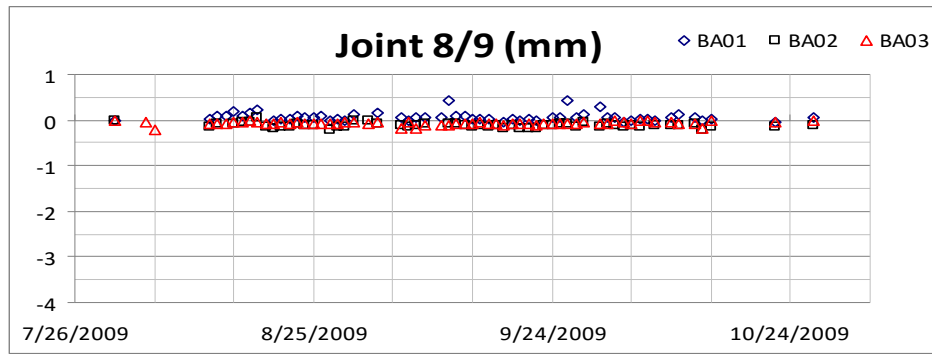
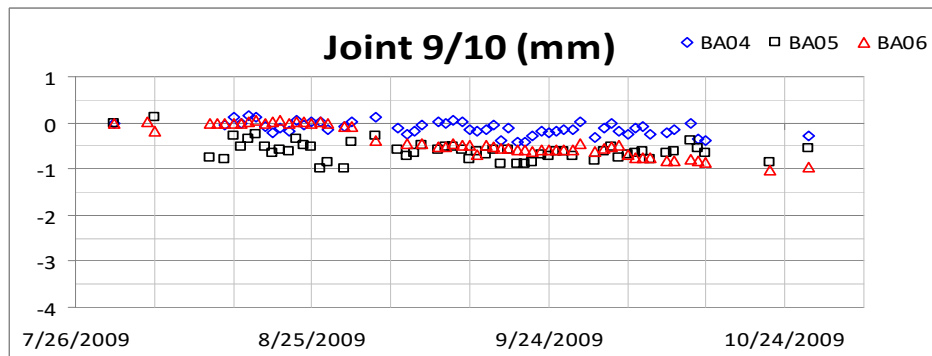
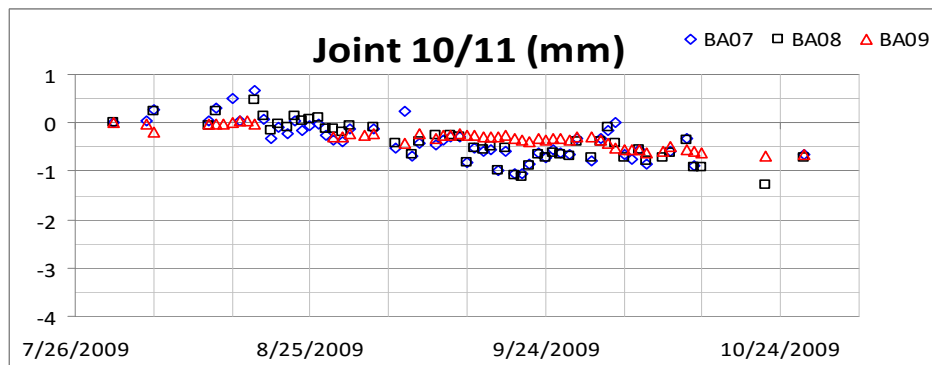
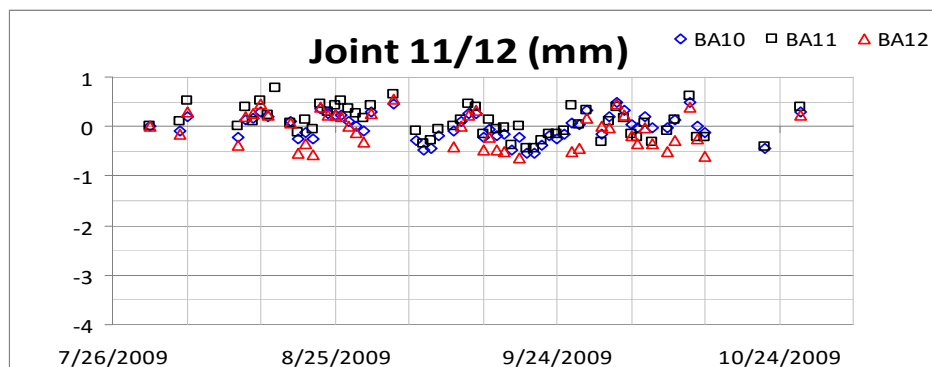
Figures 12 and 13 present the slots gap graphics monitored by the joint meters, from August to October of 2009. It is noted that: in joints 8/9 and 21/22, neighboring joints from the slots cut, showed no movement; joints 11/12 and 18/19, between the spillway and the internal left and right abutment extreme blocks, presented large dispersion in the readings which varied between -0.5 mm and 0.5 mm. Joints cuts 9/10, 10/11, 19/20 and 20/21 showed a clear trend towards closing the joints gaps. These closures were greater at the left abutment joints, about 1.5 mm, while at the right abutment joints were of about of 1 mm

FIGURE 11: Right abutment joints gap monitoring.

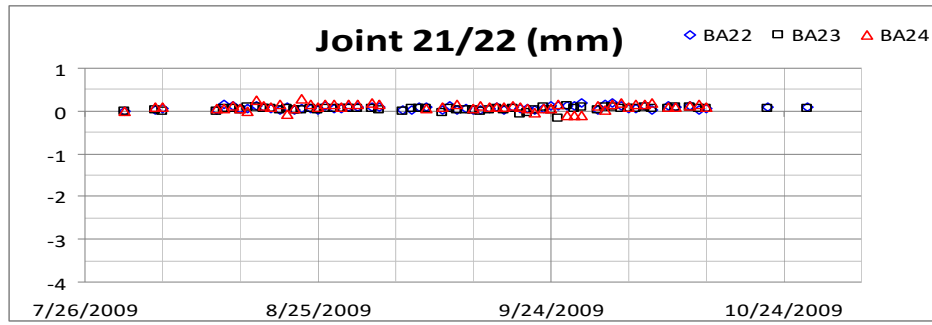
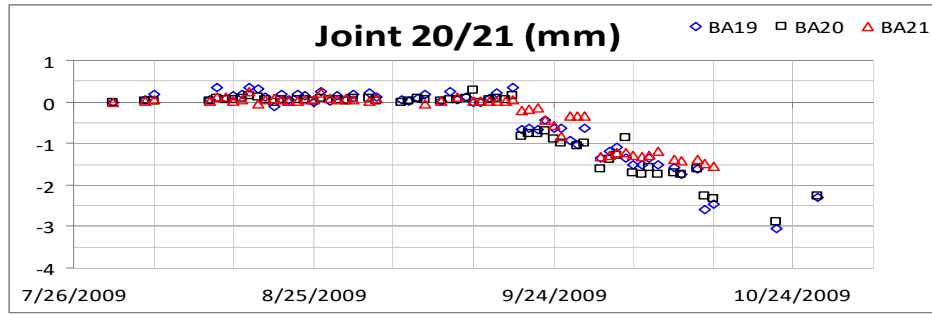
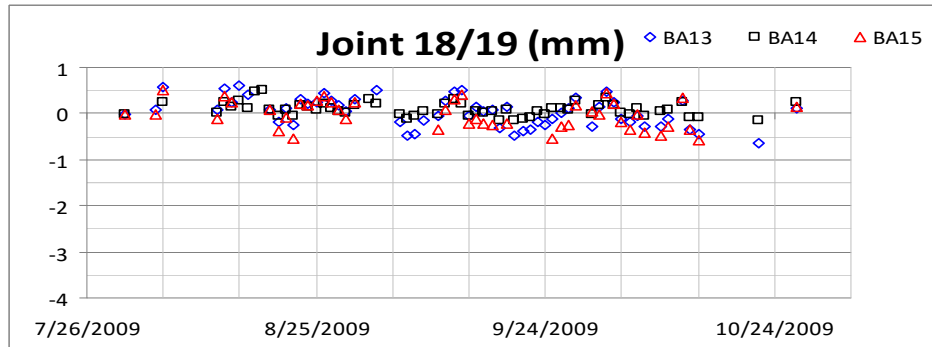
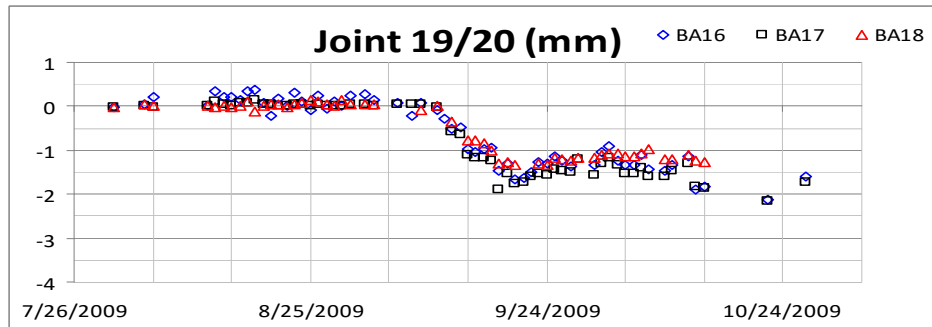
FIGURE 12: Left abutment joints gap monitoring.
