20-YEAR RESULTS OF AN IN-SITU MONITORING STUDY OF LARGE CONCRETE ELECTRICAL TOWER FOUNDATIONS AFFECTED BY ALKALI-SILICA REACTION (ASR)

Benoît Durand^{1*}, Benoît Fournier²

¹Hydro-Québec Research Institute, QC, CANADA

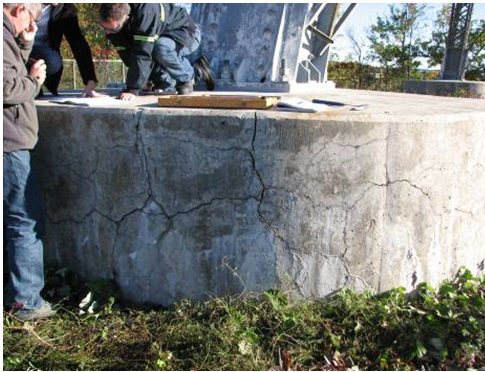
FIGURE 5: Example of a foundation injected in 2001 (2013 inspection).

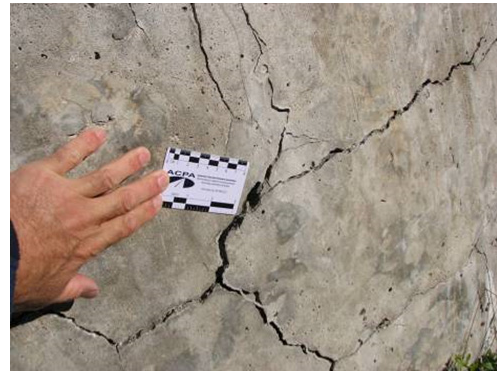
FIGURE 6: Close-up of wide cracks (2015 inspection).

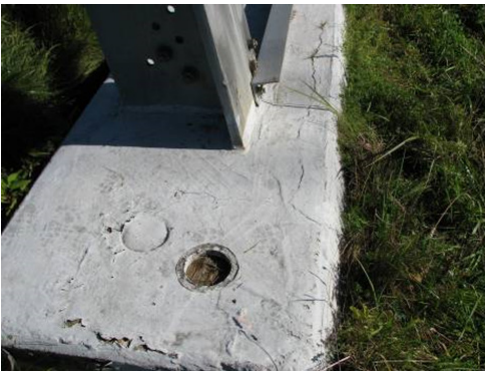
FIGURE 7: Example of a foundation covered with a membrane (2013 inspection).

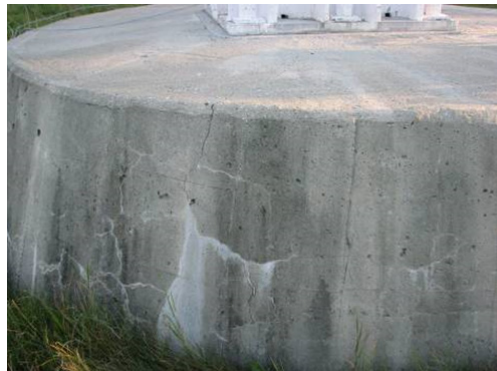
FIGURE 8: Example of an encapsulated foundation repaired in 1996 (2013 inspection).

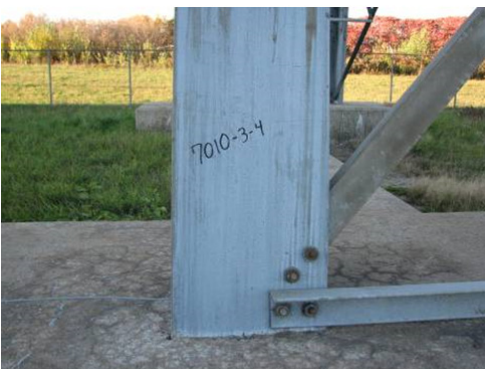
In the fall of 1991, ten core samples were taken from the reinforced-concrete tower foundations of the 735-kV transmission lines that cross the St. Lawrence River at Québec City and Île d'Orléans. It was noticed at that time that the degree of cracking was highly variable; for instance, the concrete made from limestone aggregate was usually cracked, while only one concrete foundation incorporating greywacke aggregates showed cracking. The 2012-2013 survey revealed that more foundations with greywacke aggregates developed a typical map cracking pattern [7].

FIGURE 9: Example of a foundation with a greywacke aggregate (2013 inspection).

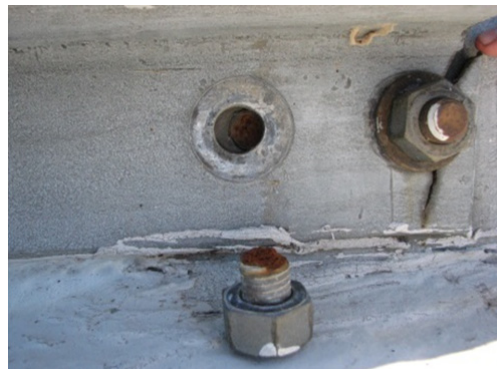
The visual observations allowed updating the previous information relating to each of the foundations, some errors on the type of intervention were indeed noted and corrected. Updated observations revealed the presence of non-listed cracked steel angles in several places. It was also noted that several of these steel angles were turn around and re-bolted on their undamaged side. Direct visual observations of some the most deteriorated foundations, regardless of the expansion rates measured, revealed that at some stage of surface crack widening, deterioration progresses rapidly with water infiltration and freezing action. Therefore, it can create large pieces of loosened concrete down to the first rows of steel reinforcement. Exposed or partially exposed steel reinforcements can also corrode and further increase the cracking and spalling of the exposed concrete surfaces of the tower foundations.

FIGURE 10: Example of ruptured bolt and steel angle (2013 inspection).

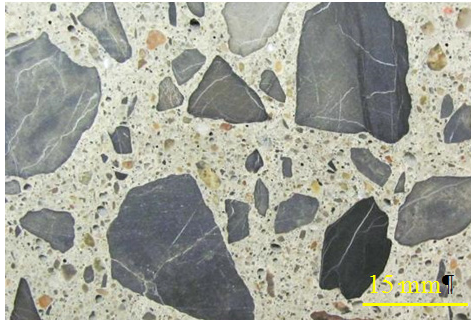
FIGURE 11: Limestone aggregates with multiple silica gel veinlets (polished surface) (2015 inspection).

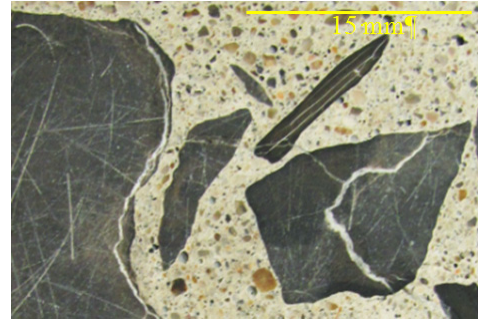
FIGURE 12: Limestone aggregates with multiple silica gel deposits (polished surface) (2015 inspection).
