SPILLWAYS AFFECTED BY ALKALI-AGGREGATE REACTION : TWO CASE STUDIES FROM HYDRO-QUEBEC

Nathalie Ishak^{1*}, Stéphane Meunier², Fateh Boussaha¹, Claudia Correa¹

¹Hydro-Québec Production, Structural dam engineers, Montréal, Québec, CANADA

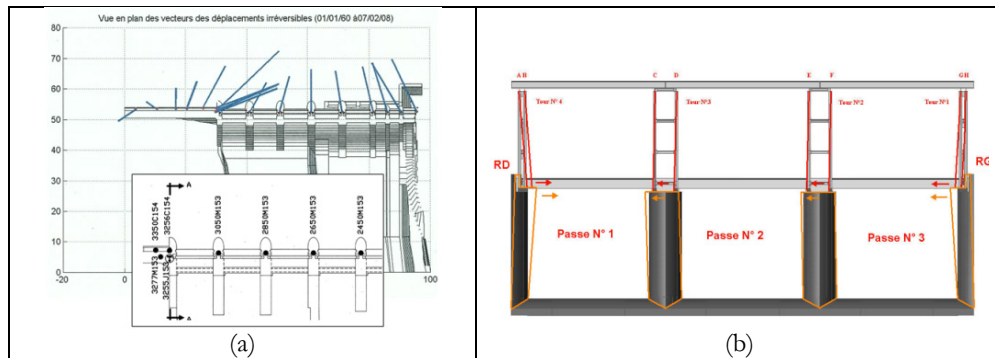
FIGURE 2: Displacement and deformation measurements:
(a) deformation of piers from top (b) verticality and flatness of spillway piers' grooves.

The first disorders attributable to concrete swelling are functional such as the jamming of spillways' gates and deformation of concrete around generating units. Monitoring is carried out by measuring deformation of piers from either side of spillway gates (FIGURE 2(a)) and around generating units.

Verticality and flatness of spillway piers' grooves can also be measured in order to check if gates are stuck, or to predict the time remaining before that will occur (FIGURE 2(b)). These measures may also be performed on permanent hoist supporting structures (FIGURE 3(a)).

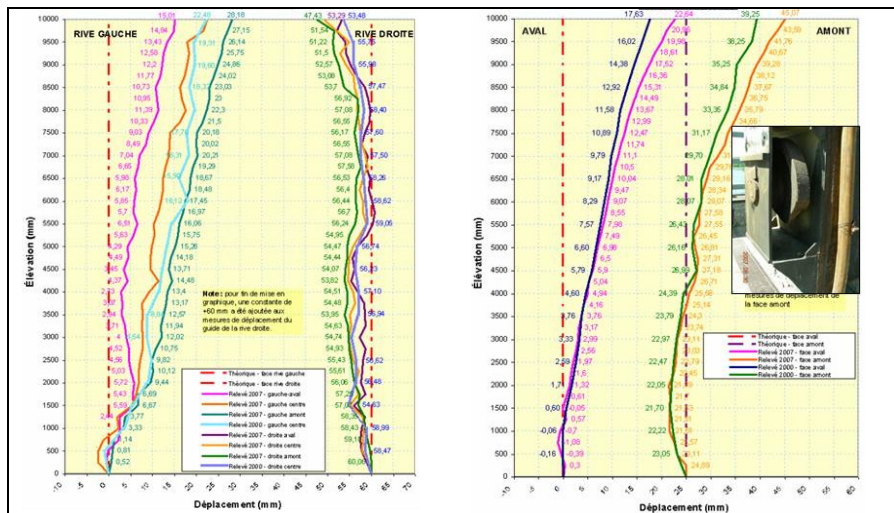
FIGURE 6: Rapide-des-Iles secondary spillway – Surveys.

The embedded parts of the gates have been the subject of many studies. The verticality of the piers groove was measured. The results for gate #5 are showed in FIGURE 6 and are summarized in TABLE 1. The most critical measurement is a lateral inward vertical displacement of 35mm. Over the 40 years of life of this structure this is an average displacement of about 0,875 mm per year.

TABLE 1: Rapides-des-Îles secondary spillway – surveys vs standard tolerances.

Measurement description	Surveys	Standard tolerances
Relative displacements of piers (left-right axis)	From 23 to 45 mm (crest)	3 mm
Inclination of piers (towards upstream direction)	From 20 to 28 mm (crest)	3 mm
Bearing guides flatness defect	From 2 to 8 mm over 0,5 m in height	0,4 mm over 2 m in height

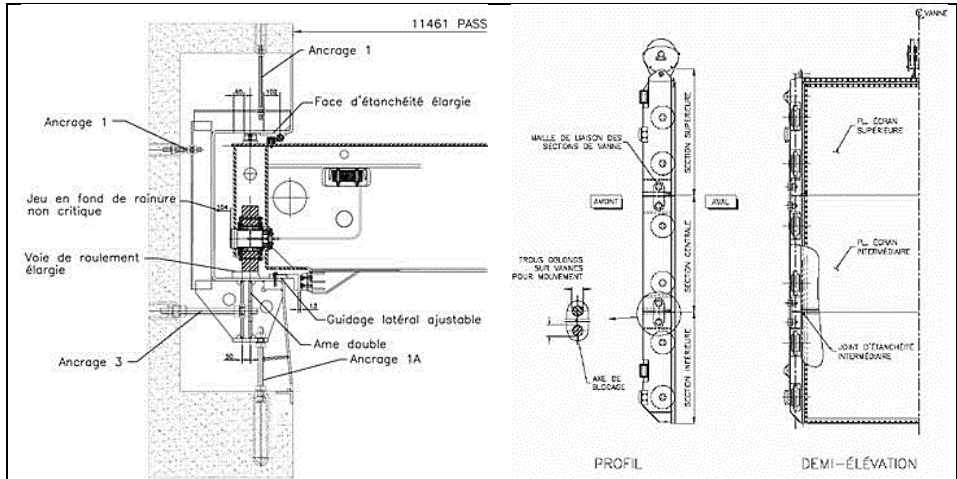
FIGURE 7: Rapide-des-Iles secondary spillway – Gates design.

Studies mentioned the presence of broken wheels, deformations of the skin plate and end girders (with wheels assemblies), and damaged to the sealing system (distorted and corroded parts). In 2007, the measured deformation of the end girder beams of gate #5 was 7mm. The maximum deformation of the skin plate was 16mm. Such disorders are closely linked to poor straightness of the gate's roller path.

To a lesser extent, the AAR also affects the straightness of the roller path on which the gates' wheels are traveling. These straightness defects cause significant overloads to the structures, compromising their durability, reliability and safety. It results in broken wheels, distorted beams and cracked concrete.

The existing vertical gates were replaced by isostatic gates. These gates consist of several sections that are fastened together by mechanisms allowing free rotation and displacements in the upstream/downstream direction. Each section is mounted on only four wheels, thereby forming an isostatic system, unlike rigid gates which are statically indeterminate. All four wheels of an isostatic gate stay in contact with the roller path, providing a predictable and controlled load distribution to the wheels gates girders, as well as to the embedded parts, roller path and supporting concrete, as shown in FIGURE 7.

The new lateral embedded parts are designed based on future movements of the piers (lateral average displacement of 0.875 mm/year per pier toward center of the sluice. In order to assess those displacements, each embedded part includes:

- A wider roller path (+50 mm);
- A wider or double web in order to control the flexural moments developed in the beam under an eccentric wheel load on embedded girder;
- An adjustable lateral guide;
- A wider sealing face;
- A non-critical depth of gates' girders.

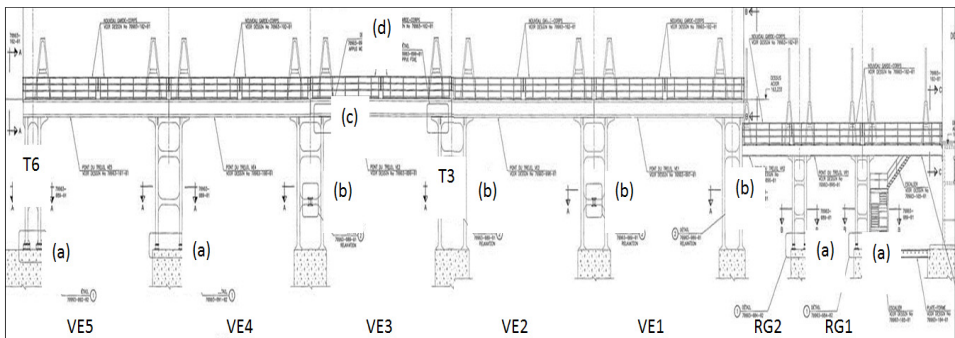
FIGURE 9: La Tuque hoist supporting structure: rehabilitation design:
 (a) adjustable fixed end (b) adjustable lower member
 (c) bridge or beam supports (d) hoists adjustable supports.

After structural analyses were performed, considering the deformed state, it was possible to determine the main effects of the evolving situation of displacement of the spillway's piers due to the AAR on the hoist supporting structure and target mitigation measures. Overall, the main effects are:

- An accumulation of stresses at the base of the towers;
- A change in the structural scheme at the support tower/bridge (loss of a degree of freedom);
- A misalignment of the screw winch.

The rehabilitation of the overhead hoist supporting structure is presented here because the solution is targeted and innovative. In making the design shown in FIGURE 9, a comprehensive and interdisciplinary approach was adopted. The decision to rehabilitate the superstructure arises from various feasibility studies, and mainly for the following reasons:
