VAL DE LA MARE DAM  
JERSEY, CHANNEL ISLANDS

Lewis H. Coombes  
Engineering and Resources Consultants

**ABSTRACT**

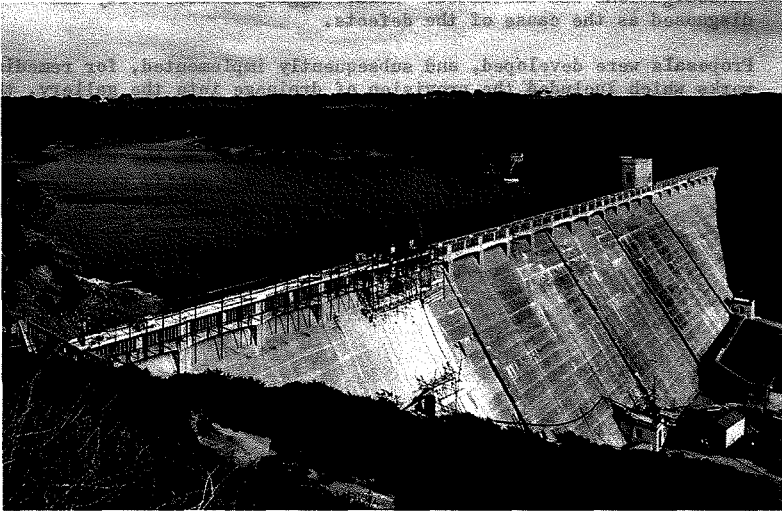
FIG. 1  
Val de la Mare Dam

The first signs of trouble appeared in January 1971, following a period of colder than usual weather. Small upstream relative movements in the order of 6 to 12 mm were noticed on certain sections of the concrete handrail of the crest walkway bridge, and darkening and damp patches were observed at the same time on the downstream face of the dam on the same blocks on which the movements had occurred, with the surface showing random hair-line cracking.

After consideration of many alternatives, the decision on the type and extent of remedial measures was made related to Block 6 and Blocks 10-20. Block 6 is situated near the right abutment, and is clearly indicated on Fig. 1 by the presence of scaffolding and equipment. Blocks 10-20 are in the centre section of the dam between the two gallery openings sited against the downstream toe.

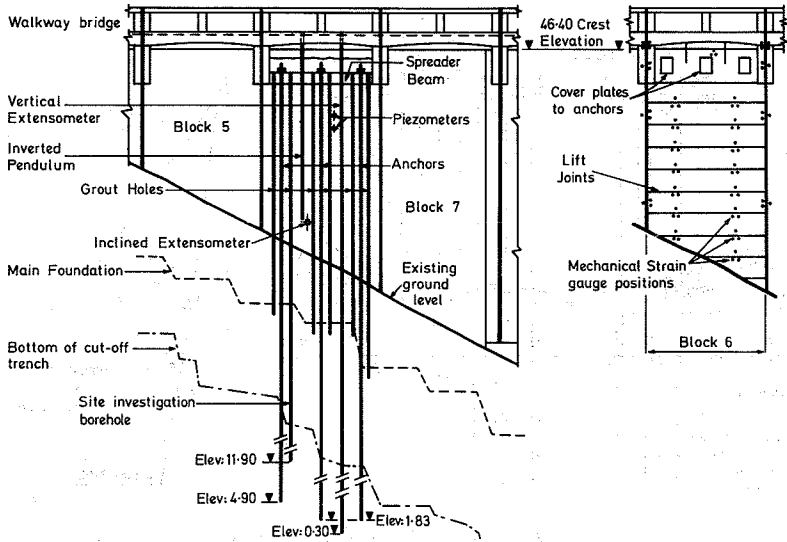
Fig.2 Locations of anchors, grout holes and instrumentation in Block 6.

In addition, one vertical borehole was drilled from the crest of Block 6, down through the concrete of the dam into the proposed anchorage zone. The position in plan of this hole coincided with one of the proposed grout holes in the centre of the block (refer to Fig. 2). Laboratory tests were carried out on cores recovered from the boreholes - the tests produced data on the elastic modulus and poisons ratio of the rock, and the shear strength of the joints. All boreholes encountered very jointed and fissured rock.

Six holes were drilled vertically down through the concrete of the dam at a distance of 1.2 m from the upstream face and between 0.9 m and 1.32 m apart. Five of the holes were drilled in 80 mm diameter - the depth of the holes varied from 13.5 m to 17.0 m such that the bottoms of the holes were approximately 0.6 m into the concrete of the cut-off trench. The sixth hole, chosen as the position of the site investigation borehole, was cored in 100 mm through the concrete and foundation rock for a total depth of 34.5 m. The positions of the grout holes are shown on Figs. 2 and 3.

The anchoring of Block 6 consists of 3 No. 40 mm diameter 'Macalloy' high tensile anchors fixed in 115 mm diameter holes positioned symmetrically across the width of the Block at 2.23 m centres and drilled through the concrete of the dam into the foundation rock - refer to Figs. 2 and 3.

Instruments were installed in and adjacent to Block 6 to monitor behaviour during the stressing of the anchors and at regular intervals after the stressing. The individual sitings of the instrumentation are indicated diagrammatically on Figs. 2 and 3.
