THE EFFECT OF ALKALI-AGGREGATE REACTION ON THE STRENGTH  
AND DEFORMATION OF A REINFORCED CONCRETE STRUCTURE

G E Blight and M G Alexander  
Department of Civil Engineering  
University of the Witwatersrand  
Johannesburg, South Africa

1. ABSTRACT

A portal that forms part of a major double deck road structure in Johannesburg has deteriorated, as a result of alkali-aggregate reaction, to an extent that is visually alarming. The upper portions of the columns and the upper beam of the portal show the greatest degree of deterioration, and an ultrasonic pulse velocity survey indicated that the visible surface cracking deeply penetrates the concrete.

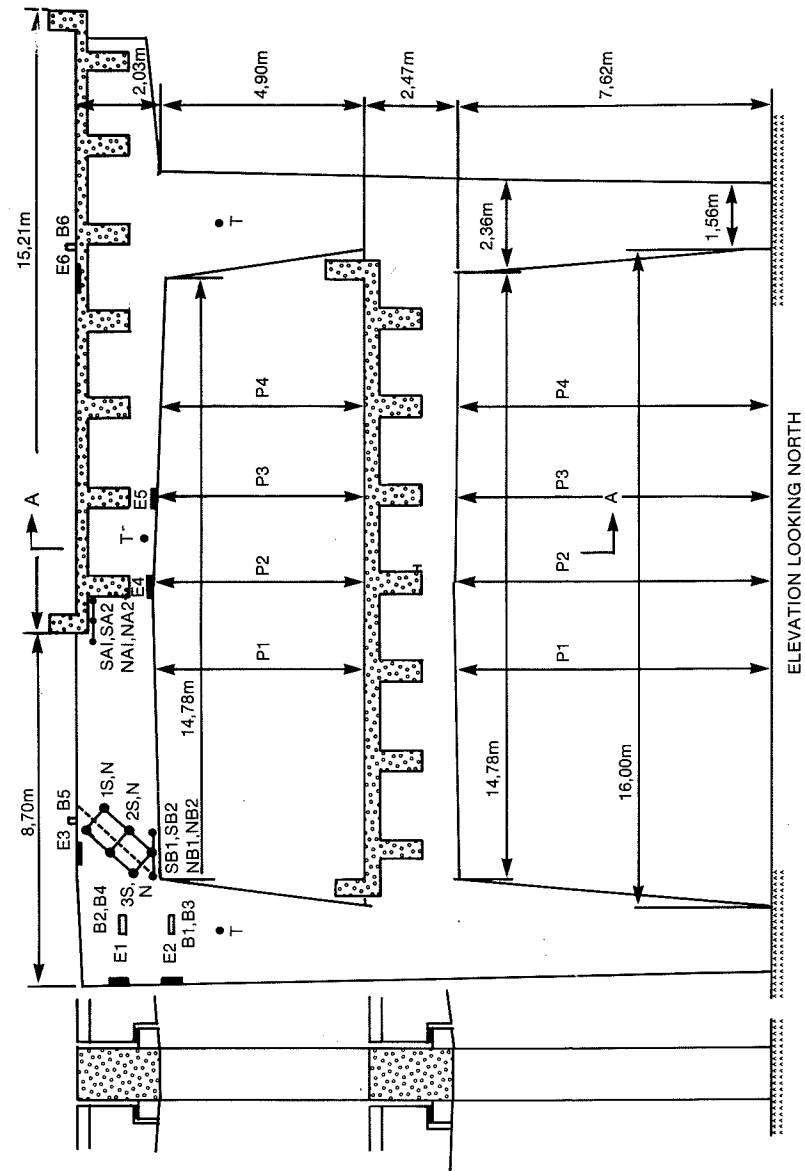
FIGURE 1. Elevation of portal frame looking north and showing positions and types of instruments:

An elevation of the portal is shown in Figure 1. The western half of the top beam of the portal and the cantilever projection to the east have experienced the worst degeneration.

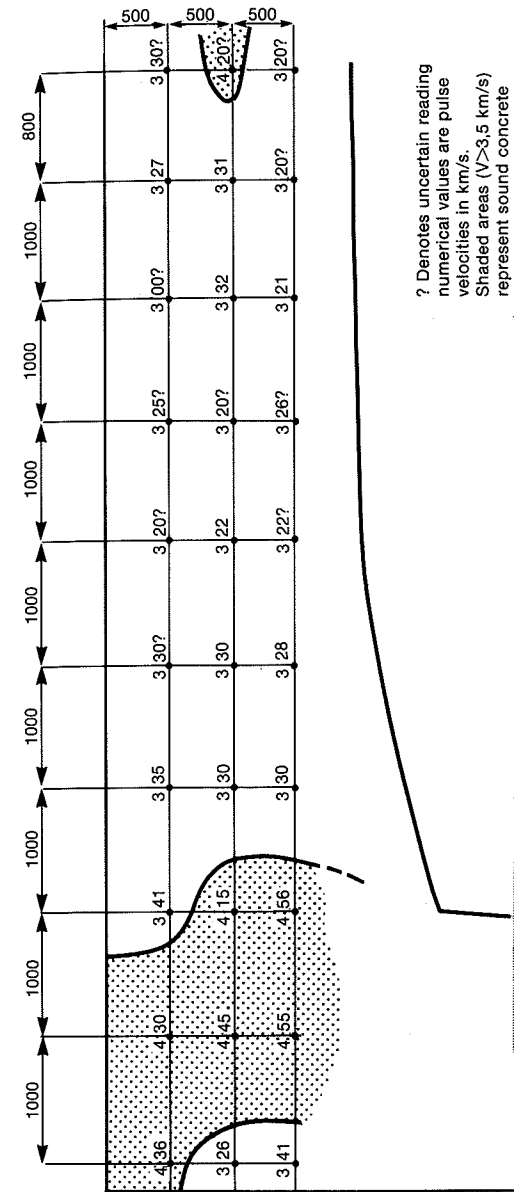
Figure 2 shows the results of an ultrasonic pulse velocity survey of the west end of the upper portal beam. The numerical values represent measurements of the ultrasonic pulse velocity made with a portable 'Pundit' instrument. Pulse velocities greater than 3,5 km/s are taken to represent sound concrete. Those less than 3,5 km/s represent concrete that has undergone some degree of deterioration. The limit of 3,5 km/s had been determined earlier /1/ by comparing ultrasonic pulse velocities measured in the laboratory on cores that had suffered deterioration, either from alkali-aggregate reaction or by deliberately cracking them under stress. It is clear from Figure 2 that almost the entire beam had deteriorated to some extent. Figure 3 shows the severe deterioration of the western face of the top of the west column.

FIGURE 2. Ultra-sonic pulse survey on west side of upper portal beam.

? Denotes uncertain reading  
 numerical values are pulse velocities in km/s.  
 Shaded areas ( $V > 3.5$  km/s) represent sound concrete

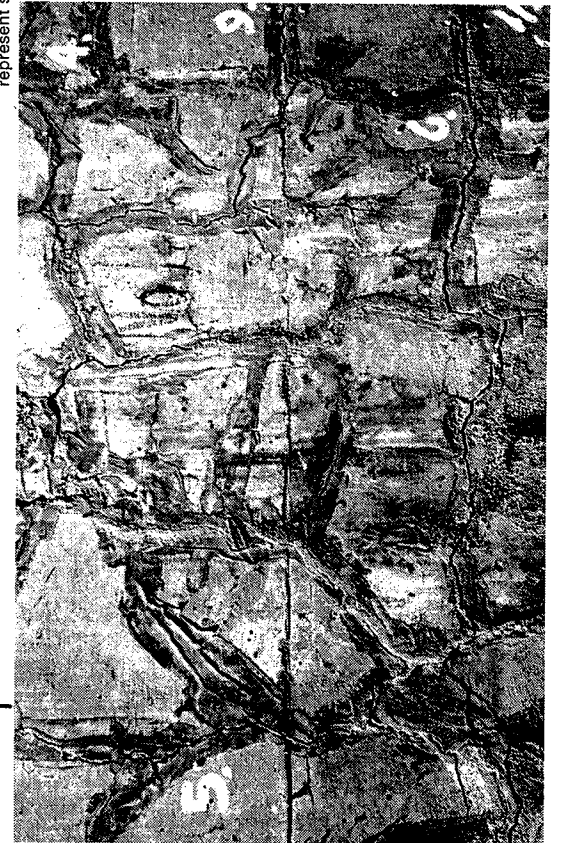
FIGURE 3. Deteriorated condition of western face of west portal column. The scale can be judged from the pair of demec targets below the pointed figure 9 at the right. These are 100 mm apart.

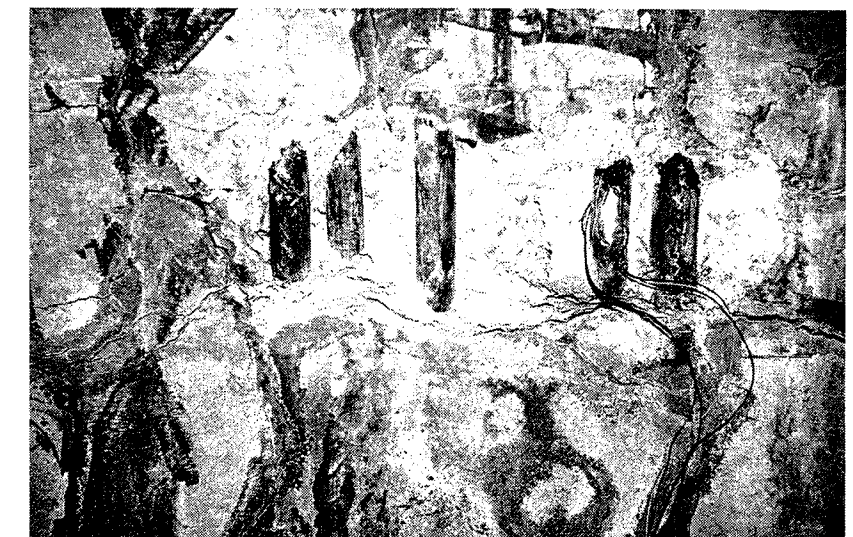
Figure 6. Main reinforcing bars in column exposed. Strain gauges mounted on second bar from right.

Figure 6 shows the main vertical reinforcement exposed in the west column near the beam-column junction J. (Note the deteriorated condition of the concrete around the exposure). Strains were recorded manually via a strain bridge.
