Investigation of the deteriorated concrete of a swimming pool and the repair is described.

Keywords: Alkali-aggregate reactions, swimming pool.

DAMAGES TO SWIMMING POOLS DUE TO ALKALI SILICA REACTIONS

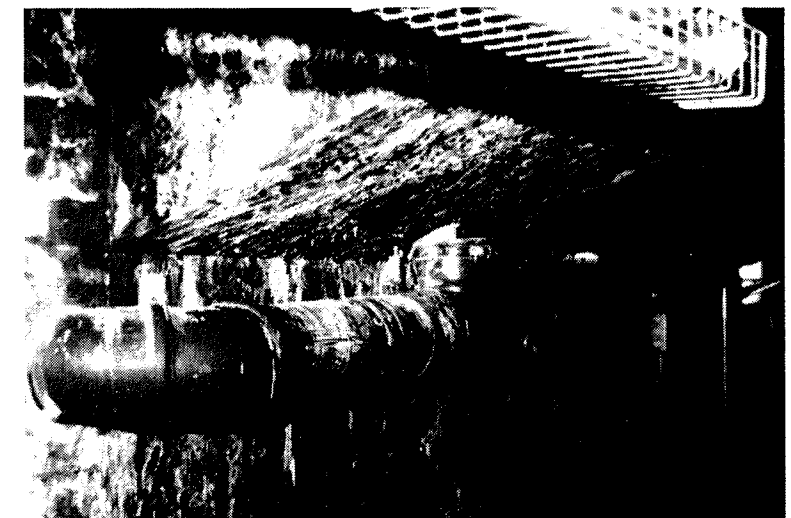
Fig. 1: Deteriorated concrete wall in the swimming pool.

The cracks were several times injected with epoxy from outside, but new cracks continued to appear. After a couple of years brown or colourless exudations of gel were observed on the outside surface of the vertical concrete walls of the pool. The gel was mostly accompanied by map cracks. The gel was relatively thin, being even able to flow through the pores of the concrete. Gel was observed on the surfaces also at places without visible cracks.

Concrete cores were drilled out both from the inside and from the outside of the vertical walls while the pool was still in use. The microscopic examination of thin sections made of the concrete of the cores confirmed that the concrete was severely attacked by alkali-aggregate reactions. The reactions were even observed in dense flint particles in the coarse aggregates. This is considered unusual and demonstrates that the exposure conditions are very aggressive.

The reasons for the very extensive reactions are due to the unfavourable conditions that prevailed when the concrete was cast, and to the unsuitable selection of the sand aggregates for the concrete. Cracks due to insufficient reinforcement undoubtedly aggravated the reactions.

As the concrete contained both silica and alkalis, and alkalis were available from the pool water, the only possible way to stop the deterioration and save the construction was to avoid contact between the saline pool water and the concrete by applying an impermeable membrane to the inside of the wall. During the subsequent drying of the concrete the alkali-aggregate reactions might become more deleterious since the actual concrete-mix might reach a pessimum proportion for humidity, like it has a pessimum proportion for silica content. However, examination of other similar concrete constructions, which have been repaired, did not indicate the presence of such a pessimum.

The whole ceramic cladding was removed and the installations were removed to the necessary extent. The concrete surface was cleaned and patched and coated with a bitumen membrane. The watertightness at all inlets and outlets through the membrane was established by steel flanges.

In order to protect the membrane against mechanical damage and to create support for a new ceramic cladding, the membrane was covered by 10 cm reinforced concrete. The concrete was connected to the existing construction by steel anchors with flanges.

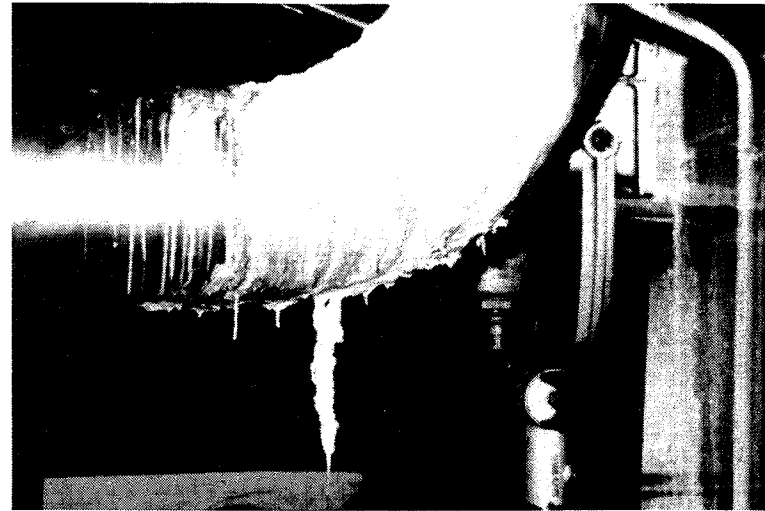
Also the walls of the pool caused problems due to cracks and water penetration,

which created abundant stalactite formations and resulted in corrosion of the operation installations in the inspection corridor.

Fig. 2: Stalactites on the installations in the inspection corridor.

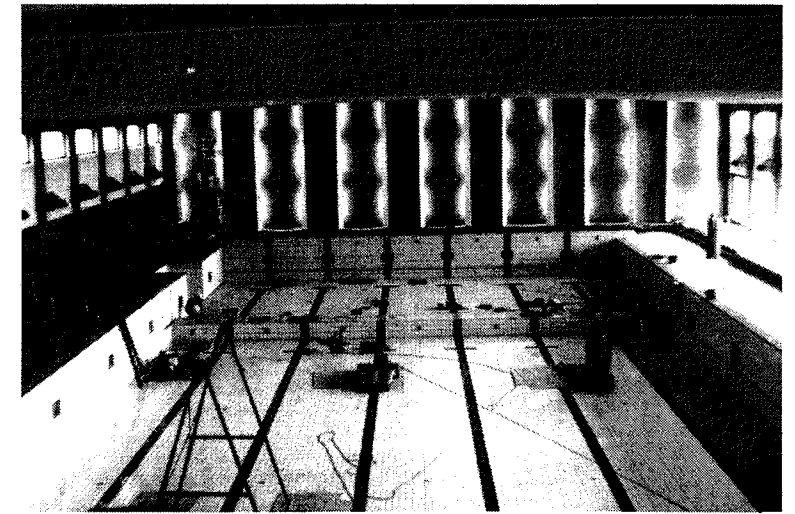
Fig. 3: The empty pool.

The 50 m long and 1.8 to 4.0 m deep swimming pool was emptied for further investigation. Shortly after it was found that a thin, viscous alkali-silica-gel was pressed out on the inside walls of the pool through microscopic cracks in the ceramic cladding.

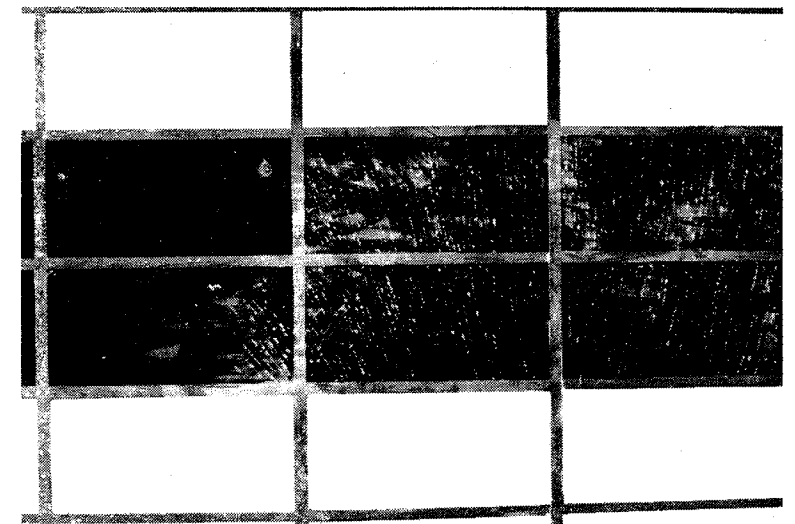
Fig. 4: Gel on the ceramic cladding.

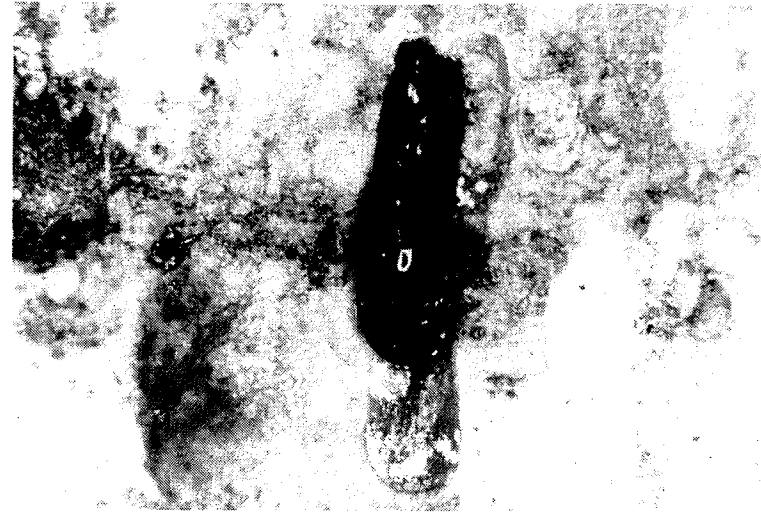
Fig. 5: Alkali-silica gel on the outside of the wall.

Figure 5 shows 3 generations of alkali-silica gel. In the bottom of the picture an old precipitation drying to a white lump is found. Above this a younger drop, and at the top a fresh adhesive precipitation is seen.

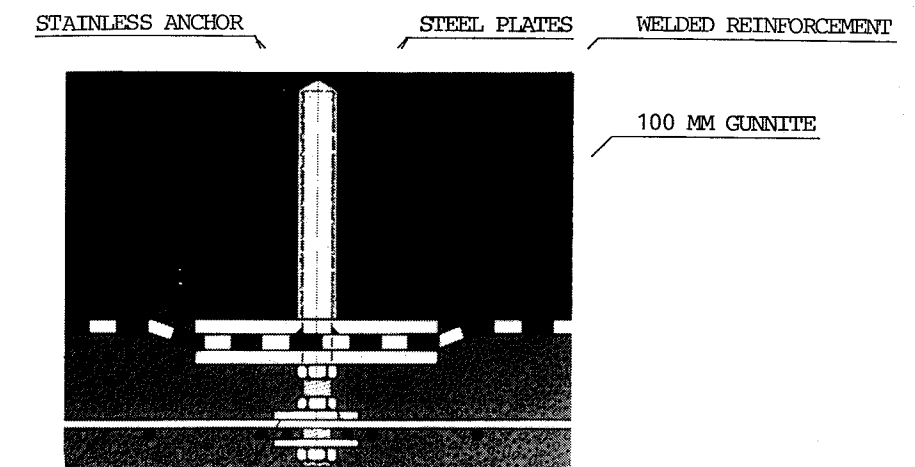
Fig. 6: Principles of plateanchor.

The internal layer of concrete was connected by steel anchors (plateanchors) to the existing construction. The principles in a plateanchor is illustrated in Figure 6.
