SERVICE LIFE PREDICTION AND ALKALI-SILICA REACTIONS

Anders Nielsen
civ.ing.,tekn.dr.

Technological Institute, Building Technology
Taastrup, Denmark*)

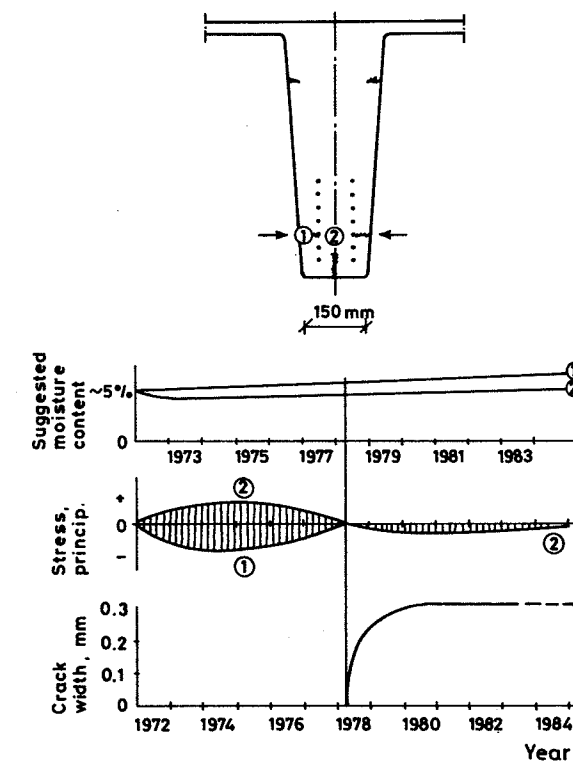
The beams were cast during the winter 1971-72, and put in place during 1972. In 1978 cracking was seen on some of the ribs. The cracks occurred as longitudinal cracks on the underside of the ribs and on the sides about 150 mm above the underedge. The cracks were limited to 8 of the 11 beams, but on these beams both of the ribs were cracked. The lengths of the cracks varied from 5% to 90% of the beam length. The deformations perpendicular to the cracks were followed by strain measurements. In 1979 most of the deformations had occurred and from 1980 no further cracks or deformations were seen; some of the cracks even started to contract. The beams were inspected latest June 1983.

As mentioned the beams were cast in winter. The cement content was 445 kg/m³. During the curing the temperature reached 60°C. With this temperature the beams were taken from the production hall to the outside stock, where the temperature was around 0°C. The geometrical and climatic conditions were so, that if no wind was blowing, the cooling of the beams was so slow that the thermal differences between the center and the rim of the beams were harmless. But if the wind velocity was about 5 m/s thermal differences above 20°C were produced causing cracking of the beams. So literally the cracking has occurred as the wind blew /2/. The cracks were formed parallel to the prestress direction. Thermal cracks normally are invisible with the naked eye when thermal equilibrium is reached.

So, the reason for this special crack pattern shall be found in the production conditions. During the first 7 years of the life time the water penetrates to the center causing stresses as principally shown on fig. 1. In the next 2 years the cracks develops, and hereafter nothing more happens.

Fig. 1. Crack development at the Hornsherreds waterworks. Top: Cross section of one rib of the TT-beam. The placing of the cracks is shown. Bottom: Principal sketch of the development of the stresses as the water penetrates the body. When compression occurs in the central parts of the beam the cracks will open.

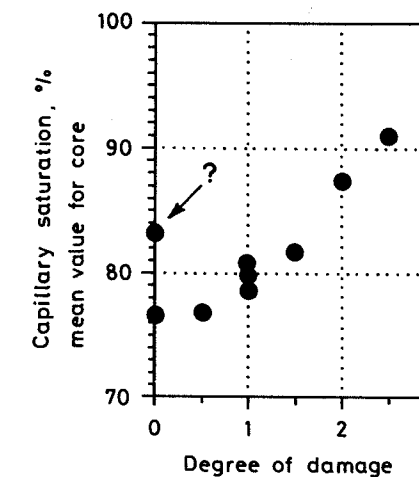
Fig. 2. Cores from 10 structural members of 4 motor road bridges. Mean value of S_{cap} for each core versus degree of damage.

Fig. 2 shows the mean value of S_{cap} for each core versus the degree of damage. A reasonable correlation is seen for 9 values. One value (shown by a question mark) falls outside the common pattern having no damage and a relative high S_{cap} . This case is explained below.

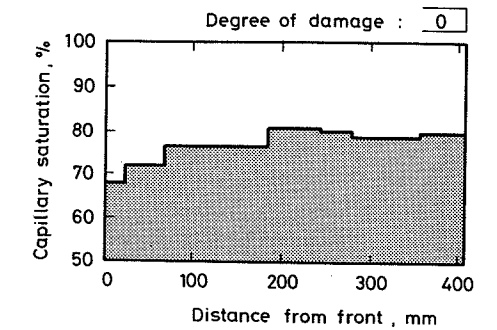
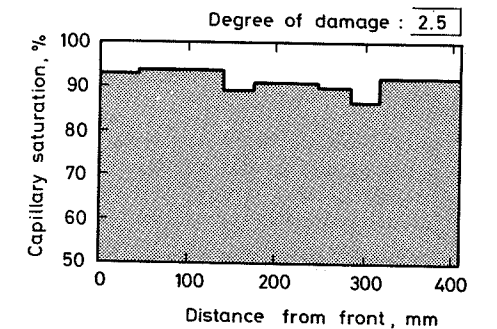
Fig. 3 shows profiles from two nominally equal retaining walls. One is uncracked and in a drying-out state, the other one is cracked and has a high degree of saturation the hole way through. It must be suggested that the last specimen has got initial cracks, so that this is the point, where the two walls differ.

Fig. 3. Retaining walls from bridge 02.
Top: Sound wall in drying-out state.
 $S_{cap} \sim 80\%$ can be calculated as what may be expected from the selfdesiccation /1/.
Bottom: Cracked wall.

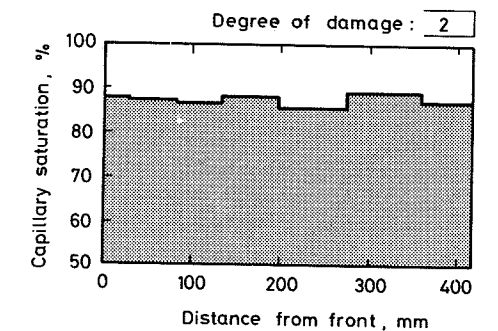
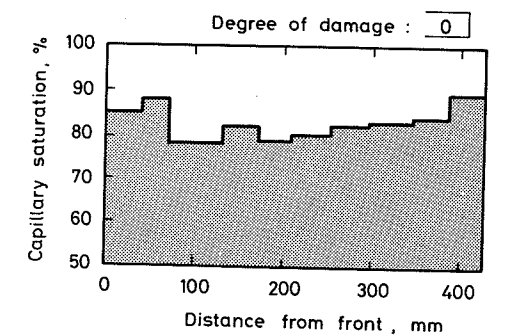
Fig. 4 shows profiles from two nominally equal edge beams. One is cracked and has a high degree of saturation the whole way through. The other one is identical with the question mark point in fig. 2. It is uncracked, but it is seen that the S_{cap} -profile is U-shaped pointing to the fact that water is penetrating the beam from both sides. It must be expected that in some years the high moisture level will reach the center and cause cracking. Then the question mark point on fig. 2 will move to a position on the correlation line.

Fig. 4. Edge beams from bridge 88.
Top: Cracked beam.
Bottom: Until now uncracked beam.
It is seen that the water is penetrating from both sides. Cracking must be expected when the water reaches the central parts. The mean value of S_{cap} is shown on fig. 2 with a question mark.

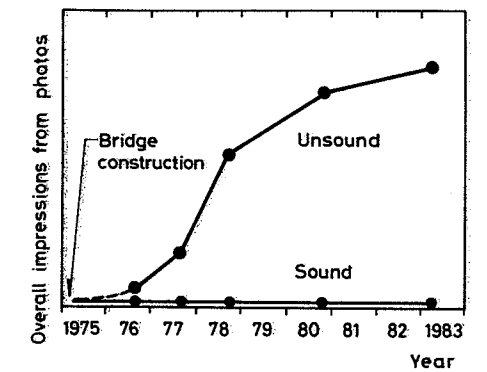
10 motor road bridges were built in 1975 between Århus and Skanderborg in Denmark. In 1976 cracks occurred on some structural elements. The cracking developed further in the next years. Inspections with descriptions and photographs were made in 1976, 1977, 1978, 1980 and 1983. From the photos it has been possible to draw a curve of the quantitative impression of the crack development, fig. 5.

The development of the cracks on the bridges is shown qualitatively on fig. 5. This is the same type of crack development as we have seen on the roof structure treated above (fig. 1). In fact we see the same time of crack development on our mortar bar experiments (fig. 6).

Fig. 5. Development of cracks in motor road bridges. Overall impression from photos (Olsen /3/).

In 1982 it was decided to paint the bridges to prevent further damage. A preparatory investigation started, which among other things included a description of the state of the bridges and a moisture analysis.
