## DAMAGES TO SWIMMING POOLS DUE TO ALKALI SILICA REACTIONS

Svend E. Petersen, Civil Engineer  
Cowiconsult, Copenhagen, Denmark

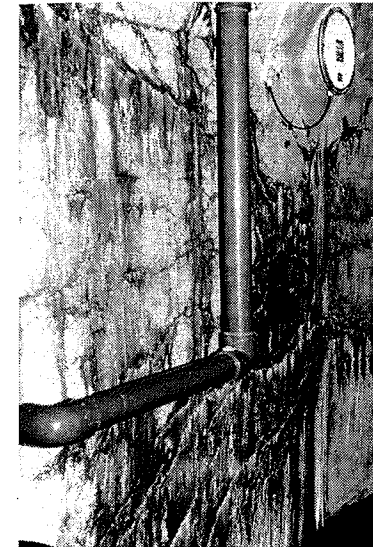
Fig. 3

The other pool showed a somewhat more complicated picture. A larger area, approx. 15% of the total wall area, showed cracks due to alkali silica reactions (fig. 3 and 4).

Certain areas showed rather wide cracks with up to 0,3 mm width and although some indications of deficient casting and compaction ("cold construction joints" and insufficiently vibrated concrete below underwater lights and around ties), the laboratory investigations could not prove beyond doubt that the development of alkali silica reactions originated from initial cracks or other deficiencies.

The visual inspections indicated that the cracking starts on the exterior face of the wall. This observation gave rise to the theory that the heavy drying out of the exterior surface results in a concentration of salt (sodium chloride) near the exterior surface which initiates the alkali silica reactions. We tried to test this theory by measuring the chloride content through the wall and found on one sample the expected profile but could not establish a connection between cracking and salt concentration.

It was observed that after the first crack appeared, a crack pattern developed rapidly (2-3 months) over a certain area but then slowed down and eventually seemed to stop.

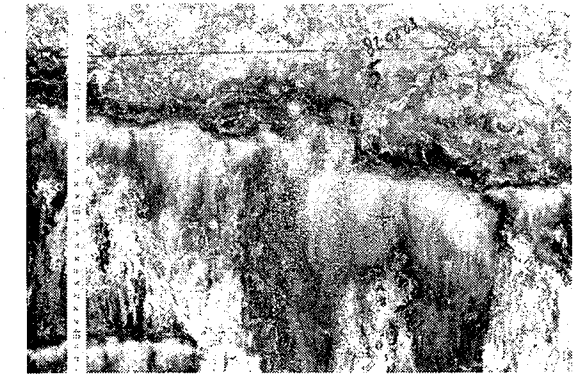
Fig. 4

Note leakage around form tie

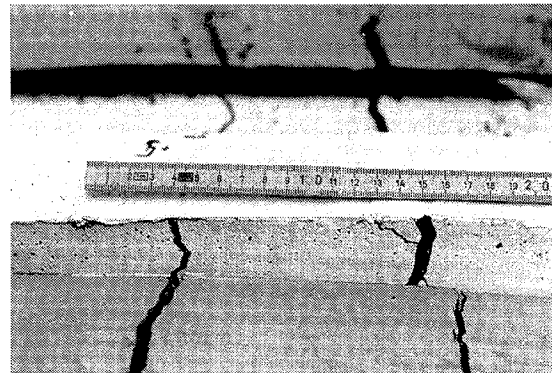
Fig. 7

Cracks normally occurring in the concrete wall should not go through the membrane, i.e. it should safely be able to bridge a gap of 0.1 to 0.2 mm. We added a safety margin and required 0.4 mm. The various membranes were build up on concrete beams which were then bent in an ordinary testing machine (fig. 7 and 8). The best membranes could bridge a gap of more than 1 mm.

Sikaflex membrane bridge a crack of 7.5 mm.
