Niels Thaulow

Teknologisk Institut, Byggeteknik
Gregersensvej, Taastrup, Denmark

In the Itezhitzezi Dam Project, Zambia, substantial expansion of the concrete of the intake-towers to the diversion tunnels was noticed about 5 years after the concreting. The expansion of the towers was estimated to be in the order of 40 mm over a height of 30 m. Field inspection showed a typical map cracking pattern. Before erection, the aggregate was tested according to ASTM C227 and was found non-expansive.

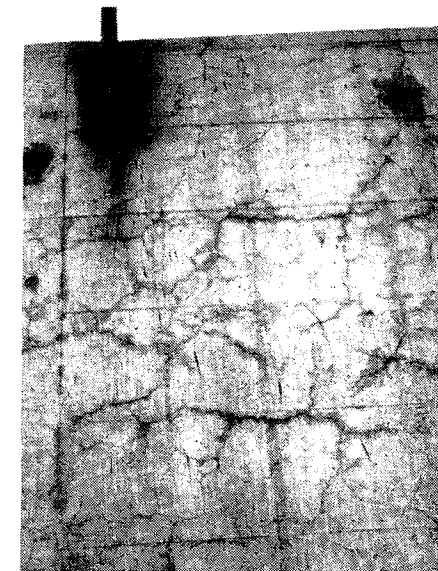
The concrete of the intake towers showed clear signs of expansive alkali-silica reaction in form of a typical coarse map-cracking pattern. The reaction seems to be severe and some of the reinforcement bars are under tension due to the swelling of the concrete. Measured strain on one vertical \varnothing 16 mm rebar was 0.18%. A typical crack width was 0.5 mm. See Fig. 2.

Fig. 2. Upstream outer face of intake tower. Heavy map-cracking is visible.

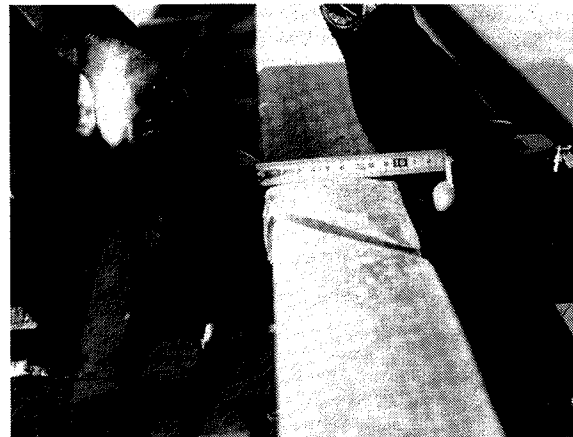
Fig. 3.
Gantry crane rail is displaced due to swelling of the intake tower.

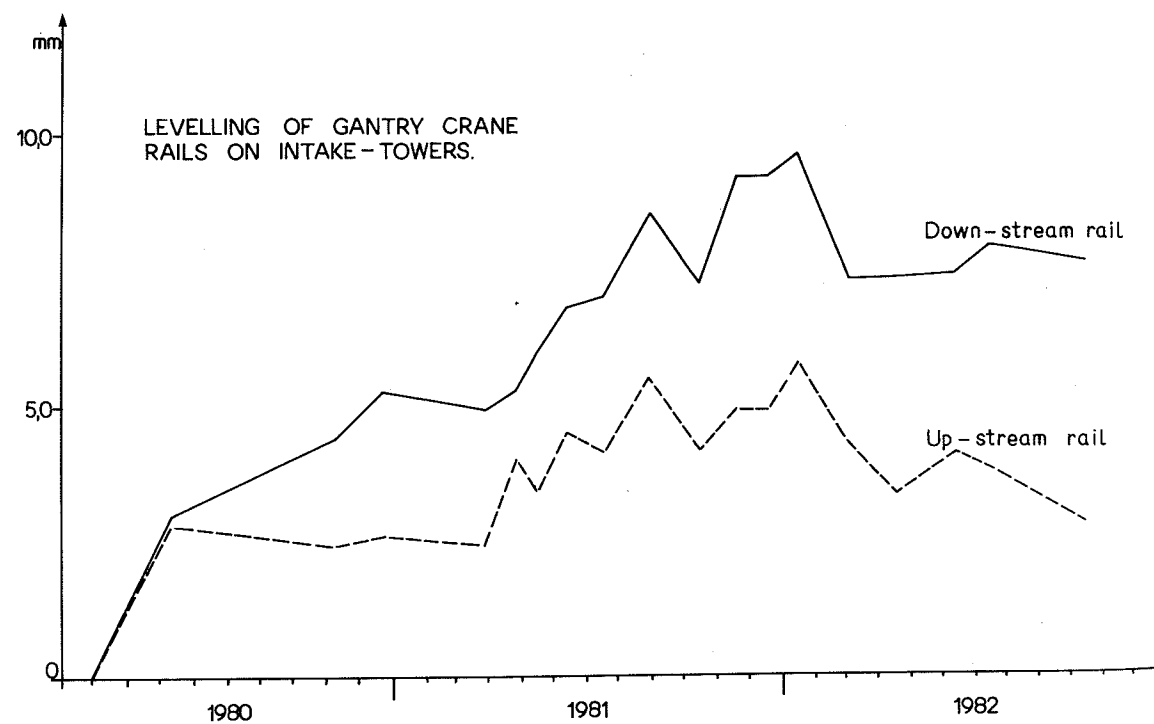
Continued levelling of the intake towers in the period 1980-1982 showed expansion of less than 10 mm. The expansion seemed to level off during the end of 1981. During 1982, some shrinkage took place. See Figs. 3 and 4.

Fig. 4. Expansion of intake towers, 1980-1982.

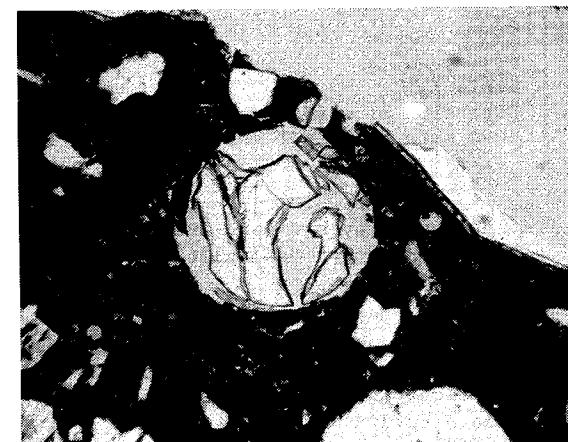
Some round air voids contained alkali-silica gel. See Figs. 5 and 6.

Fig. 5. Thin-section showing alkali-silica gel in an air void in the cement paste. Magnification 60x. Transmitted light.
