## AAR IN PORTUGUESE STRUCTURES. SOME CASE HISTORIES

M.O. Braga Reis; H.S. Silva and A.S. Silva  
Laboratório Nacional de Engenharia Civil  
Av. Brasil, 1799 Lisboa Codex - Portugal

This paper presents some considerations on the nature of climatic and lithological AAR conditioning factors in Portugal and describes two cases of damaged concrete structures whose causes of deterioration were investigated at LNEC.

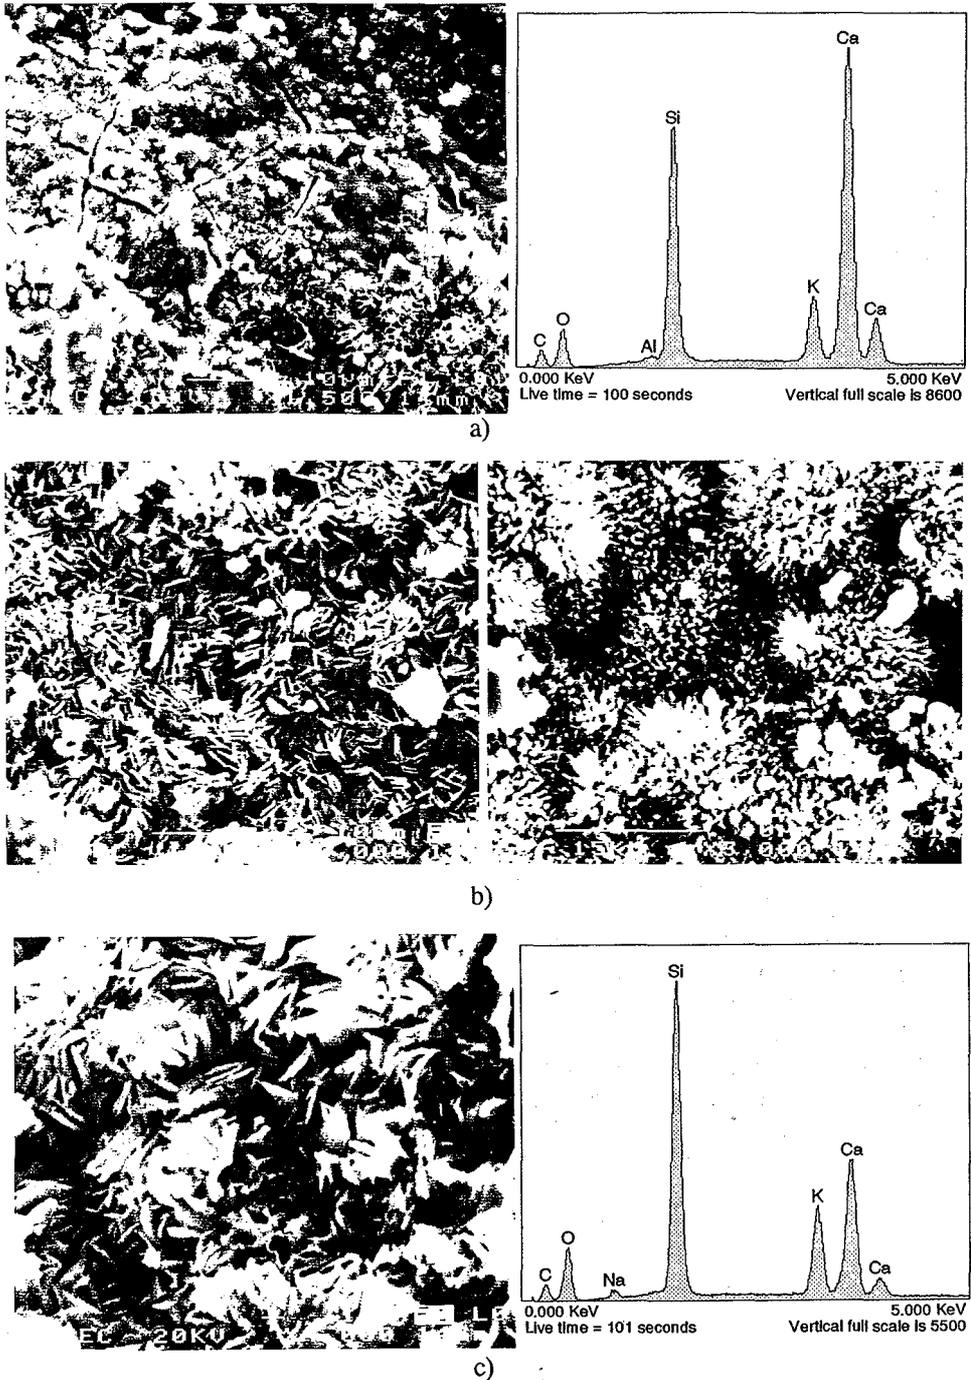
SEM/EDAX analysis revealed the presence of typical ASR products, gels and crystalline forms, in paste and limestone/paste interfaces (Fig. 3). These products are calcium and potassium silicates, being the gels richer in Ca than crystalline products. The occurrence of these ASR products in limestone/paste interfaces suggest the existence of reactive silica inclusions in the limestone as will be expected in turonian limestones. In fact, petrographic examination of thin sections of concrete samples have confirmed the presence of reactive silica forms (chert and siliceous) inclusions in the limestone aggregate. It was also observed the occurrence of ettringite, in acicular crystals and massive forms, disseminated in the paste and filling voids and microcracks (Fig. 4). The presence of ettringite was also detected by XRD analysis. SEM examination of the thin sections prepared for petrographic analysis have shown also some interesting aspects revealing signals of ASR and eventual sulfate attack (Fig. 5,6).

Fig. 3 ASR products in limestone/paste interfaces. a) Gel with microcracking and EDAX spectra, b) Lamellar and acicular crystalline products co-existing with gel, c) Lamellar crystals and EDAX spectra.

From all experimental results it may be concluded that the concrete deterioration would have its origin in an internal cause in result of ASR, due mainly to the reactive silica inclusions in the limestone aggregates. An eventual attack by sulfates of external origin, as a result of the atmospheric pollution, would also contribute to the deterioration. Subsequently, concrete cracking would be provided, in some places, conditions of reinforcing steel depassivation and consequent appearance of corrosion, causing thus the increase of cracks width and concrete spalling.
