# THE ASSET MANAGEMENT OF A LONG BRIDGE STRUCTURE AFFECTED BY ALKALI-SILICA REACTION

Alan Carse  
Queensland Transport,  
Transport Technology Division,  
GPO Box 1412,  
Brisbane, Australia. 4001

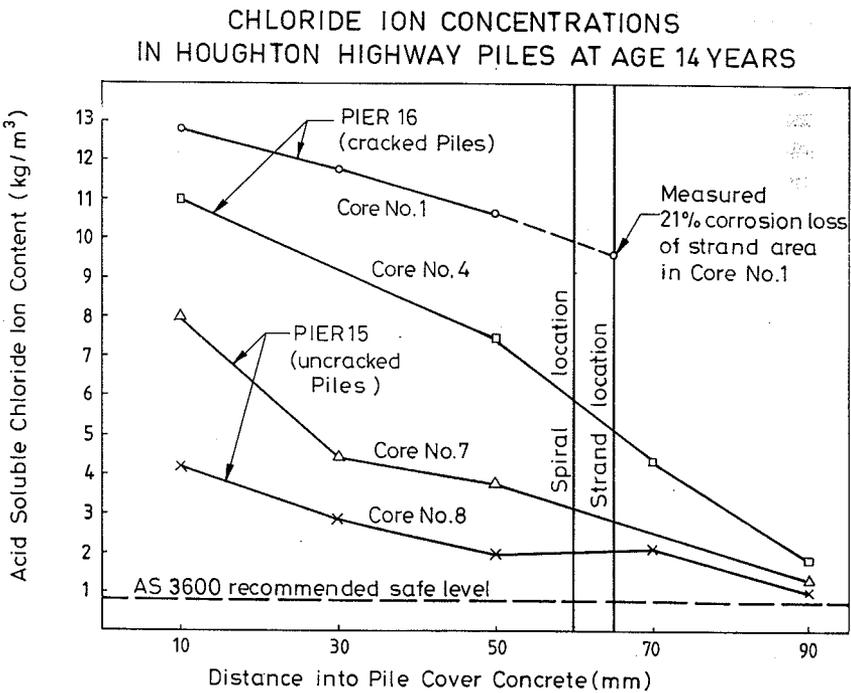
Fig. 1 Chloride Ion concentrations in pier 15 & 16 piles

From Table 4 it is estimated that a 21% loss of strand area has occurred in the individual strands contained in Core No. 1. This is consistent with the very large crack (8 mm) in this location. Fig. 1 shows all the information on chloride ion diffusion in Table 3 plotted graphically.

- The crack net work set up the ASR mechanism has allowed a significant penetration of chloride ions (See Fig. 1) leading to subsequent corrosion of the included reinforcement. A corrosion loss of 21% of strand area was measured at Pier 16 in Pile D, Core No. 1. This core was taken over a crack of width 8 mm.

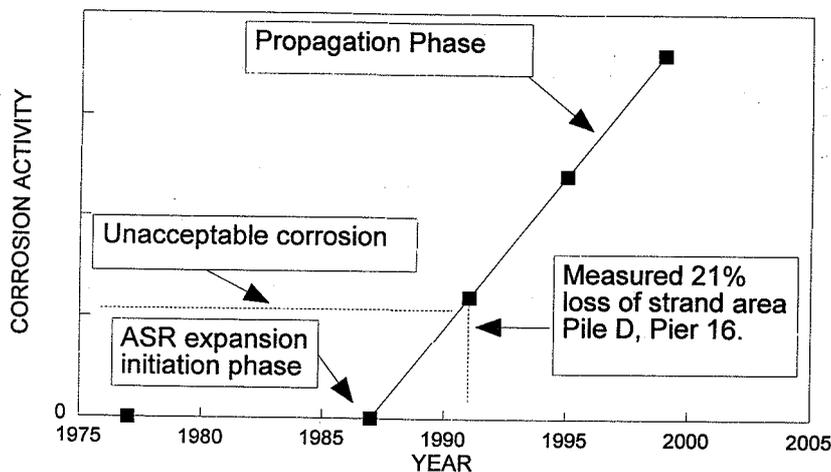
Fig. 2 - Corrosion activity in piles

The future life of this structure will depend significantly on the action taken to inhibit the onset of corrosion of the prestressing strands. Fig. 2 shows diagrammatically the corrosion history that has occurred at pier 16, Pile D. From Fig. 2 it can be seen that unacceptable corrosion damage has already occurred in some of the piles.
