DETERIORATION OF REINFORCED CONCRETE SLABS WITH ALKALI AGGREGATE REACTION

This paper deals with inspection results of cracks due to Alkali Aggregate Reaction (AAR) in reinforced concrete (RC) slabs of highway bridges. The field records over the decade and the test result of load-carrying capacity performed on test specimens using reactive aggregate are presented. The assessment of AAR damage and maintenance methods are proposed based on these studies.

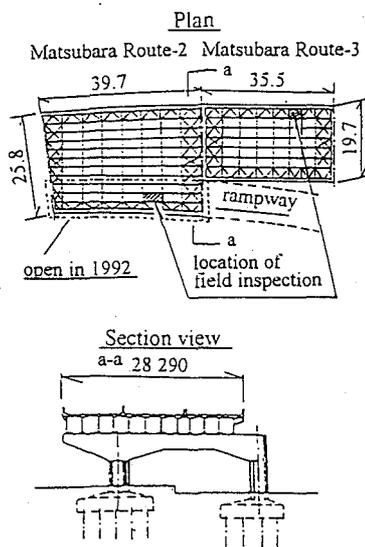
The general view of structures in Matsubara Route-2, -3 are demonstrated in *Fig. 1*. Both spans are composed of steel simply-supported I-shape composite girders, which are the most popular in Hanshin Expressway and designed by Specifications for Highway Bridges (1983 Version). In this design specification, the slab thickness was increased as a result of the studies of fatigue damage due to live loads. The bridge has been in service since 1980-1981 and the rampway of Matsubara Route-2 was opened in 1992.

Fig. 1 General view of structure
(Matsubara Route-2, -3)

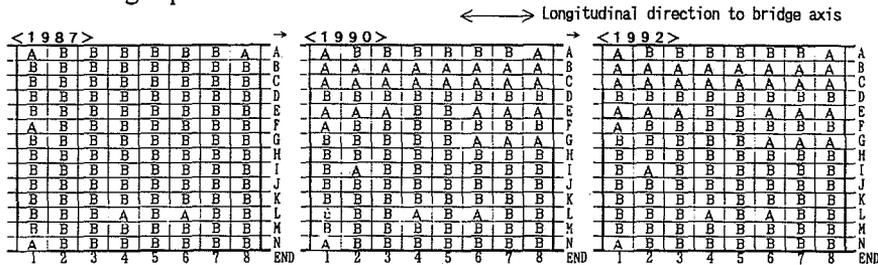
Fig.2 shows the results of the past three periodical inspections of slabs on Kobe Route. Inspection result is ranked as A, B, C in a decreasing order of damage. For instance, Rank A states that biaxial cracks are over 0.1mm wide and below 40cm spacing, slab corner spalls, and so on. Fig.2 shows that damage of slabs is progressing with a rather high speed.

Fig.2 Change of periodical inspection result (Kobe Route-1)

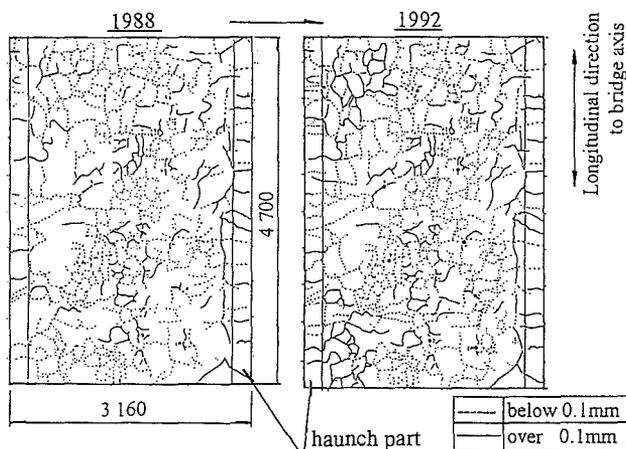
An example of crack configuration change is demonstrated in Fig. 3. In general, it is difficult to clarify the cracks in longitudinal direction and transversal direction to bridge axis because tilting crack growth was remarkable. The particular cracking configuration of AAR that cracks cross in the angle of about 120° was well observed. It is worth mentioning that in the

Fig.3 Change of cracking configuration (Kobe Route, Panel L-4)

haunch part cracks only occurred in the direction of the adjacent section. Change of crack configuration shown here is what happened during four years. New cracks are continuously occurring and growing in the whole slab.

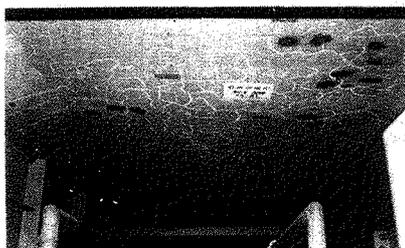
Photo 1 shows the inspected slab. Photo 2 shows an example of slab crack damage (Rank A) due to live load. It is understood from Photo 2 that cracks in transversal direction to bridge axis are more obvious and its density is much smaller than those of inspected slabs.

Photo 1 Cracking configuration
(Density: 21.3m/m²)

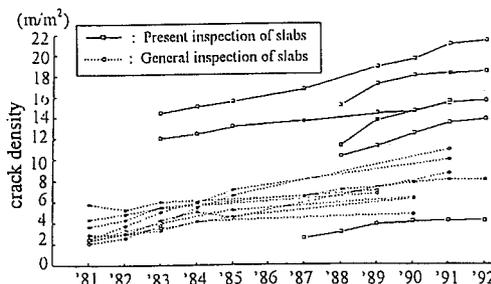
Besides the six panels of slabs in the present inspection, field inspection is also performed on slabs with ordinary deterioration. Fig.4 shows that the density of crack over 0.05mm width in those slabs varies with the years passed.

The present inspection of panels shows that it is almost over 12m/m² and the maximum is even up to 21m/m². The crack densities observed on the surface of the slabs are increasing almost at the same rate. It seems that the crack densities will grow constantly in the future. The initial value of crack density of the inspected slabs are over 10m/m². It can be inferred that a lot of cracks on Matsubara Route have occurred in the early days after the construction, i.e. after the opening to traffic in 1980, especially after 1983 when inspection of Matsubara Route started.

Fig.4 Growth with the years passed of crack density

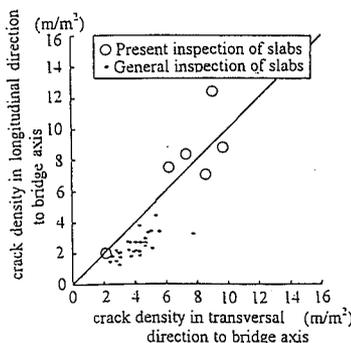
Fig.5 gives the ratio of density of over 0.05mm wide cracks in longitudinal

Fig.5 Comparison of crack density

direction to that in transversal direction to bridge axis. For slabs, especially designed by the design code of 1964 version, cracks first occurred in transverse direction to bridge axis due to insufficient reinforcements. After slab slit caused by transverse cracks was formed, cracks finally appeared in longitudinal direction related to the main reinforcements. Therefore, cracks in transversal direction to bridge axis are more prominent as shown in Fig.5 by black circles. However, the present inspection of slabs may not show this tendency.

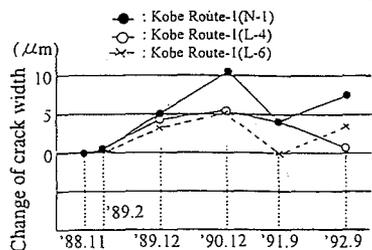
At the beginning of inspection, crack width was measured for cracks over 0.1mm wide. Fig.6 shows the variation of crack width with the years passed in three panels on Kobe Route. Although the temperature effect on crack width is considered, the change is not so much. Therefore, the cracks over 0.10mm wide have not grown so much. The reason is thought to be the growth of neighbor small cracks or the occurrence of new cracks.

Fig.6 Measurement result of crack width

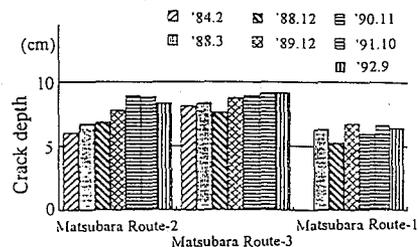
At the beginning of inspection, crack depth was measured for cracks over 0.2mm wide by ultrasonic detector. Fig.7 shows the variation of crack depth with the years passed in three panels on Matsubara Route. Crack depth was over 5cm at the beginning of inspection that propagated from the cover layer 3cm apart from the existing steel bar, and then did not increase so much. It is necessary to beware of corrosion of steel bar.

Fig.7 Measurement result of crack depth

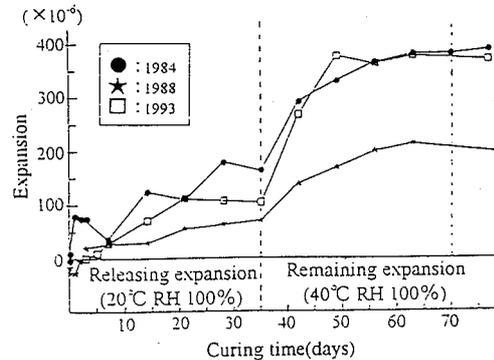
Fig.8 shows the measurement result of core expansion during accelerated curing. Hanshin Expressway Public Corporation prescribes that the overall expansion is the sum of releasing expansion up to the fifth week and the remaining expansion from the fifth to the tenth week. Accordingly, for the thin members outside the above regulation, such as slabs and railing, the standard value of overall expansion for AAR judgement is taken as $1,000 \mu \epsilon$.

Expansion in present test was measured after 60 days of sampling for all samples and the overall expansion was about $150-400 \mu \epsilon$ which is much smaller than that of bridge piers. In the tests of 1984 and 1988, gel was not found. It was the same at the beginning of 1993, but reaction ring was found in the section of core sample slice.

Fig.8 Measurement result of core expansion

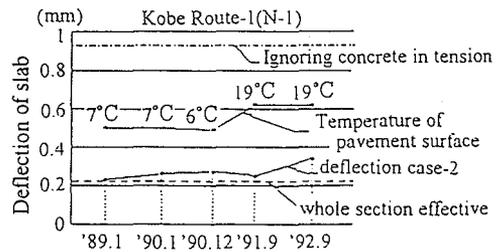
Fig.9 shows the measurement result of slab deflection under the load of a truck with gross weight of 20tf. The computed values, based on the assumptions that the whole section is effective in isotropic plate and that concrete in tension is neglected, and the temperature of pavement surface are also considered.

The measured deflection is close to the computed value. Moreover, although variation in pavement stiffness due to temperature difference was taken into account, the change of deflection with years passed is very small and there is no problem in load-carrying capacity and stiffness.

Fig.9 Measurement result of slab deflection
