SURVEYS AND REPAIRS OF AAR-DAMAGED CONCRETE STRUCTURES (BRIDGE SUBSTRUCTURE AND WATER TANK)

In this paper, reports are made on the results of the surveys (expansion, crack development, EPMA, SEM) and countermeasures conducted on the bridge substructure, and on the results of the surveys and repair work implemented on the industrial water tank.

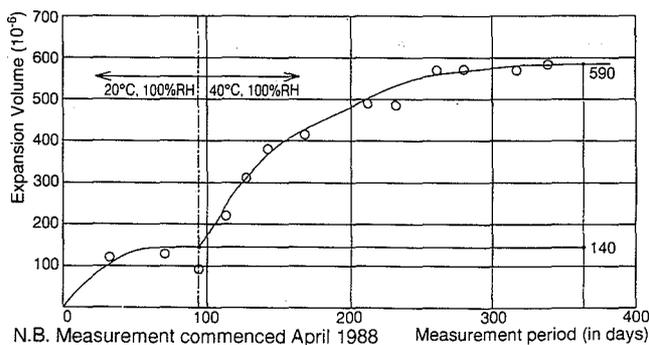
- 4) According to a JCI (Japan Concrete Institute) accelerated expansion test of the sample cores, the starting expansion strain was 140×10^{-6} , and the permanent expansion strain 450×10^{-6} (Fig. 1).

Fig. 1 Measurement results of expansion caused by AAR

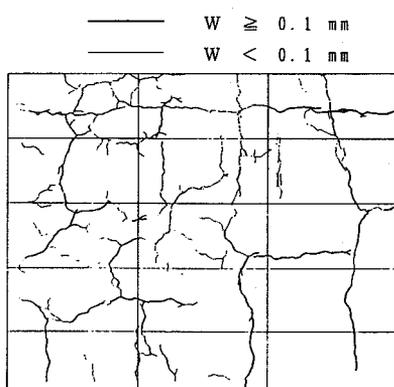
The condition of the cracks in the substructure in February 1989 and March 1993 is given in Fig. 2. The results of a survey of crack density and crack width within 3 m-long horizontal and vertical courses of traverse is given in Table 2. During a period of three years, the amount of cracks increased from 11.1 m/m² to 15.0 m/m², and crack density and width increased as well.

Fig. 2a Crack distribution pattern (February 1989)

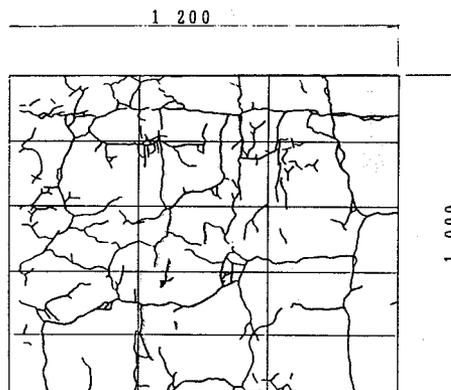
The 'apparent expansion strain,' obtained by dividing the increase in crack width by the 3 m course of traverse, was similar in the horizontal and vertical directions, coming to 563×10^{-6} and 573×10^{-6} respectively. This apparent expansion strain is larger than the 450×10^{-6} permanent strain. Moreover, exfoliation of the concrete and brittle fracture of the steel reinforcements, which were not observed in 1989, were confirmed in the upper portions of the bridge structure in 1993 (Fig. 3). Such phenomena exceed the damage predicted by the measurement of expansion shown in Fig. 1.

Fig. 2b Crack distribution pattern (March 1993)

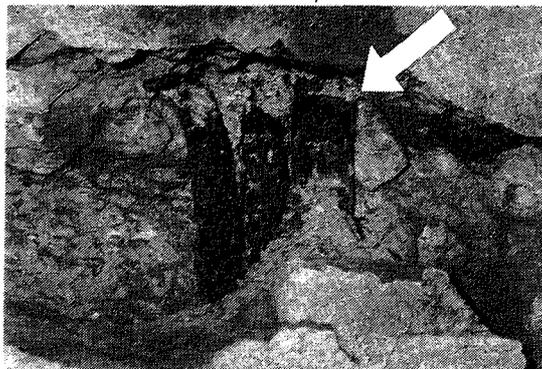
Fig. 3 Fracture of steel reinforcements

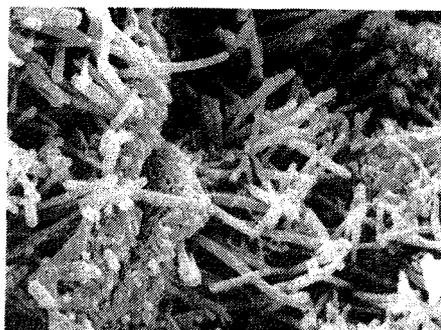
According to observations by scanning electron microscope (SEM), hairline cracks had arisen in the interior of the core at a depth of approximately 40 mm, and a large number of needle crystals were observed in their vicinity (Fig. 4). Powder x-ray diffraction showed these needle crystals to be $C_3A \cdot 3CaSO_4 \cdot 32H_2O$ (Ettringite) and $C_3A \cdot CaCO_3 \cdot 12H_2O$ (para-alumohydrocalcite), as shown in Fig. 5.

Fig. 4 SEM observation

From such results, it can be deduced that cracks occurring in the structure as a result of AAR were aided in their growth by needle crystals which formed as a result of extraneous sulfur and carbon.

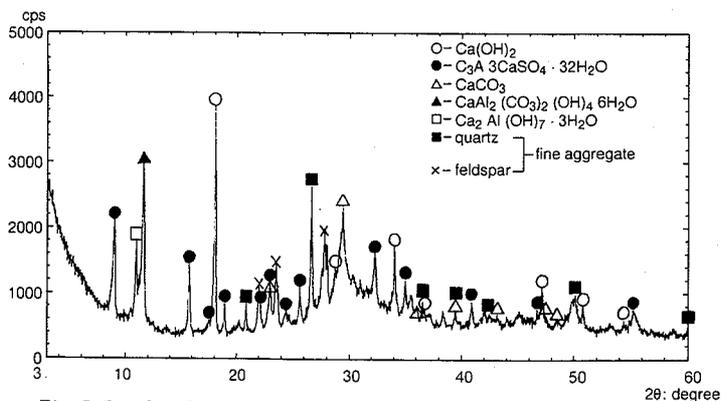
Fig. 5 Results of powder X-ray diffraction analysis ($CuK\alpha$)

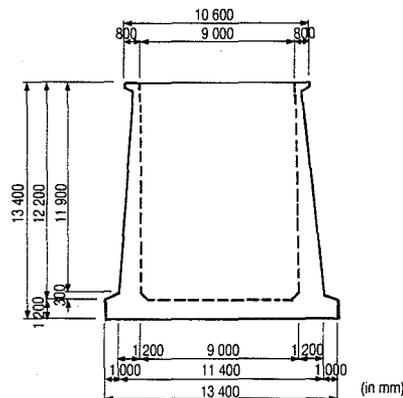
Fig. 6 Water tank cross section

The results show that the damage to the water tank is due to AAR. As given in Table 3, the crack density on the exterior is 1.6 times as much as on the interior. The crack density and crack width were most advanced on the exterior of the northern side. It is believed that insolation, which affects the contrast between moistness and dryness on the concrete surface, affects the degree of damage caused by AAR.

As the survey showed that no rust could be confirmed on the steel reinforcements and the fall in durability was less than expected, caulking with crack filler and a surface membrane was selected as the appropriate repair technique. From the results of the tests on the sample core, it was judged that AAR would progress slightly after repair, and an elastic material was selected as filler and membrane for both the interior and exterior surfaces.
