**EFFECT OF COATING TO INHIBIT ALKALI-AGGREGATE REACTION
OF CONCRETE STRUCTURES**

Manabu Fujii*, Toyoaki Miyagawa**, Minoru Tomita***,
Koichi Ono**** and Mamoru Imae*****

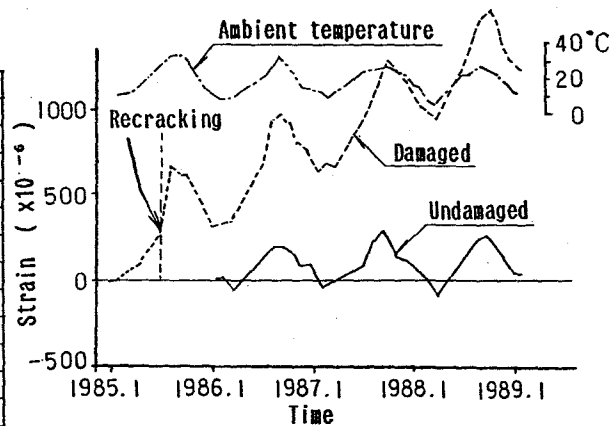
Figure 2 Expansion after coating (Polyurethane)

Table 2 shows the results of investigation carried out for the column in 1984. The column was repaired by polyurethane coating in January 1985. Injection of the cracks was not done for this column. Since the repair, expansion and crack opening of the repaired column have been measured once a month. Expansion of the equivalent but undamaged column has been measured for the comparison. Figure 2 and 3 are these results. These measured values include strain by temperature change, drying shrinkage and ASR expansion. According to these results, this coating could not stop the ASR expansion. About 300×10^{-6} /year of ASR expansion and 0.1mm/year of crack opening have been occurring after coating. Figure 4 shows re-cracking occurred about 6 months after the coating.

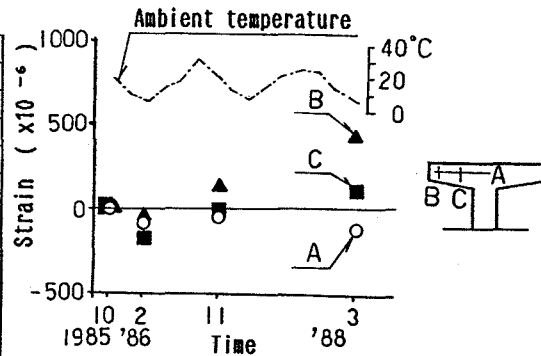
Figure 5 Expansion after coating (Epoxy)

Table 3 shows the results of investigation carried out for the beam in 1984. This beam had plenty of typical ASR cracks in the horizontal direction before the repair. This beam was repaired by epoxy coating with crack injection by a flexible epoxy resin in March 1985. Figure 5 and 6 show the expansion and crack opening, respectively. This beam cracked again about 6 months after the repair and the cracks developed as seen in Figure 7. According to the results shown in Figure 6, opening of the injected crack ceased after the repair although expansion of the beam continued. This indicates that cracks appeared in Figure 7 were probably newly developed ones.

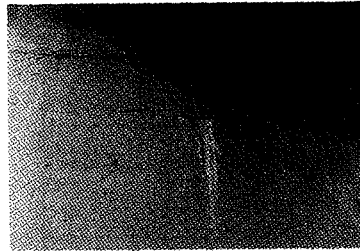
Figure 8 Appeared crack and exuded gel

Table 4 shows the results of investigation carried out for the abutment in 1984. The abutment was repaired in 1986 by polybutadiene coating with crack injection by flexible epoxy resin. Strain measurement was not done for the abutment since the expansion estimated by the drilled core was small. However, 2 years after the repair, cracking appeared again partly and gel was exuded as seen in Figure 8.

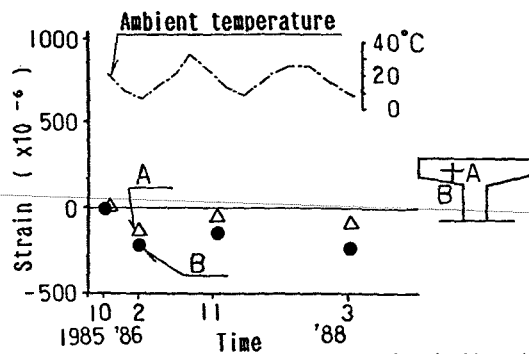
Fig.9 Expansion after coating (Silane)

Table 5 shows the results of investigation done for the beam in 1983. The beam was repaired in March 1985 by silane coating with crack injection by flexible epoxy resin. This repair had been effective for 3 years as shown in Figure 9. However, micro cracking started to appear on the surface of the coating. Therefore, successive observation is required.

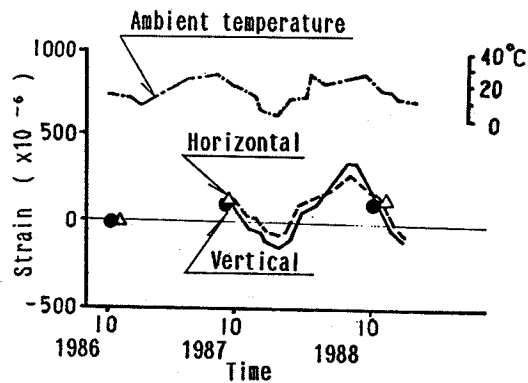
Fig. 10 Expansion after coating (Aeration Polymer)

Table 6 shows the results of investigation done for the beam in 1985. The beam was repaired in October 1986 by aeration type of polymer cement after injection of the cracks by flexible epoxy resin. Figure 10 shows that expansion of the beam after the repair is stable in spite of the high potential of the residual expansion. This result indicates that the repair by the polymer cement might stop the ASR expansion. Figure 11 shows the repaired beam in which no cracking has been observed since repaired. However, successive observation is required to confirm the effect.
