CHARACTERISTICS OF ROAD STRUCTURES DAMAGED BY AAR
ON THE HANSHIN EXPRESSWAY DUE TO CONTINUOUS OBSERVATION

Mikitake Ishizuka*, Shigeru Utho**, Kazuhiro Kuzume***,
Masanobu Sugimoto**** and Masahiro Nishiboshi****

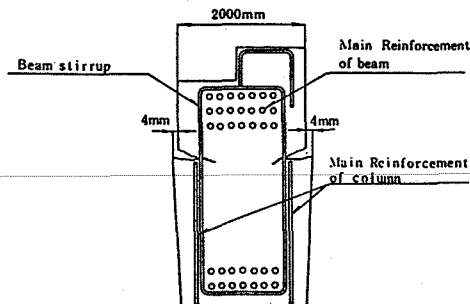
Fig. 1 Detail of Crack in Pier Beam

As shown in Fig. 1, the crack on the beam of Pier-42 (P42) and Pier-45 (P45) were appeared at upper end of main re-bar of column and surface between both sides of the crack had about 4mm in gap. A series of inspection,

The characteristics of those cracks were assumed to be different from the shrinkage and/or heat of hydration, because these were observed the phenomena that the surface level gap between both sides of the crack and an enlargement of structure which was measured using a trace of panel as reference line. This means that those cracks had associated with concrete expansion. In addition, the core samples were taken from adjacent piers on which several cracks were observed. On the cored samples, a reaction rim around aggregate was observed then transudation of reaction gel was recognised with an elapsed time. From those phenomena, the cause of the structural damages was caused by Alkali-Aggregate Reaction (AAR). Also, the aggregate consists those concrete structures were clarified as α -Cristobalite and Bronzite Andesite containing some crystal.

In October 1979, a crack was found through those inspections at a beam of T-type concrete pier on Osaka- Matsubara Route before open road. Next March 1980, a repair by means of a resin injection into the cracks was done. Further progress and enlargement on those treated cracks were observed in May 1985 in spite of the treatment.

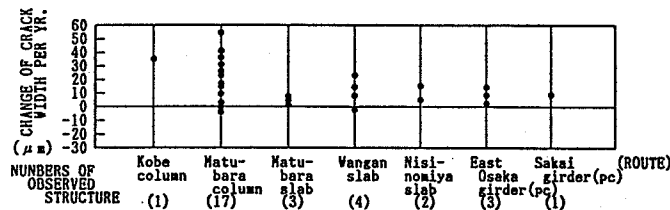
Fig. 2 Changed Width of Cracks per Annual

28 piers, 3 spans of PC girders and 5 slab panels are employed the crack width observation. Annual change value of crack width as a simplification to adjust time of observation is shown in Fig. 2. As shown in Fig. 2, the most of cracks are growing in time. Particularly the cracks appeared on Matsubara Route show remarkable growth even after treatment by the resin injection and coating.

In addition, newly created cracks other than the treated one are also found.

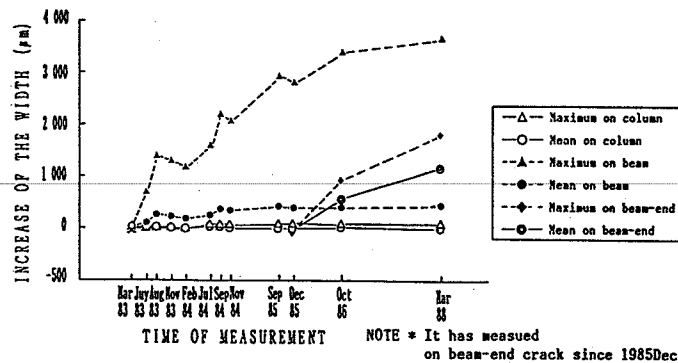
Fig. 3 The Width of Crack

The measuring results of crack width show a remarkable growth at P42 on Matsubara Route which is shown in Fig. 3.

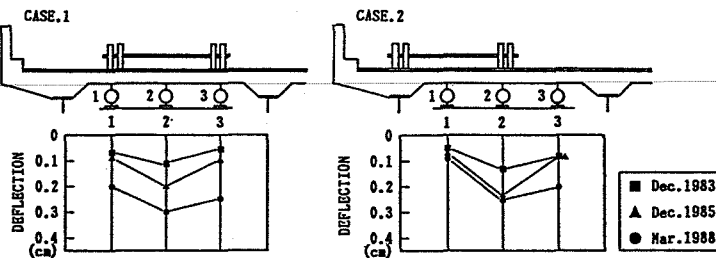
Fig. 5 Result of Slab Deflection

A slab deflection was measured on 583-slab on Matsubara Route by the loading test using a 20 tons vehicle. Figure 5 indicates an increase of deflection of the slab and decrease of slab stiffness contrarily. This deflection of the slab and decrease of slab stiffness contrarily. This means that a progress of crack-width, depth and an increase of crack density have worked decrease of slab stiffness.

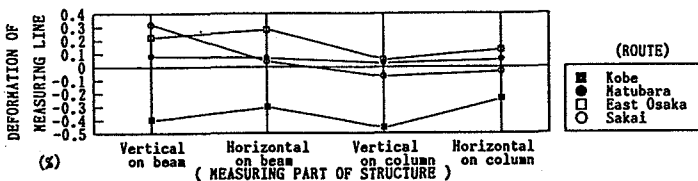
Fig. 6 Structure Concrete

The mass expansion are measured for 35 piers. The average results on each route are shown in Fig. 6.

Excepting the column on Kobe and Sakai Routes, all results show a tendency of concrete expansion. In addition, even after repaired by the resin sealing and coating treatment, all expansion at each route results on Matsubara Route show same tendency as well. This means that those structures are having a certain structural damages caused by ASR and the concrete expansion is still going on even waterproof coating has been made.

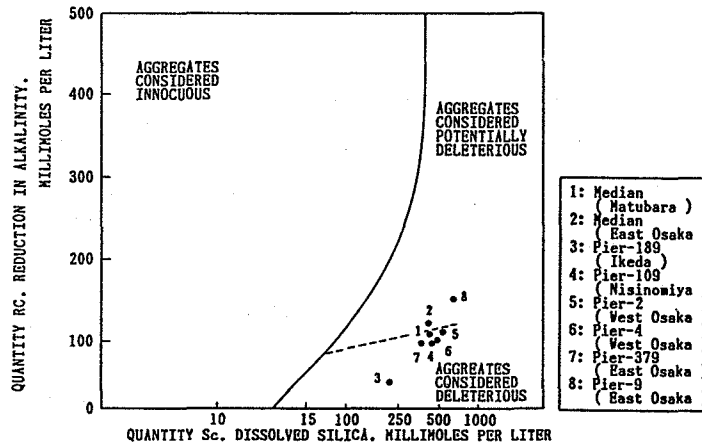
Fig. 7 Result of Chemical Test C289

The results of Chemical Analysis in accordance with ASTM C289 are shown in Fig. 7. It indicates that all aggregates of observed structures have considered deleterious and/or potentially deleterious.

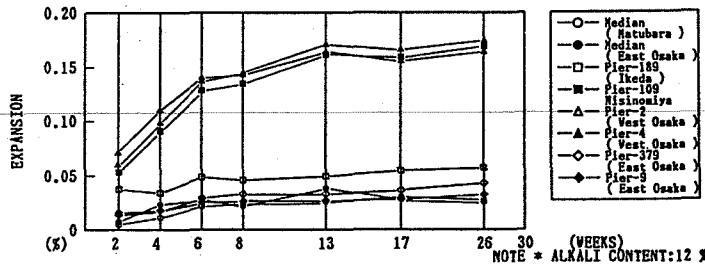
Fig. 8 Result of Mortar-Bar Testing

The material age versus expansion rate of Mortar-Bar Test in accordance with ASTM C227 is shown in Fig. 8. Some of test results indicates that a large expansion is introduced with an elapse of time. This means that some structures have possibility of ASR problems even any structural damages have not been recognised so far. A continuous observation and attention are required.

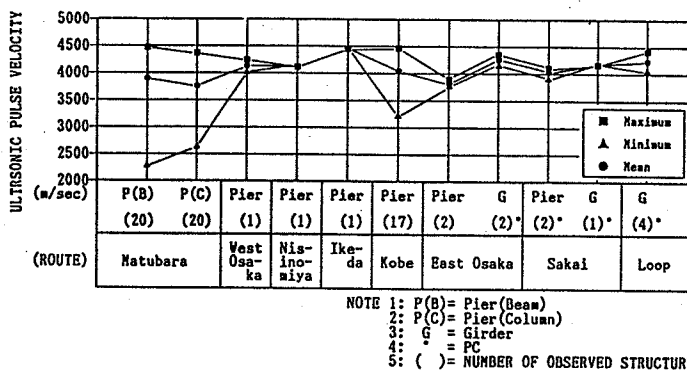
Fig. 9 Result of USP Velocity Measurement at Each Route

The measurements of Ultrasonic pulse velocity on the structure concrete have been performed on 38 piers and PC girders of 3 spans. The results are compiled in each route on Fig. 9.

In Matsubara Route, extremely low velocity was observed at the beams of P42 and P45 on which a remarkable increase of the crack width was also observed.

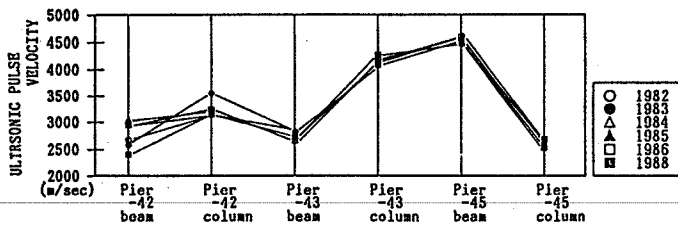
Fig. 10 Result of USP Velocity Measurement

Particularly low velocities on P42, P43 and P45 among other piers of Matsubara Route are shown on Fig. 10. The beams of P42 and P45 and the column of P43 are evaluated to be seriously damaged because of the large crack widths and expansion values of concrete structures.
