**SOME FIELD STUDIES OF THE NEW INSITU METHOD FOR IDENTIFICATION
OF ALKALI SILICA REACTION PRODUCTS**

Kumar Natesaiyer and Kenneth C. Hover

School of Civil and Environmental Engineering,
Cornell University, Ithaca, NY 14853 U.S.A.

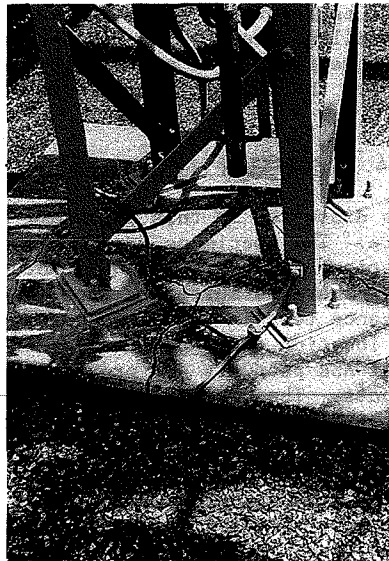
The foundation piers of an electrical substation were found to be severely damaged in service. The top surface of the foundations showed lateral expansion and cracks almost 1.2 cm wide (Figure 1). The owner hired the services of an independent petrographer who concluded that the observed deterioration was due to alkali silica reaction [3]. The authors received two cores from cracked piers from the petrographer for analysis. The cores were 20-25 cm long and 5 cm in diameter. Both the cores had been saw cut longitudinally and were thus received as two half cylinders. The concrete was friable and the cores broke into pieces during transit.

Figure 1. View of cracked foundation pier of electrical substation

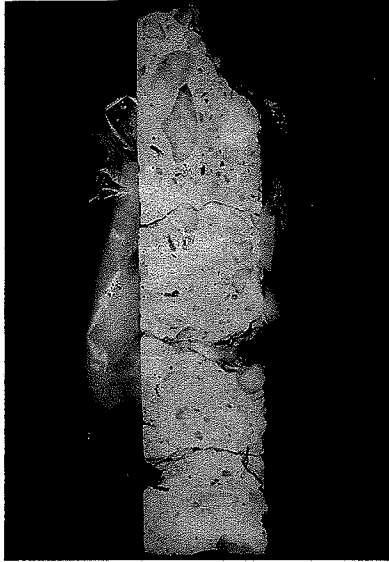
The coarse aggregates in the concrete were composed of quartz, quartzite, and sandstones while the fine aggregate was made of quartz, quartzite, and chert. The sawn surface of the half cylinder, shown in Figure 2, exhibited distinguishable evidence of alkali silica reaction. The quartzite aggregates had distinct reaction rims and white products were found near the cherts in the fine fraction. The surface shown in Figure 2, after treatment with uranyl acetate is shown under ultraviolet light in Figure 3. The presence of ASR products around the coarse aggregate particles is clearly highlighted. A reacted chert particle 'C', not easily visible in Figure 2, is seen to fluoresce brightly.

Figure 2. Interior saw cut surface of core from cracked foundation; Electrical substation

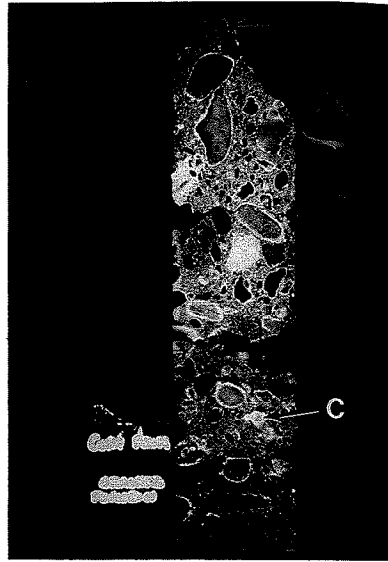
Figure 3. Fluorescence of surface shown in Figure 2; UV light

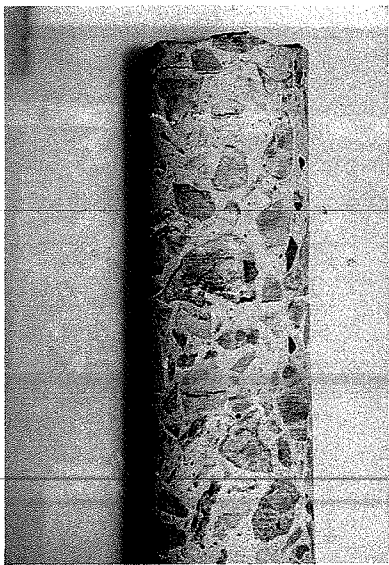
All the three cores showed extensive cracking along horizontal 'bedding' planes (Figure 4). The cracks were filled with a white substance. On application of minimal hand pressure, two of the cores split along the horizontal crack planes, exposing the interior surface of the cores. The reactive aggregates had distinct reaction rims 'A' and were surrounded by white deposits 'B' (Figure 5). The top half of the core shown in Figure 4, after treatment with uranyl acetate is shown in Figure 6. Under ultraviolet light, it is seen that the horizontal cracks are filled with alkali silica reaction products. The gel

Figure 4. Core from subway station slab showing horizontal cracking

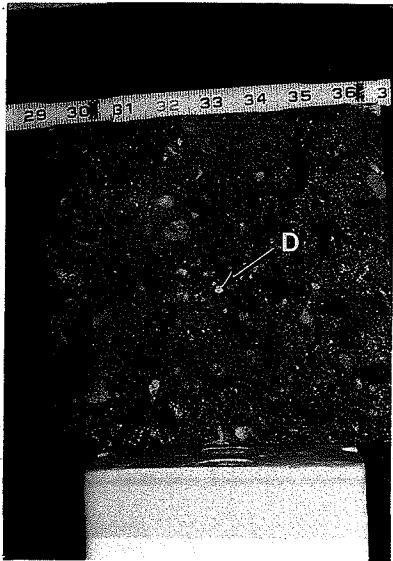
The underside of a 1.2 cm thick concrete piece, from the top surface of one of the floor slabs is shown in Figure 8. Visual examination shows little evidence of alkali silica reaction. The same surface, after treatment with uranyl acetate, observed under ultraviolet light is shown in Figure 9. Fluorescent gel products are observed extensively on the surface. Closer observation of Figure 9 in conjunction with Figure 8 shows that fluorescent products in Figure 9 are associated with white specks 'D' in Figure 8. The reactive particles thus seem to be present only in the fine aggregate fraction.

Figure 8. View of underside of concrete piece from top surface of parking garage floor slab

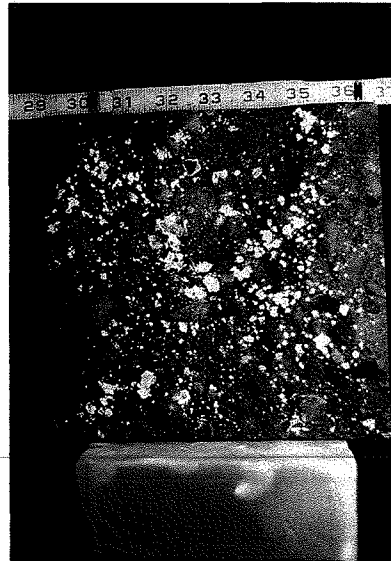
Petrographic examination revealed that the coarse aggregates were composed of fine sandstones, siltstones, limestones, quartz, and small amounts of volcanic fragments. The fine aggregate on the other hand, was mainly composed of carbonates and cryptocrystalline chert. The results of the gel fluorescence test when considered with the results of petrographic examination, thus shows that the chert particles are the reactive components of the concrete.

Figure 9. Fluorescence of concrete specimen shown in Figure 8; UV light
