ALKALI-AGGREGATE REACTIVITY — IS IT ALWAYS HARMFUL?

Serge Raphaël\*, Shondeep L. Sarkar\*\* and Pierre-Claude Aitcin\*\*

\* Hydro Québec, 855 Ste-Catherine est, Montréal, Québec, Canada

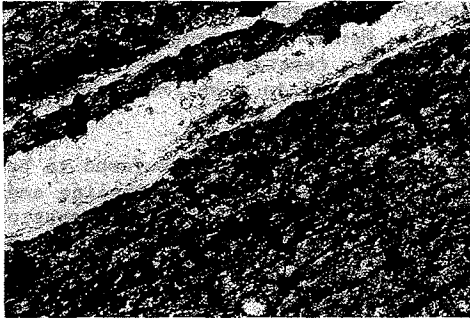
Manifestation of alkali aggregate reactions
FARMERS	Exudation of some silica gel. Severe internal cracking in the laminated rocks (Fig. 1). The other aggregates are intact.
MERCIER	Localized reaction rims around some coarse granitic aggregates (Fig. 2). Some quartz grains are heavily microcracked (Fig. 3). No detrimental effect on the concrete.
RAWDON	Some reaction rims around some coarse granitic and quartzite aggregates. Some quartz grains show polygonization (Fig. 4).
BEAUHARNOIS	Reaction rims around coarse aggregates and severe microcracking inside. Boundary discoloration visible (Fig. 5).
LES CÈDRES	Severe microcracking around quartzite aggregates (Fig. 6). Secondary cracks are filled with some silica gel. Dolomitic aggregates are unaffected by AAR.
GRAND'MÈRE	Only very localized AAR observable with an optical microscope. No detrimental effect on the concrete.
LA GABELLE	Quartz with undulatory extinction. Reaction rims can be observed at microscopic level. No detrimental effect on the concrete.

Fig. 1: Delamination in a stratified rock

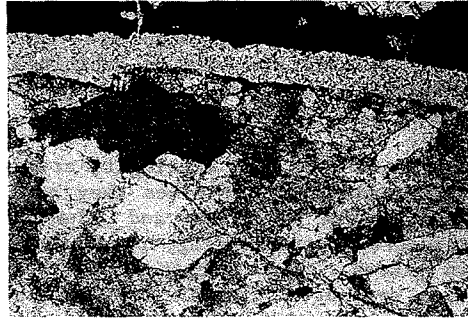
Fig. 2: A thick reaction rim around the aggregate

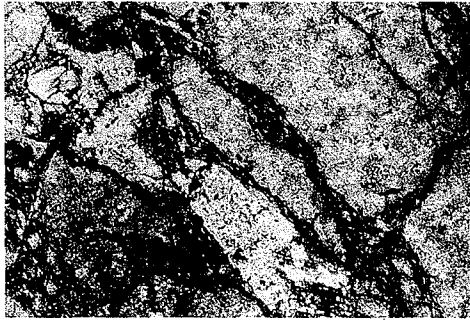
Fig. 3: Inter and intragranular fissures in quartz grains

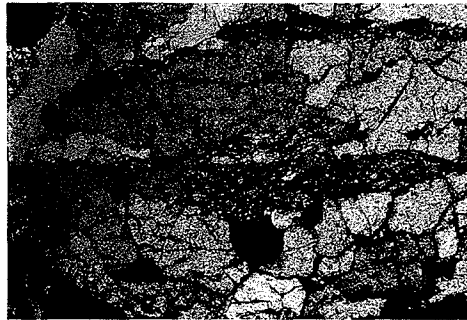
Fig. 4: Polygonization of a quartz aggregate

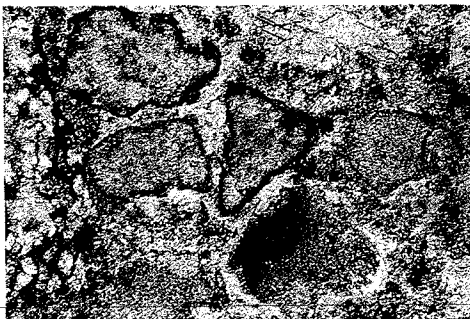
Fig. 5: Discoloration along the periphery of aggregates

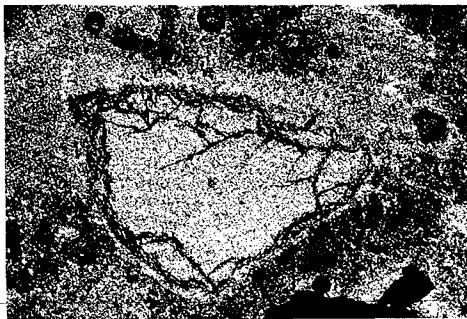
Fig. 6: Boundary cracks in a quartz aggregate
