**PETROGRAPHIC EXAMINATION AND CHEMICAL ANALYSIS  
OF THE LUCINDA JETTY PRESTRESSED CONCRETE ROADWAY**

Niels Thaulow, Jens Holm and Kim Thordal Andersen

G.M. Idorn Consult A/S  
44 Blokken, DK-3460 Birkerød, Denmark

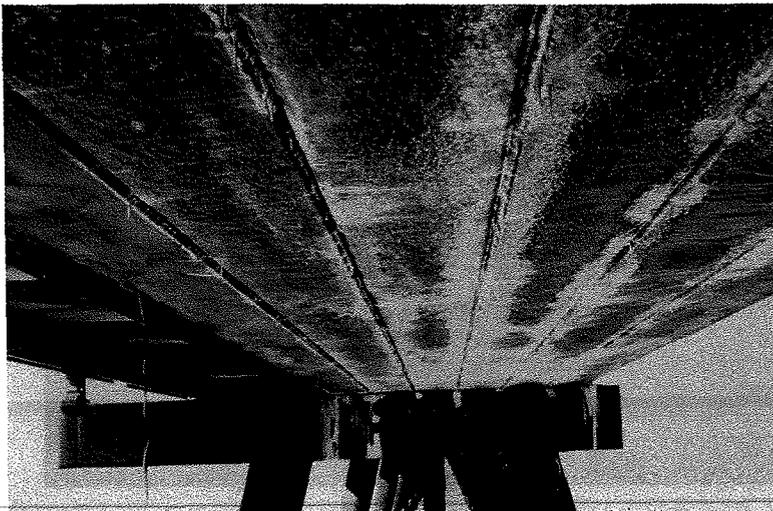
Figure 2 Photograph of the underside of the Lucinda Jetty. The concrete beams are partly covered with alkali-silica gel and calcite.

The manifestation of deterioration, as evidenced by deposits and cracking on the underside of the roadway, is highly variable, as illustrated in Figure 2. Thus, spans with extensive deposits may be observed immediately adjacent to spans which appear free of damage. Within a given six-girder assembly of a span, undamaged as well as heavily cracked and stained undersides of individual girders may be observed. Even within a given girder, considerable variability in damage may be observed.

On the underside of the tail-end structure, where the clearance between the water level and the underside of the roadway is reduced, and waves of warm, salty water frequently hit the bottom surface of the roadway, viscous, transparent gel exudes from micro-fissures in the concrete in sufficient amounts to be scraped off with a pocket knife and collected for further studies. This abundance of gel products is probably unique - based on available published case histories.

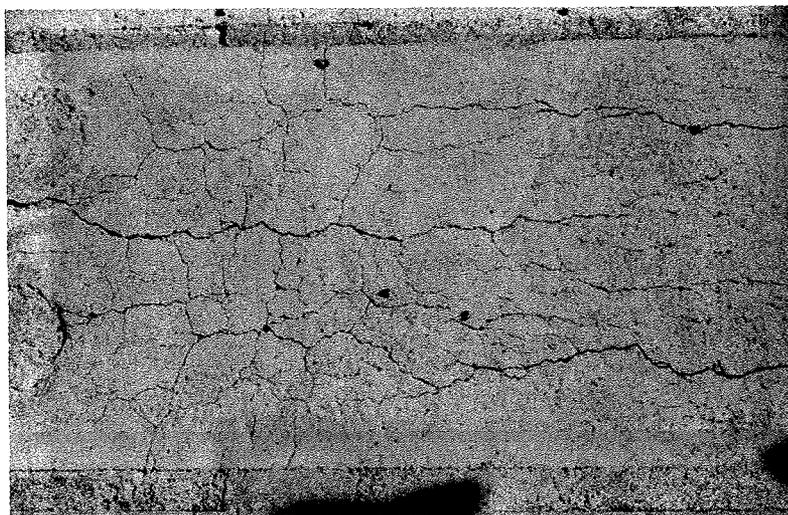
Upon removal in selected areas of the bitumen coating, the extensive level of cracking of the top surface of the beams became evident, as illustrated in Figure 3. Structural analysis and load testing, nevertheless, demonstrated predictable behaviour and high strength reserves [1], a finding which is corroborated by other accounts of load testing of structures subjected to deleterious alkali-silica reactions [2]. A comprehensive monitoring programme established at the jetty [1] has further demonstrated that while longitudinal expansion of the girders is modest, transverse expansion of the girder assemblies is about 70 times as high.

**Figure 3** After removing the bitumen coating and sand blasting the concrete surface the extensive cracking of the beams became evident.

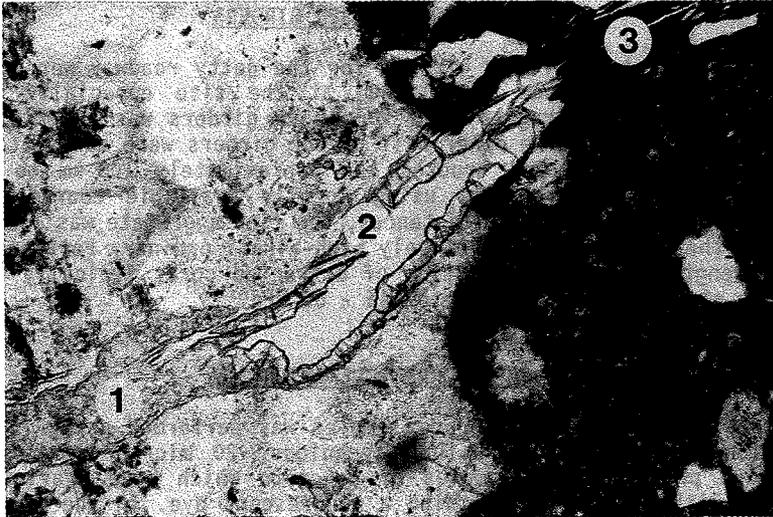
A detailed investigation of the petrographic manifestations of distress in the concrete from the Lucinda jetty is presented by Andersen & Thaulow [3]. These investigations show that alkali-silica reactions are the cause of cracking and consequent expansion. The examinations have further identified the source of the reactive silica to be the coarse aggregate, a volcanic rhyolitic tuff. Cracks are seen penetrating such coarse aggregate particles and deposits of at least three distinct types of gel have been identified in the cracks immediately inside and outside the perimeter of the aggregate particles. Figure 4 is a micrograph of a reacted coarse aggregate particle depicting the different types of gel.

Figure 4 Micrograph of part of the light coloured, reacted coarse aggregate particle (left). Three types of gel are seen:

1. Crystalline "gel" inside a crack in the aggregate.
2. Amorphous gel lining crack in aggregate and in the paste.
3. Dark layered gel in crack in the paste.

Field of view 2.5 x 4 mm.

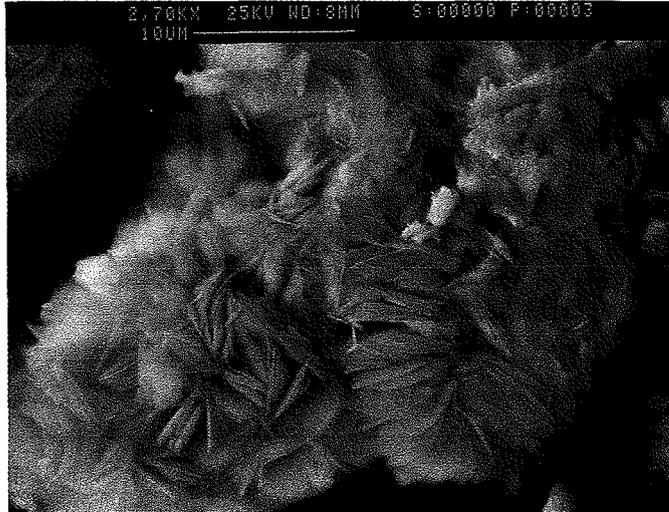
Samples of gel collected from the underside of the tail-end structure and gel observed in thin-sections at the perimeter of cracked aggregate particles have been studied by SEM and EDX. The SEM studies show that the gel within the cracked particles is crystalline with a rosette-like appearance, Figure 5. Similar appearances of gel have been described by Mather & Buck [4] and Regourd et al [5]. Close to the paste/aggregate interface but inside the aggregate the gel exhibits transparent, amorphous appearance, and further out within the hardened cement paste, the gel tends to have a non-transparent, grained and layered appearance.

Figure 5 SEM micrograph of crystalline "gel" with a platy morphology. This type is found inside cracks in reacted coarse aggregate particles. Magnification 2700 times.
