**ALKALI-AGGREGATE REACTION IN BELGIUM :
CONCRETE HIGHWAY AND OFFICE BUILDING**

Dionys Van Gemert

Dept. of Civil Engineering, Katholieke Universiteit Leuven
de Croylaan, 2, B-3030 Heverlee, Belgium

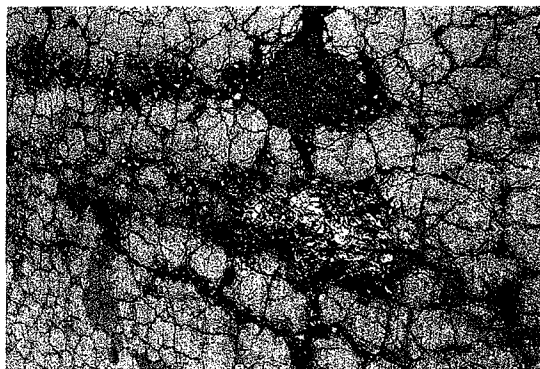
The plain concrete road, built in 1976, already showed some local damages three to four years after construction. No special attention was paid to these small damages, and they were repaired by the municipal technical services on the occasion of the regular maintenance inspections. The repairs were carried out with a bituminous mortar, as can be seen in Figure 1.

Fig. 1. : Typical damage and crack pattern, with local patchwork repairs.

It is found that all the alkali contents exceed the dangerous limit of 0,6 % of cement content. The fact that some samples show damage, whereas others do not, is accounted for by the higher content of water-soluble alkali in these samples (samples 1 to 4). Although we can explain the presence of alkali-aggregate reaction in the concrete, we cannot blame only the cement for it. It is the combination of reactive aggregates with highly alkali containing cements which is the cause of the damage. In this case of damaged road concrete the only solution is the complete renewal of the deteriorated section of the road.

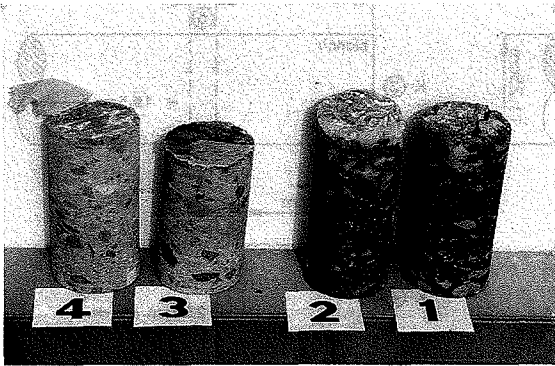
Four cores were bored out of the concrete. The cores K1 and K2 were taken out of deteriorated strips, whereas the cores K3 and K4 were taken out of visually non deteriorated strips. The cores are shown in Figure 2.

The sound cores were dry and had a grey outlook. The damaged cores were dark and still humid, because all the cracks had been filled up with water during the boring operation. Figure 3 gives a detailed view of core K1.

Fig. 2. : External appearance of test cores.

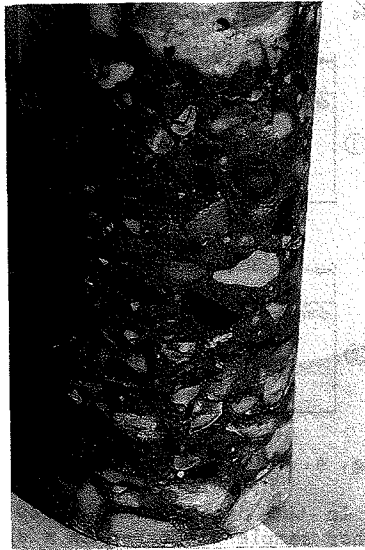
Fig. 3. : Core K1-detail.

Figure 3 shows that the fracture surfaces run straight through the aggregate stones. A crevice originated around the stones, as a consequence of the chemical reaction between these stones and the cement lime. The crack openings amount to more than 5 mm. These local swellings generate very high stresses in the surrounding concrete, which the concrete is impossible to resist. As a result, the concrete becomes heavily cracked throughout the whole mass. In the cracks the concrete surface is covered with a white bloom, due to an amorphous salt deposit. This bloom was also present on a "freshly" cracked surface of the damaged as well as of the undamaged cores. Identification of the bloom salt material by means of RX diffractometry proved to be impossible, because of the non crystalline nature of the deposit. By chemical analysis we found that the bloom was mainly composed of K, Na, Ca and SiO_2 . These elements also form the expansive silica gel. Six representative samples of the cores were chemically analysed, according to the procedures of the Belgian Standard NBN B15-250. The Al_2O_3 and Fe_2O_3 contents were measured by using the "Induction field coupled plasma"-technique. The Na_2O and K_2O contents were measured by means of the atomic absorption technique. The location of the test samples in the cores is indicated in Figure 4.

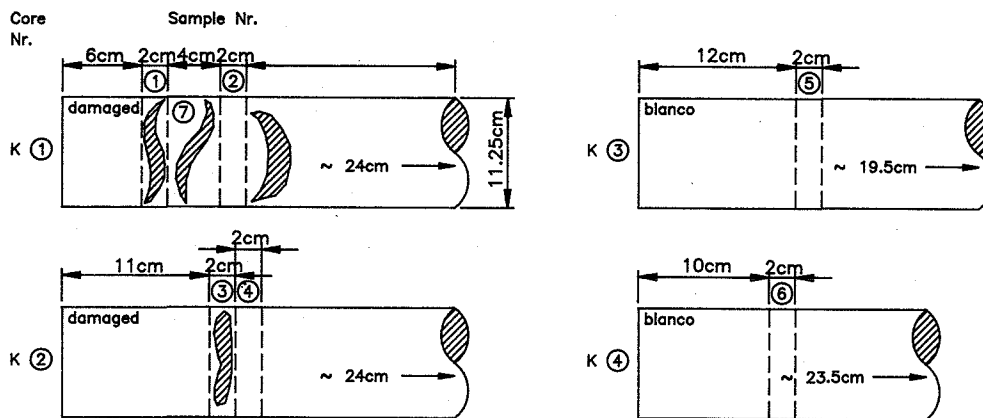
Fig. 4. : Location of chemically analysed samples.

In the deteriorated cores one sample was taken containing a crack, the other sample was taken in a still sound part of the core. The results of the analysis are summarized in Tabel 1.

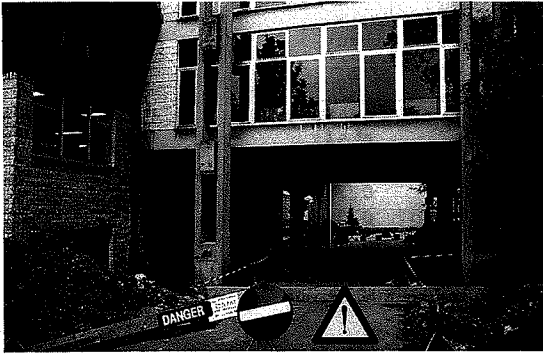
An interesting alkali-aggregate damage phenomenon was found in the supporting columns of an office building. The column type is shown in Figure 5. A detailed picture of the cracks and damage pattern is shown in Figure 6. A chemical and petrographic study of the concrete gave the same results as discussed above.

Fig. 5. : Column type.

The only possible way to stop the swelling of the concrete is to avoid water penetration into the concrete. This means that any remedial treatment will only be effective if the whole exterior surface of the columns is coated with a damp permeable but waterproof coating. However, concrete will never be completely dry, because the hardened cement gel always contains some physically bonded water. This means that we can never be sure that the expansive reaction is completely stopped. The structure, used to strengthen the columns, must therefore be flexible enough to allow the additional deformations, accompanying the reactions. A rectangular steel casing allows important swellings without causing high strains, because the arc nearly remains equal to the cord. The remedial treatment consisted of two phases :

- injection of cracks
- placing of steel casing, welded in situ.

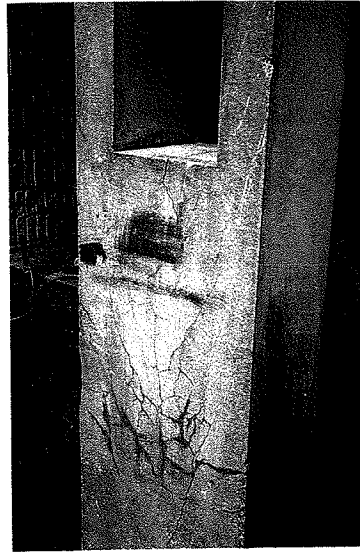
Fig. 6. : Detail of crack pattern.
