THE IDENTIFICATION OF ASR IN THE CONCRETE COOLING TOWER  
INFRASTRUCTURE OF THE TARONG POWER STATION

Alan Carse

Transport Technology Division of Queensland Transport Brisbane,  
Australia

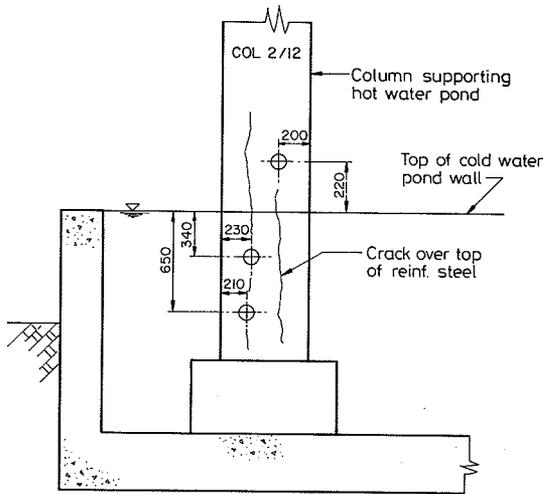
From Fig. 3 it can be seen that the predominant zone of cracking was at the water line and below in the cold water pond at ground level. Cores marked A and B were extracted below the maximum water level and core C above this level. Each cooling tower has an inside and outside circular row of columns supporting the hot water ponds. Each row consists of 54 precast columns and hence, each cooling tower has 108 columns.

Figure 3 View of concrete core locations at column no. 2/12

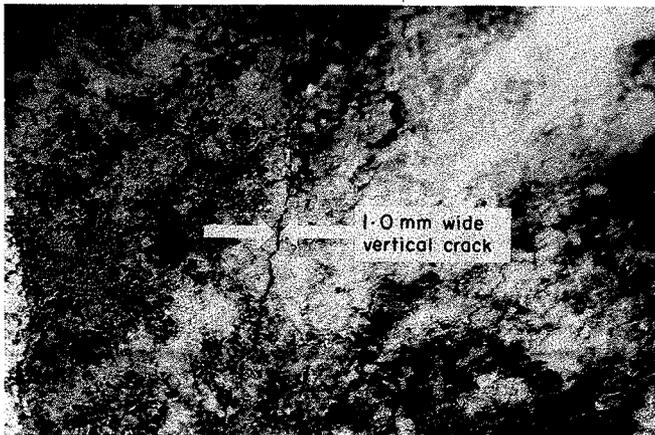
Petrographic Analysis. Table 2 details the width and extent of cracking observed in the cores. Figure 4 shows a view of the crack in column no. 1/26 and Figure 5 shows the cracking in cores no. 1/26A and 1/26B.

With reference to Table 2, it can be seen that the crack widths at the surface of the columns vary from 0.1 mm to 1.0 mm with corresponding penetrations of 33 mm to 110 mm. Hence, the range of cracking observed in the columns is quite substantial.

Figure 4 View of the vertical crack in column no. 1/26

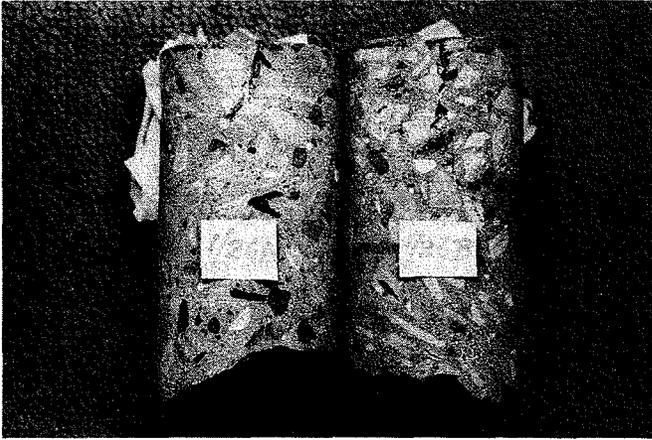
- (i) The observed cracking mainly traverses the cement paste but there are numerous examples of the fractures cutting coarse aggregate and sand grains.
- (ii) Alkali-silica gel and crystalline derivations fill or more commonly line some air bubbles.
- (iii) It seems likely that the vertical cracking observed in the columns is due to swelling of the interior concrete as a result of alkali-silica reaction. Electron microscope work should confirm this diagnosis.
- (iv) Potential sources of reactive aggregate are:
  - (a) Coarse aggregate - Chert
  - (b) Fine Aggregate - Chert, jasper, quartzite
- (v) The environment surrounding the columns is aggressive in relation to ASR.

Figure 5 View of cracking in cores no. 1/26A and 1/26B

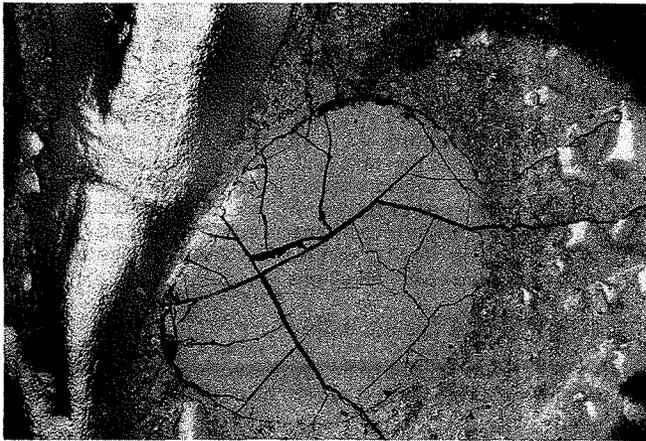
From Table 3 it is clear that the predominant reaction product (filling the observed cracks and entrapped air bubbles within the concrete) is a calcium/alkali/silica complex. Fig. 6 shows a view of the reaction product filling an air bubble in core no. 1/26A. This analysis confirms the hypothesis from the petrographic report that the vertical cracking observed in the cooling tower hot water pond columns is primarily due to swelling of the interior concrete due to alkali-silica reaction. The mechanism of ASR is accelerated in areas of high temperature and humidity. The water temperatures that exist in the hot and cold water ponds are summarised in Table 4.

Figure 6 View of alkali-silica gel filling a 2 mm dia. air bubble in core no. 1/26A
