ALKALI-AGGREGATE REACTIONS IN THE NETHERLANDS

Wim M.M. Heijnen

TNO Building and Construction Research, Department of Building Technology
P.O. Box 49, 2600 AA Delft, The Netherlands

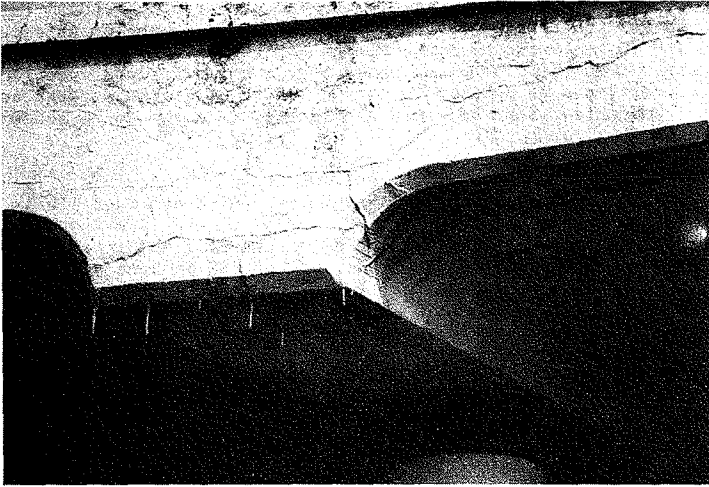
From visual inspection, the road deck concrete surfaces and a number of the abutments showed some cracking. Most of the cracks run in the direction of the length of the viaduct and form a pattern of more or less parallel running cracks, these were also associated with transverse cracks (Figure 1).

Crack widths were measured on the side of the road deck, on the underside near the support point on the columns, and also on the top of the road deck. On the side of the road deck the largest crack widths were associated with horizontal cracks. On the eastside the crack widths varied from 0.4 mm to 3.5 mm for the horizontal cracks and from less than 0.1 mm to 0.2 mm for the vertical cracks. On the westside the crack widths varied from 0.5 mm to 3.5 mm for the horizontal cracks and from less than 0.1 mm to 0.4 mm for the vertical cracks. The largest crack widths measured on the top of the road deck were in the direction of the length of the viaduct. Dependent on the number of parallel running cracks, the crack widths varied from 0.2 to 1.0 mm for a small number of cracks.

- 7.8 mm over 1.0 m, is 7.8 mm/m (eastside);
- 12.0 mm over 1.0 m, is 12.0 mm/m (westside).

Figure 1 Cracks in the side of the road deck near a row of columns

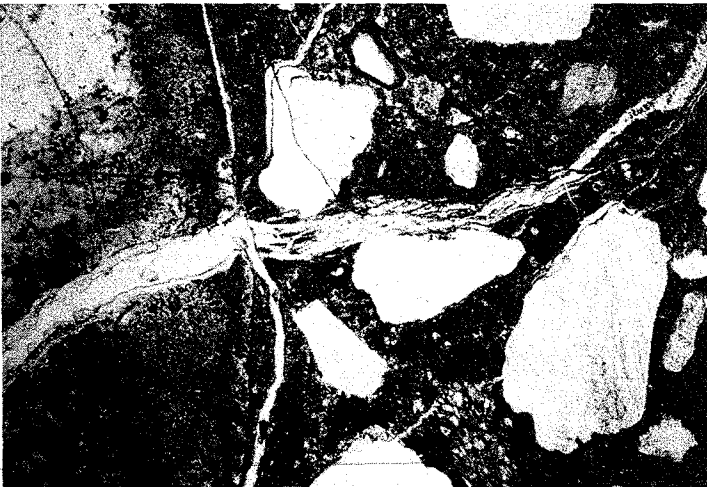
From the petrographic analysis it was concluded that the crack formation in the concrete of the cores S-W 1 and N-E 1 was caused by ASR. This reaction occurred in a number of porous chert particles in the gravel fraction.

Figure 2 illustrates this reaction clearly. In addition distinct types of quartzite (e.g. quartzites containing sericite and quartzites containing quartz grains showing undulatory extinction) present in the gravel fraction show some reaction. The reaction goes hand in hand with the formation of large amounts of expansive alkali-silica gel.

The cracks resulting from ASR are sometimes filled with secondary ettringite. The alkali-silica reaction was most intense in the interior of the concrete mass of core S-W 1 and to a lesser degree in core N-E 1. Core N 1 (from the northern abutment) showed no reaction.

Figure 2 Petrographic microscope picture of core S-W 1 (area shown=1.5x2 mm²); reaction of a porous chert grain with associated cracking and expulsion of gel

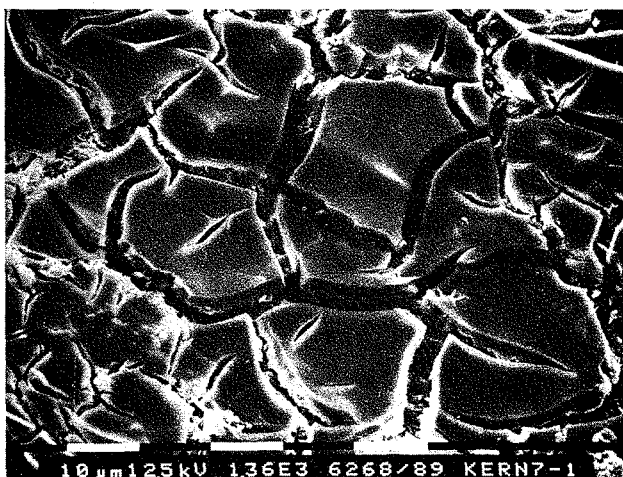
SEM investigation of a prominent reaction rim of a chert grain showed the presence of a gel-like substance (Figure 3). The gel showed obvious shrinkage cracks probably as a result of the extraction of water during the preparation. With help of EDS (Energy Dispersive X-Ray spectrometry) coupled with SEM the gel was found to comprise predominantly of SiO_2 , but at the same time contained a considerable amount of potassium. The estimated Si/K ratio (in percentage atoms) was about 5:1.

Figure 3 SEM picture of alkali-silica gel in a reaction rim of a chert grain

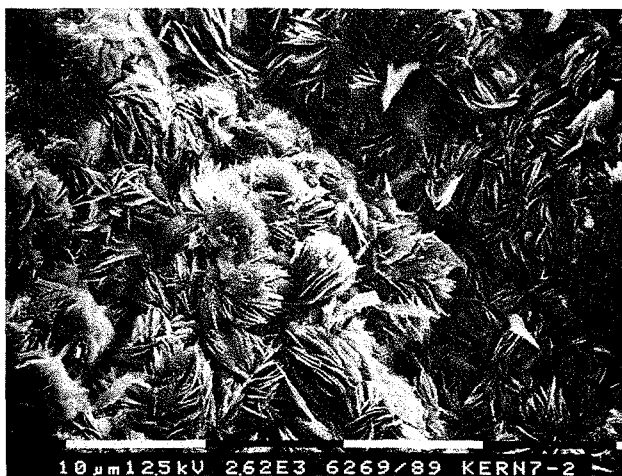
Rosette-like conglomerations of potassium calcium silicate were found to be present in the reaction rim of another chert grain (Figure 4). Via EDS the estimated content (in percentage atoms) was about 1:1:4. Such rosette-like arranged crystals have been described in concrete affected by ASR by de Ceukelaire (3) and Davies and Oberholster (4).

Figure 4 SEM picture of rosette-like conglomerations of crystalline ASR reaction products in a reaction rim of a chert grain
