REHABILITATION OF A GENERATING UNIT AFFECTED BY ALKALI-AGGREGATE REACTION

Alberto Jorge C. Tavares Cavalcanti, Adelmo Tabosa Campos,
Eduardo M. Mota Silveira, Evandro Gastão Wanderley
Companhia Hidro Elétrica do São Francisco
Rua Delmiro Gouveia 333 - Recife - Brazil - CEP 50761-901

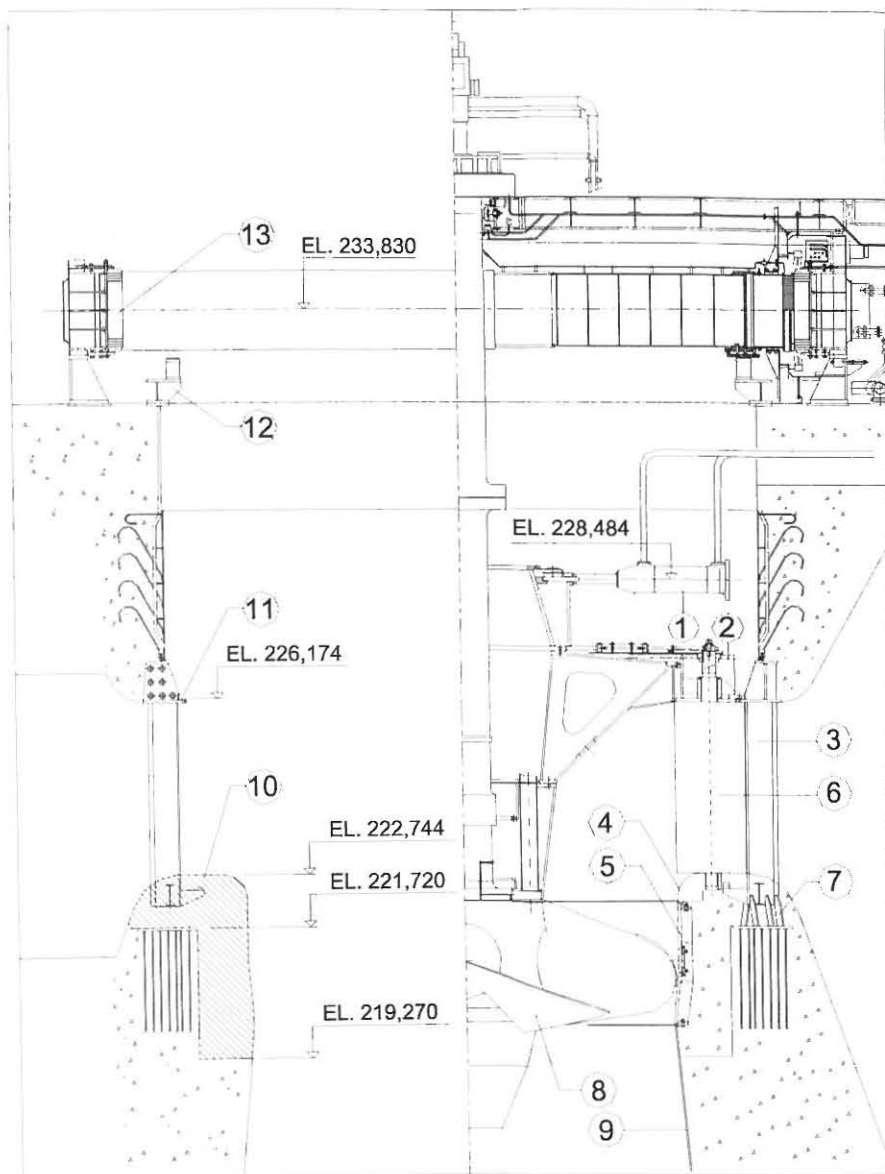
Fig.1: Generating unit cross section

The stress relief of the stay vanes was accomplished by cutting the rib base welds at their lower end. At the upper region of the stay ring the vanes remained fixed to the concrete. After the complete release of the vane, the six base ribs were welded again taking care to minimise the heat-induced stresses. The sequence was such that between the last welded vane and the one being released, there was one vane completely released. The Fig. 1 presents a cross section of the generating unit, showing in the left portion one released vane.

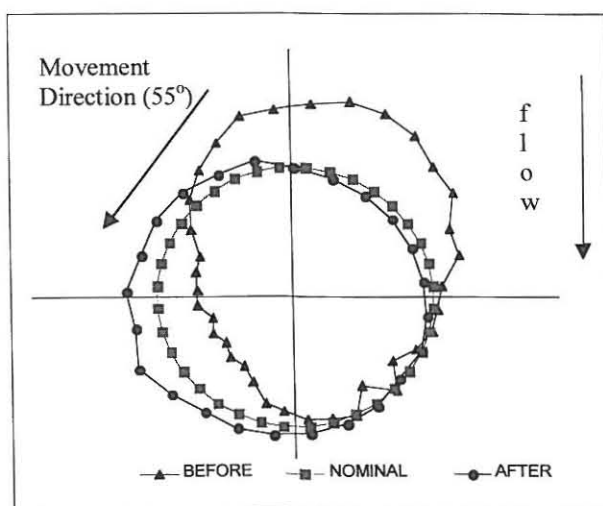
Fig. 2: Relative position between the turbine runner and discharge ring

To set the new position for the head cover, the relative displacement of the discharge ring to the runner blades, from downstream-right to upstream-left direction, due to the AAR phenomenon, was taken into account. The new position of the head cover was set off centre with the discharge ring, in the opposite direction of that resultant from the AAR, in order to allow a larger gap at the point where the runner approach the discharge ring. This displacement increased the clearance between the discharge ring and runner blades in the downstream-right region by 2 mm. As the theoretical radial clearance is 6 mm, was set the runner blades with a value of 2 mm approximately on the side where the clearance increases and of 10 mm in the side where it decreases. Furthermore, this new position will allow up to 12 mm displacement of the head cover in future, before recentering operations will be required.

The gap closure rate between the discharge ring and runner blades was about 0,85 mm a year. So, one can foresee that the unit will operate for more than 15 years without needing any similar interventions. Fig. 2 presents the situations before and after correction.

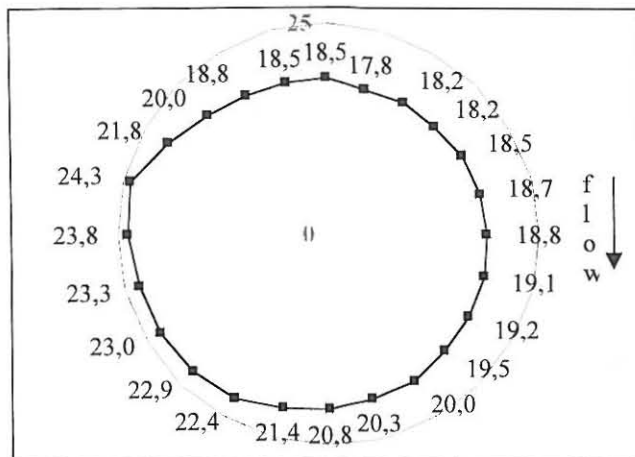
Fig. 3: Vertical displacements of the upper lip ring (mm)

The cumulated vertical displacements of the upper lip support rings, since the assembly (Fig. 3) showed an upward range of 17.8 mm near the upstream side to 24.2 mm close to the right bank side, resulting in a 6.4 mm off level.

After the stay vanes stress relief, the levelling of the head cover supporting rings at the upper lip plate was performed through the material removal and by grinding and adding shims to get the required level.

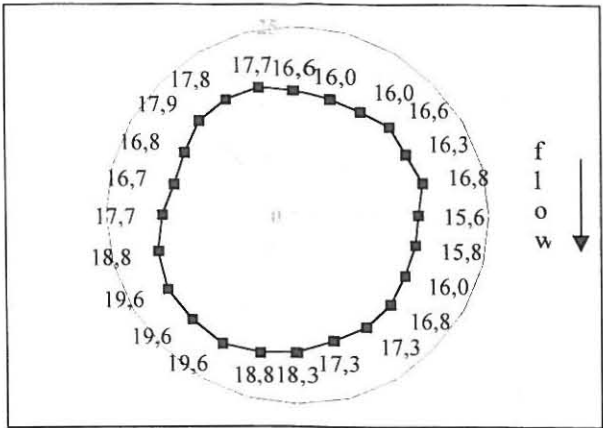
Fig 4: Vertical displacements of the lower lips (mm)

The vertical displacements of the distributor bottom ring was between 16 mm in the upstream- left direction to 19,6 mm in the opposite direction. (Fig .4)

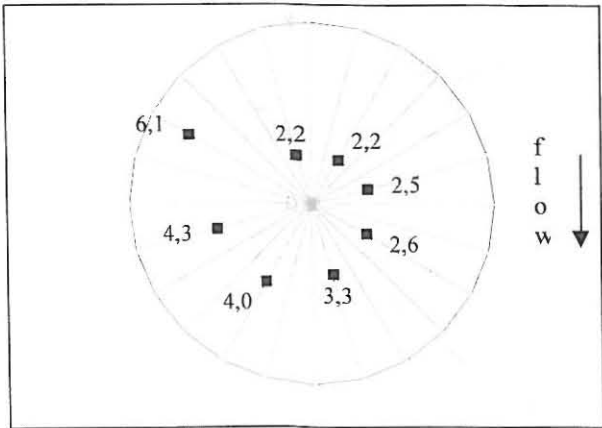
Fig. 5: Distributor height variation (mm)

The distributor height was controlled by measuring the distance between the distributor lower ring and the head cover bottom side, at eight wicket gates sealing surfaces, to assure the distributor free movement. The distributor height was increased from 2.2 mm near upstream to 6.1 mm at the right-upstream region (Fig. 5). The higher increase at the right semicircle is consistent with the wicket gates vertical clearances evolution (Silveira et al. 1995).

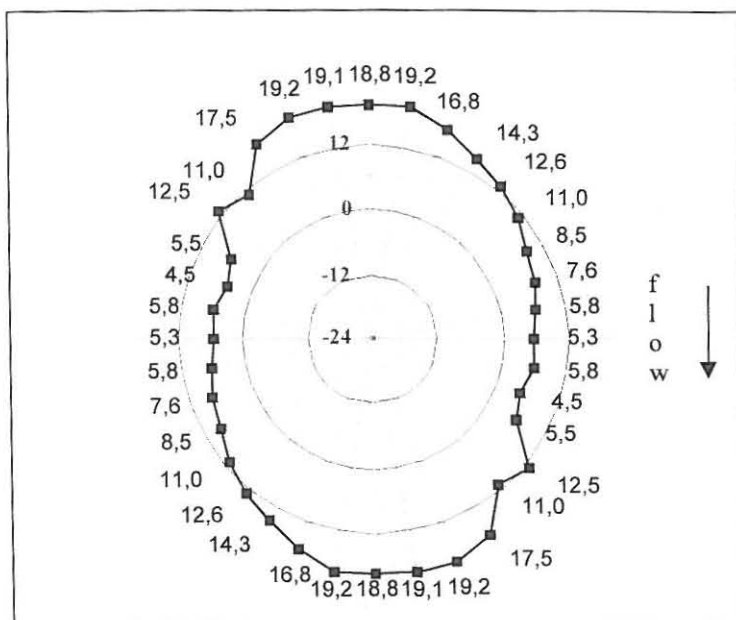
Fig. 6: Runner - discharge ring diametrical gaps (mm)

The roundness of the discharge ring was measured with the intermediate and the outer head cover in place and taking the centre at the shaft sealing centre line. It was measured the roundness of the discharge ring at the Kaplan blades centre level and in planes 0.5 m above and below this elevation. The discharge ring roundness at the Kaplan blades centre level presented a maximum ovaling of 14.7 mm and an eccentricity of 9.2 mm, in the direction 35° from upstream, clockwise.

The diametrical gaps between the turbine rotor and the discharge ring, originally 12 mm, varied to a maximum of 19.2 mm and a minimum of 4,5 mm, turning impossible to place the runner with the minimum 3 mm radial gap (Fig. 6).

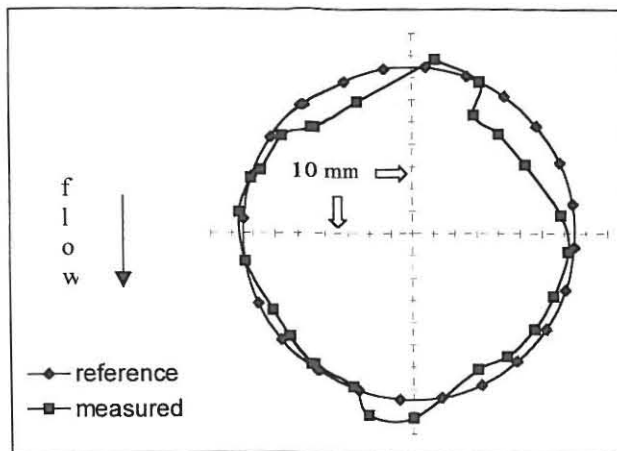
Fig. 7: Horizontal displacements of the stay vanes

Horizontal displacements - The horizontal displacements measured by the three-orthogonal meters due to the stress relief, shows movements up to 20.4 mm toward downstream and 17.4 mm toward the right bank side. The displacements scale unit, marked on the axis, is 10 mm (Fig.7)

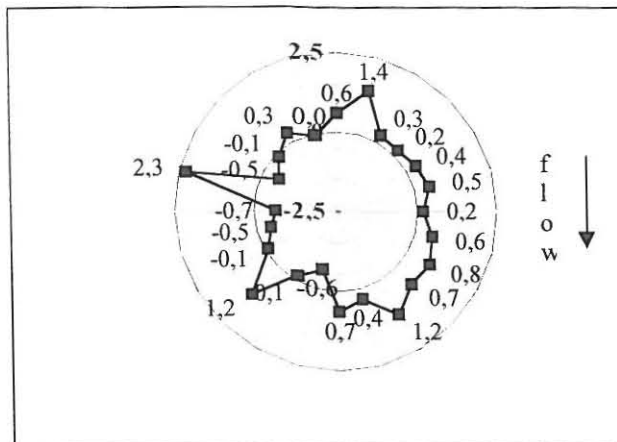
Fig. 8: Vertical displacements of the stay vanes (mm)

Vertical displacements – The larger vertical displacement was near the right bank with 2.3 mm upward. All vanes of the left semicircle had upward displacements indicating tensile stress, while at the right side all vanes, except three, had small downward displacements (Fig. 8).

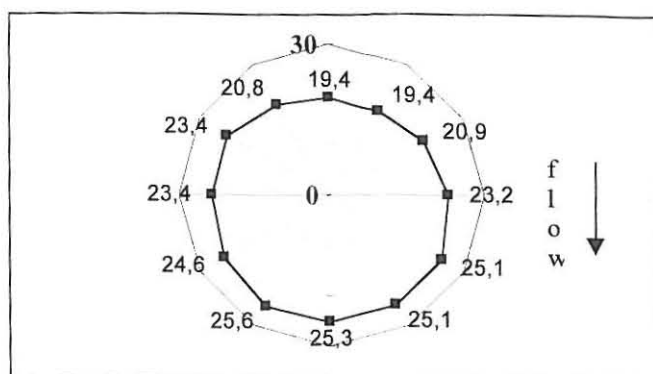
Fig. 9: Vertical displacements of the generator stator.

The generator stator magnetic axis levelling presented upward displacement between 19.4 mm and 25.6 mm related to the nominal level and a maximum difference of 6.2 mm (Fig. 9). As the stator have been repositioned before, these displacements does not reflect the total caused by the AAR.

The correction of the generator brake bases level was obtained by cutting its steel bases and the correction of the stator level was accomplished by the vertical displacement of the magnetic nucleus, through the removal of existing shims between the bases and the stator structure.

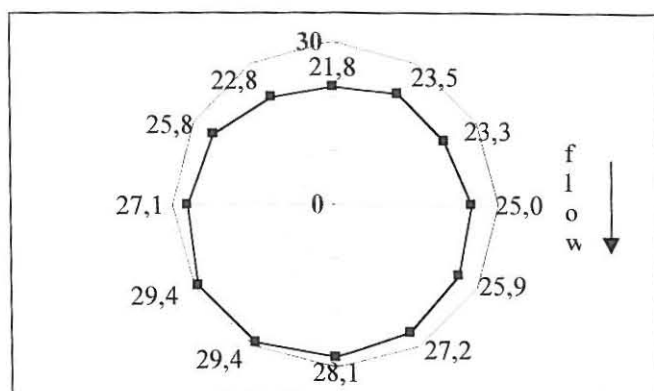
Fig. 10: Vertical displacements of the generator brake bases

The generator brake bases vertical displacements (Fig.10) varied from 21.8 mm at upstream to 29.4 mm at the downstream-right region, due to the concrete expansion.
