CASE STUDY OF ALKALI-SILICA REACTION DUE TO SILICA-FUME PELLETS IN A MORTAR REPAIR

Gilles Escadeillas, Eric Massias, André Carles Gibergues
Laboratoire Matériaux et Durabilité des Constructions, INSA
135 Avenue de Rangueil, 31077 TOULOUSE Cedex04, FRANCE

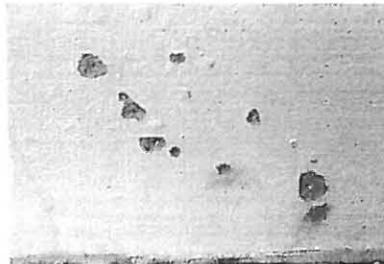
The first disorders appeared towards the end of work. They affect the mortar locally and result in some visible pop outs through painting (photo 1). Most of the pop outs are observed on posts of the southern frontage on which one can note the presence of a strong moisture (related to the presence of flower window box). Other pop outs of mortar are also observed on the other frontages. Systematically, the presence of a black point is noted in bottom of crater. Some cracks are also visible on the work.

Photo 1 : Disorders on the wall

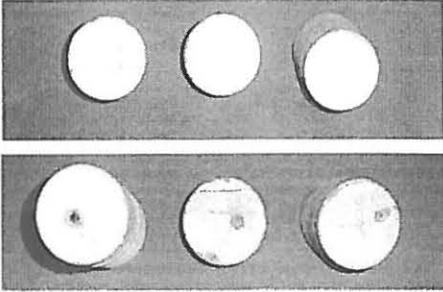
Sampling was carried out by coring in damaged zones presenting craters or pop outs and in zones seemingly healthy (photo 2). In all cores, one can observe many black points in all the depth of the mortar (photo 3). These black points can be either in the form of powder (especially in the healthy zones), or be solidified (in the damaged zones).

Photo 2 : Cores from healthy zones (top) and damaged zones (down)

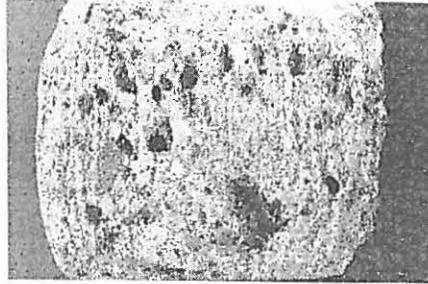
Photo 3 : Black points on the depth of mortar

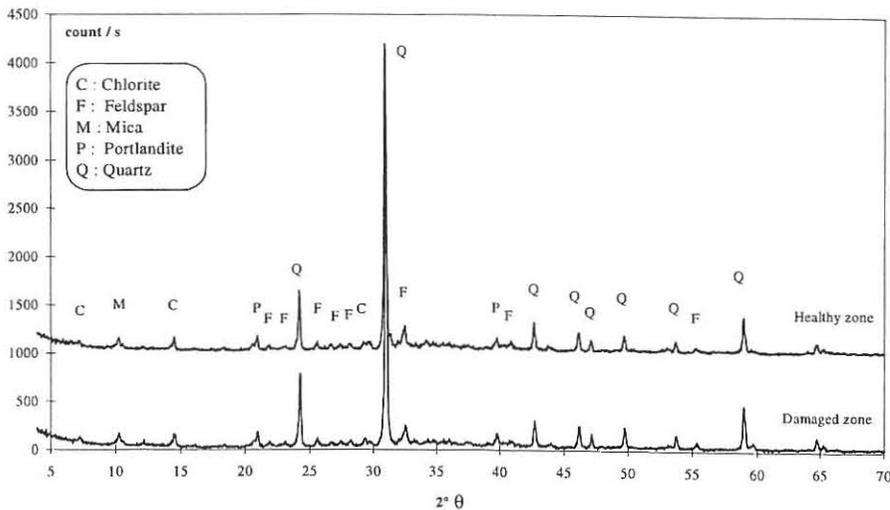
The diagrams obtained on the mortars taken in healthy zones and in damaged zones are similar and show (Fig.1) :

- characteristic phases of the aggregates : quartz, feldspar, chlorite, and mica ;
- crystallized phase of the hydrated cement paste : portlandite.

Fig. 1 : X-Ray diffractogram of the mortars

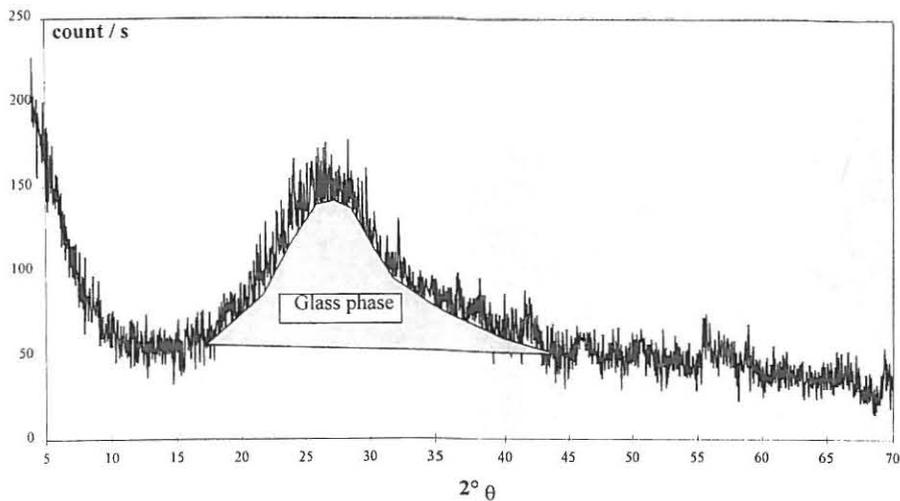
The diagram carried out on the black points show only one important vitreous phase (Fig. 2).

Fig. 2 : X-Ray diffractogram of the black point

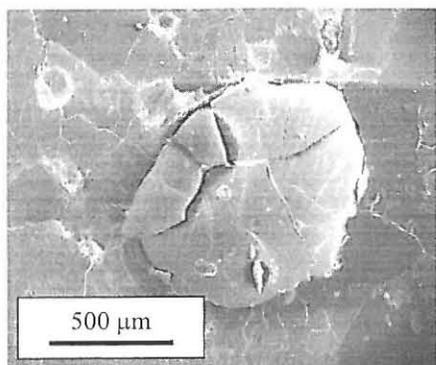
The observations carried out on polished sections confirm that, in damaged zones, black points appear as amorphous gel of variable size (photo 4). The qualitative chemical analysis carried out by X-spectrometry on the gel of photo 4 (figure 3) reveals the presence of silicon, potassium, sodium, and calcium. The gel observed is thus silico-calco-alkaline gel, comparable to the classical gel of alkali reaction.

Photo 4 : Pellet of gel observed in the mortar

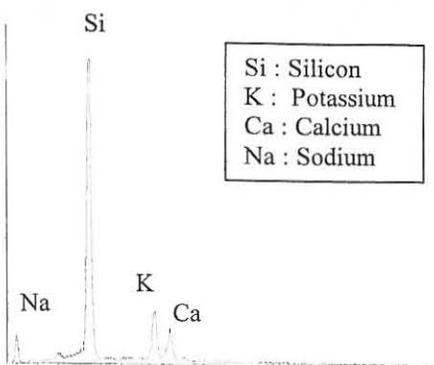
Fig. 3 : X-spectrometry of gel shown on photo 4

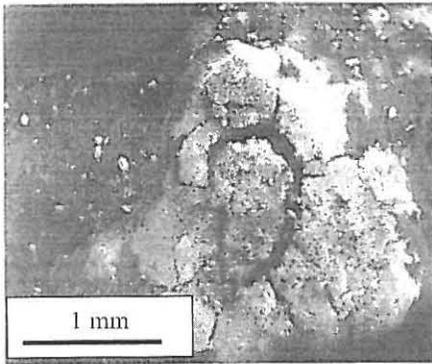
Certain gel was also observed in the zones seemingly healthy (photo 5). One can notice a beginning of formation of gel at the periphery of the black point and a powder aspect in the center. The chemical analyses by X-spectrometry show a more significant potassium content in gel in formation that in the heart of the black point (figure 4). So, the alkali-silica reaction is in progress.

Photo 5 : Pellet of gel in formation observed in the mortar
