MANAGEMENT OF STRUCTURES OF PETI DAM AFFECTED BY AAR

Ricardo A. Magalhães, Adelaide L.C. Carim, Amanda M. Costa, Carlos N. Moura
 Departamento de Manutenção de Estruturas Civas de Geração - GR/EC,
 Companhia Energética de Minas Gerais - CEMIG, Belo Horizonte, Brazil

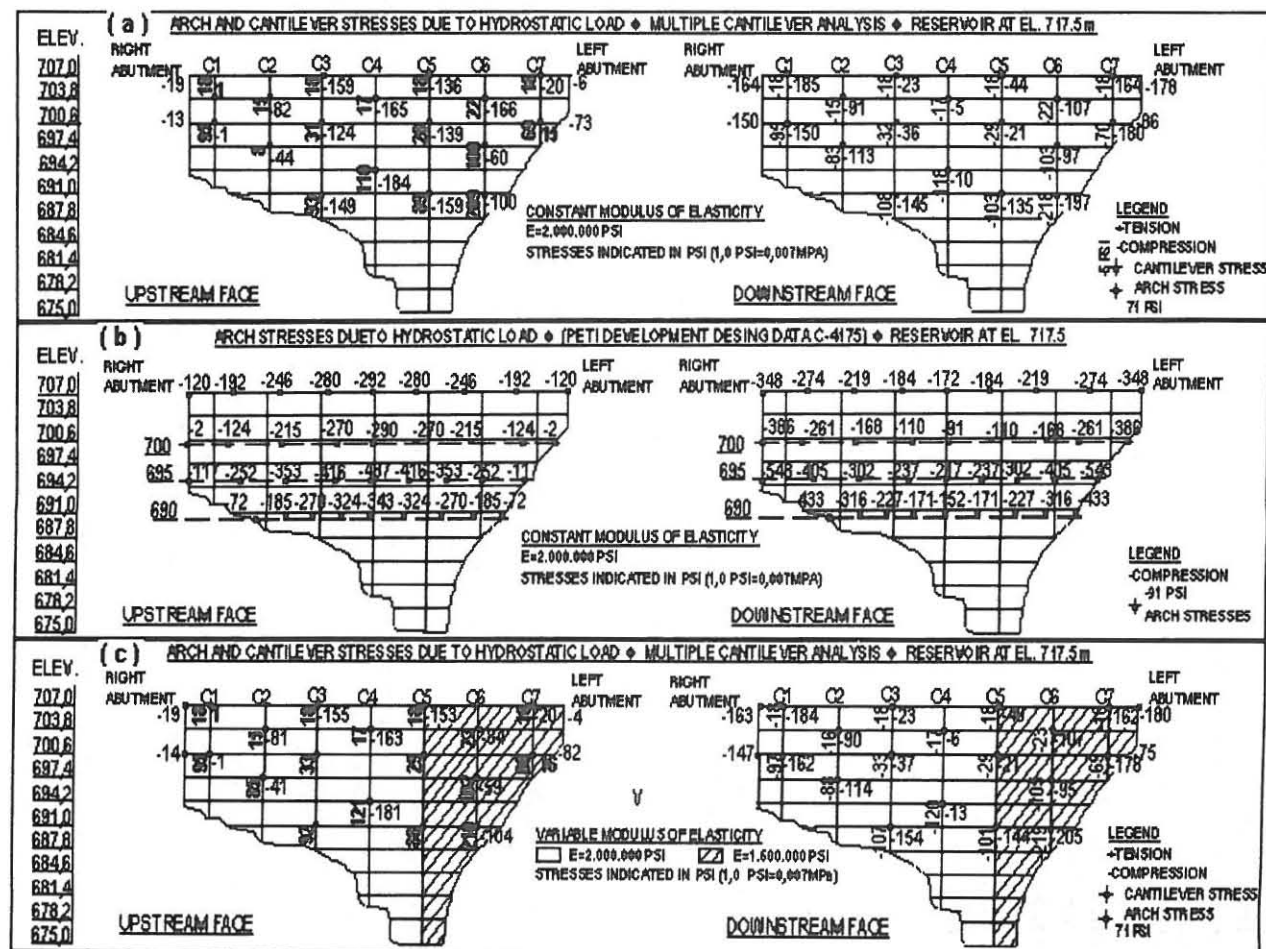
Fig. 2: Results of stress analysis.

The results of this stress analysis, using original design criteria regarding material characteristics are shown in Figure 2 (a). Figure 2 (b) shows the results of the stress analysis given in the Peti H E Development Design. As would be expected, the more sophisticated analysis, which considers cantilever action of the structure, results in lower stresses than the original, conservatively calculated, values. Additionally, a stress analysis utilizing a lower elastic modulus for the left half was also performed. The results shown in Figure 2 (c) indicate a general increase in stress levels at the left side however the newly calculated stress levels are still lower than the original allowable design stresses.

The main results of this stress analysis using the original design criteria regarding material characteristics (Maximum Stresses):

• Upstream face	- Cantilever stress	0,48 MPa (tension)
	- Arch stress	0,51 MPa (compression)
• Downstream face	- Cantilever stress	0,49 MPa (compression)
	- Arch stress	1,26 MPa (compression)

• Upstream face	- Cantilever stress	1,46 MPa (tension)
	- Arch stress	1,29 MPa (compression)
• Downstream face	- Cantilever stress	1,53 MPa (compression)
	- Arch stress	1,38 MPa (compression)

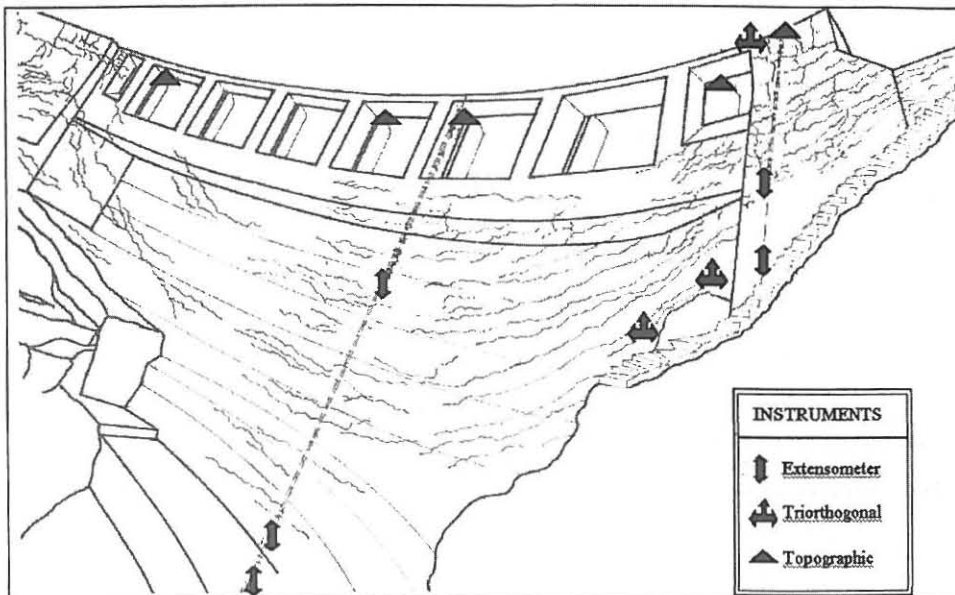
Fig. 3: Instrumentation installed for surveillance.

- Concrete coring of the left abutment and central portion of the Dam;
- Petrography analysis of concrete specimens (Pacelli, 1997);
- Laboratory testing to determine strength to concrete (Ferreira, 1997);
- Installation of extensometers and other instruments, as shown in Figure 3.
