**SEVERE PAVEMENT DAMAGE CAUSED BY ALKALI-SILICA REACTION IN
LIMESTONE COARSE AGGREGATE CONTAINING VERY FINE
QUARTZ PARTICLES**

Michael A. Ozol

ABSTRACT

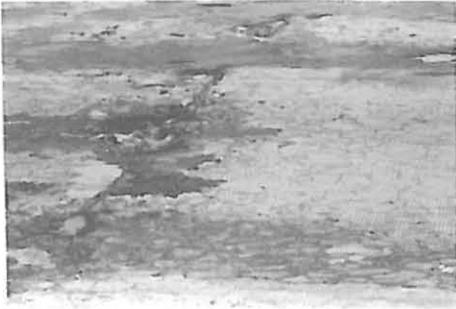
Both projects exhibited early distress and by December 1996 the appearance of a badly distressed portion in the west project was as shown in Figure 1, with extensive map cracking and shallow holes in the pavement a few inches deep and up to one foot (30 cm) in diameter. Where the pavement is not as badly distressed as in Fig. 1 it exhibits severe pattern cracking and the presence of one, or more, horizontal crack planes which develop below the wearing surface at typical depths between 25 to 75 mm (1 to 3 inches). Figure 2. The combination of the vertical and horizontal cracks in the wheel paths isolates chunks of concrete which are then excavated by the traffic.

Figure 1. Appearance of badly distressed roadway surface in the West project in December 1996. Note extensive pattern cracking, and shallow holes in the pavement near the joint where chunks of concrete have been excavated by traffic. Some asphalt patching has been attempted.

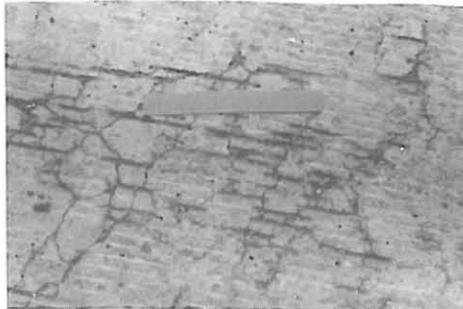
Figure 2. Distressed roadway surface, West Project, December 1996, scale is 6" (150 mm). Note pattern cracking. The cracks penetrate 1-2" (25-50 mm) vertically, and pieces of concrete isolated by cracks may be pried loose along a horizontal crack plane present at a depth of 1-2".

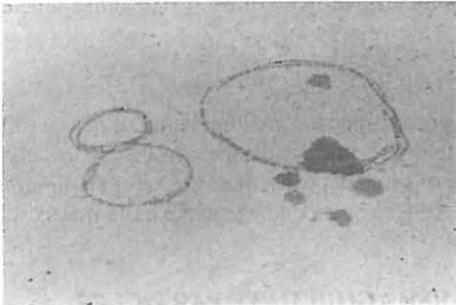
The concrete in the shoulder, of presumably the same composition as in the traffic lanes, exhibits little to no apparent cracking Figure 3. On the assumption that the pavement cracking is related to an expansive cement/aggregate reaction, a core was taken for the particular purpose of addressing the question of why the concrete in the shoulder is in so much better condition than in the adjacent severely cracked roadway if the concrete in the shoulder and the roadway is the same material.

Figure 3. Shoulder surface, West Project, December 1996, circle is approximately 6" (150 mm) in diameter. Note absence of visible cracking as compared to Figure 2 which is taken in the adjacent traffic lane at the same scale.

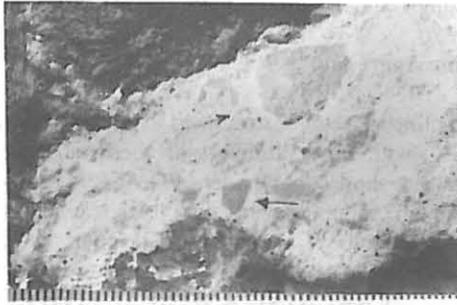
Coincident with the inspection of the roadway and the taking of core samples (December 1996) portions of severely distressed roadway were in process of excavation. The excavated concrete was stored temporarily in piles near the highway. The rubble piles provided large areas of broken-across vertical and horizontal interior section for examination. These broken-across sections revealed numerous interior paste/mortar surfaces coated with white powdery material, which also occurred around coarse aggregate particles exhibiting reaction rims, Figure 4. The appearance and occurrence of the white material was strongly suggestive of it being an alkali-silica reaction product.

Figure 4. Broken interior surface of excavated concrete. Note white material around coarse aggregate particles (arrows).

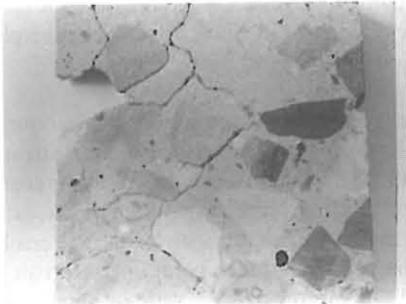
Figure 7. Interior vertical section of cracked pavement core from the east project with coarse aggregate particle of crack-generating lithology (arrow).

Using study slabs from regions of the cores with fewer cracks going through both the matrix and the coarse aggregate particles the required information can be obtained. An example is shown in Figure 7 in which cracks propagate through the matrix but around all coarse aggregate particles in the field except for one, in which there is a full width crack extending into the matrix on both sides of the particle. Figure 8 shows a detail view of the cracked particle with reaction rim, and the crack, wider in the particle mid-region and with parallel microcracks, extending into the matrix on both sides.

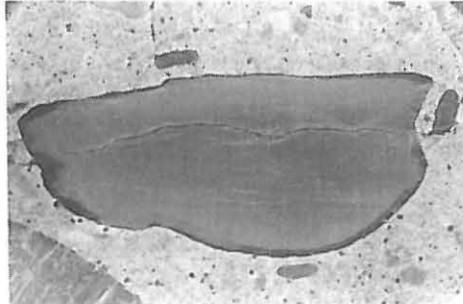
Figure 8. Detail view of arrowed particle of Figure 7 showing main internal crack exiting particle at both left and right edges, and family of micro cracks parallel to the main crack.

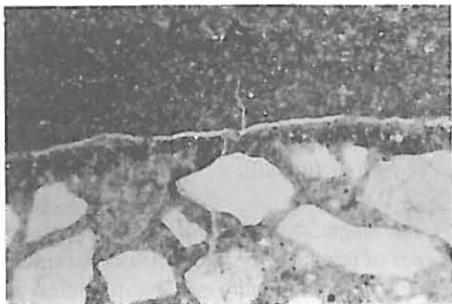
- Peripheral cracks separating the particle margin from the enclosing matrix. Figure 9.
- Cracks from the particle interior into the matrix, often with alkali-silica gel filling in the crack, Figure 10.

Figure 9. Thin-section, coarse aggregate particle of crack-generating lithology above (CA), and concrete matrix below, PPL, field is 2.7 mm width. Note peripheral separation between CA and matrix, and radially oriented crack across CA/matrix interface and into matrix.

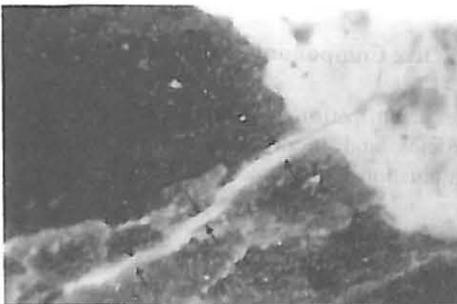
Figure 10. Cut and polished section, shoulder concrete core, field is 1.9 mm across. The white crack-filling material (arrows) extends into the paste, and the micro-crack extends into the paste a greater distance. The crack-filling material is ASR product as identified optically and which fluoresces in UV light on the uranyl acetate treated surface.

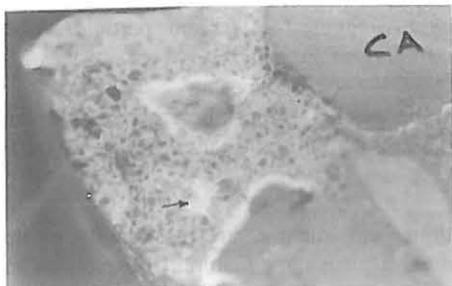
- Alkali-silica reaction product inward of the particle perimeter extending into the paste to form exterior margins around the particles. Figure 11. Such features are the plan views of the crack planes seen in cross section in e.g., Figure 10.

Figure 11. Partially saw-cut and broken section, shoulder concrete core, parallel to pavement surface at 127 mm (5 in) depth, field is approximately 30 mm across. Surface treated with uranyl acetate solution and photographed in UV light. The ASR product around the central and lower coarse aggregate particles fluoresces brightly. The interior of the central particle is lightly coated with ASR product and fluoresces weakly. The arrow indicates a void with reaction product.

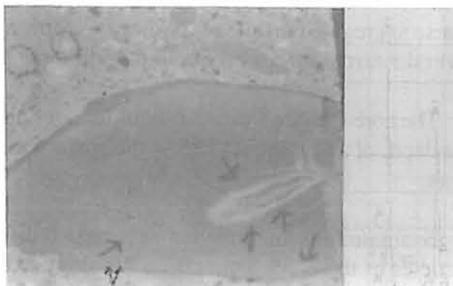
- Alkali-silica reaction product within, and adjacent to, micro-cracks in the interior of particles of the crack-forming limestone lithology, as identified on uranyl acetate treated surfaces in UV light and by SEM and EDS. The treatment of the reactive coarse aggregate particle cross-section in concrete with the uranyl acetate solution produces the exudation of a soft, shiny, jelly-like, material in, and around, the interior particle cracks. The material is strongly fluorescent, with the yellowish-green color characteristic of alkali-silica gel in UV light, and produces EDS spectra characteristic of alkali-silica reaction product, Figure 12.

Figure 12. Saw-cut vertical section treated with uranyl acetate solution and photographed in UV light. Fluorescent envelopes of ASR product are present around internal cracks in coarse aggregate particle (arrows). An EDS spectrum of the fluorescing material is shown.

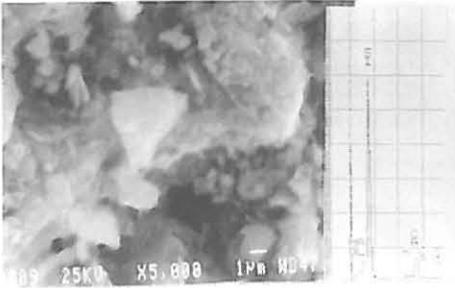
The presence of numerous quartz particles in the limestone matrix still smaller than ten micrometers was also noted under the optical microscope. Those were more conveniently studied and identified by means of scanning electron microscopy and EDS, which established the presence of quartz particles in the two micrometer size range. Figure 13 shows an approximately 5 micron quartz particle with its EDS spectrum.

Figure 13. SEM micrograph of area of limestone matrix with quartz particle (lighter gray, triangular, in center of field) and its EDS spectrum.

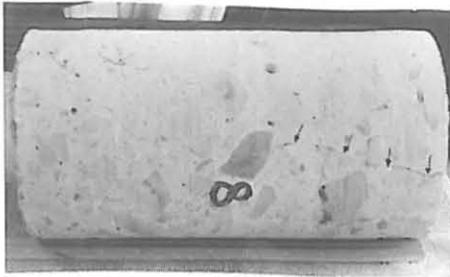
The core sample from the road shoulder, which shows no readily apparent cracks, Figure 3, does in fact have a surface crack which extends to a depth of 114 mm (4 ½ inch) where it enters a coarse aggregate particle of the crack — forming lithology Figure 14. The same particle exhibits several internal micro-cracks and peripheral separation from the matrix.

Figure 14. Core from road shoulder, top to right, showing surface crack extending to dark coarse aggregate particle of crack-generating lithology (right arrows). The upper left arrows indicate cracks near the core bottom.
