## THE IDENTIFICATION OF ALKALI-AGGREGATE REACTION AT THE GARDINER DAM, OUTLOOK SASKATCHEWAN

S. T. R. (Scott) Roy, P. Eng., M. Eng.

Prairie Farm Rehabilitation Administration (PFRA), Agriculture and Agri-Food Canada  
1800 Hamilton St., Regina, Saskatchewan, S4P 4L2

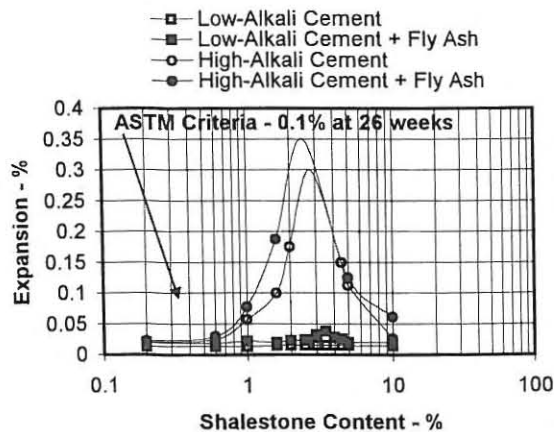
Fig. 1. Pessimism effect of Gardiner Dam fine aggregate with varying percentage of shalestone materials using the Mortar Bar Test (ASTM C-227).

Mortar Bar tests were also used to determine if there was a pessimum shalestone content at which maximum expansion would occur. Fig. 1 shows that excessive expansion did not

occur using the low-alkali cement, both alone and in combination with the high-alkali fly ash. In the high alkali-cement mixes, excessive expansion was noted in both the straight-cement and fly ash mixes.

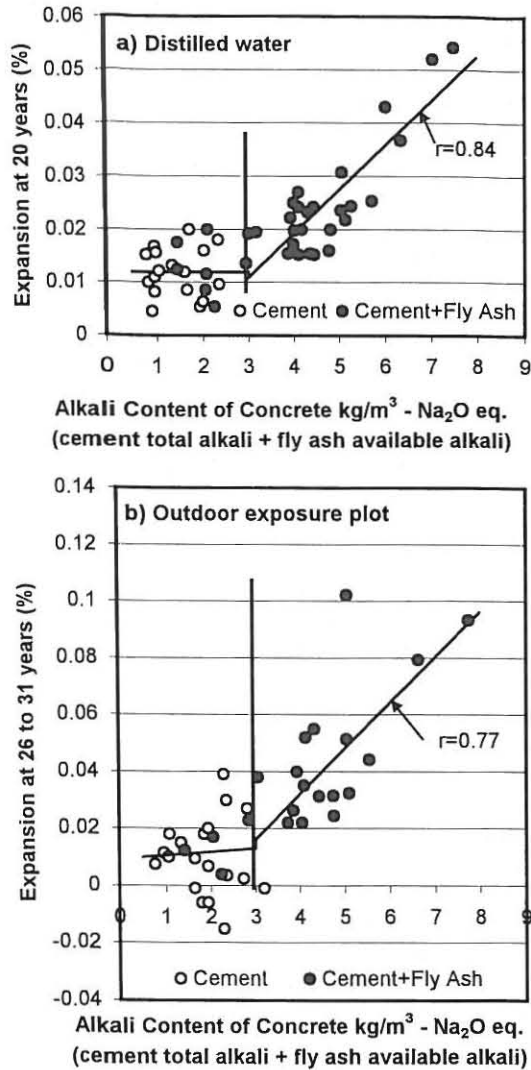
Fig. 2. Concrete prism expansion vs concrete alkali content (kg/m<sup>3</sup> as Na<sub>2</sub>O eq.), stored: a) in distilled water for 20 years and b) at outdoor exposure plot for 26 to 31 years.

Concrete prisms were manufactured using a variety of cement and cement-fly ash combinations, and stored: over water in sealed containers, in a 38° C environment; in distilled water at room temperature; and in a field exposure plot containing high sulphate soils. Fly-ash levels ranged from 0 to 28 % as a percentage of total cementing materials. Specimens stored over water for periods up to 3 years did not show excessive expansion. Again, it is unknown if the testing conditions leached alkalis from the test specimens. Prisms stored in distilled water and in the field exposure conditions for 20 to 31 years showed a linear relationship for increased expansion when the concrete alkali content exceeded 3 kg/m<sup>3</sup> (Fig. 2).

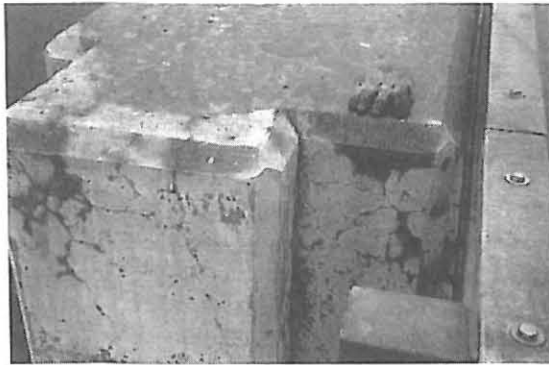
Concrete condition surveys were conducted on the exposed and accessible portions of appurtenant works of the Gardiner Dam in 1987 and 1989. The upper portions of the pier pedestals (16 upstream and 16 downstream) showed pattern cracking to varying degrees. Some portions were hollow sounding and the top surfaces had varying numbers of shalestone popouts present (Fig. 3). Cores retrieved from the pier pedestals showed pattern cracking throughout their length and when crack faces were exposed, numerous reacted shalestone particles in the 4.75 to 9.5 mm size fraction were observed. These were soft, dark and severely reacted as evidenced by profuse amounts of gel over the entire crack surface.

Fig. 3. Pattern cracking and surface popouts on upstream spillway pier pedestal # 8.

The possible influence of other destructive mechanisms on the deterioration noted in the pier pedestals was investigated. On the basis of mix parameters, freeze-thaw testing and air-void analyses on hardened concrete, the concrete in the pier pedestals was judged to be sufficiently durable to resist deterioration from freeze-thaw cycles. Deicing salts ( $\text{NaCl}$ ) have been routinely applied directly to the highway adjacent to the structure. Powder samples from a drill hole on a pier pedestal indicated that concrete contained chloride levels ranging from  $730 \text{ }\mu\text{g/g}$  to  $3900 \text{ }\mu\text{g/g}$ . Although the pattern of cracking observed was not directly attributed to corrosion of the reinforcing steel, the chloride levels observed were sufficient to de-passivate the reinforcing steel, and corrosion may be contributing to the degree of deterioration noted. There is also a strong possibility that the deicing salts have influenced the rate of the reaction caused by AAR and have been a source of external alkalis.

structures, at the time of the investigations, was deemed unnecessary. In areas where the prognosis for continued deterioration is likely or where significant potential expansion is identified, alternative mitigative measures could be researched in the field on minimally deteriorated areas. Examples include the use of surface sealers to reduce the access of external alkalis and moisture, or lithium salts to slow or stop the reaction.

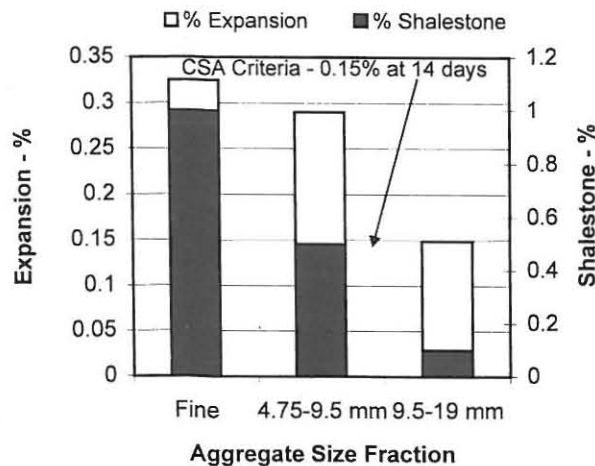
Fig. 4 shows the expansion at completion of Accelerated Mortar Bar Tests (CSA 1994c) between three Gardiner Dam aggregate size fractions, along with the corresponding shalestone contents, indicating a direct relationship. Accelerated

Fig. 4. Accelerated Mortar Bar Test (CSA A23.2-25A) results on various size fractions of Gardiner Dam aggregate.

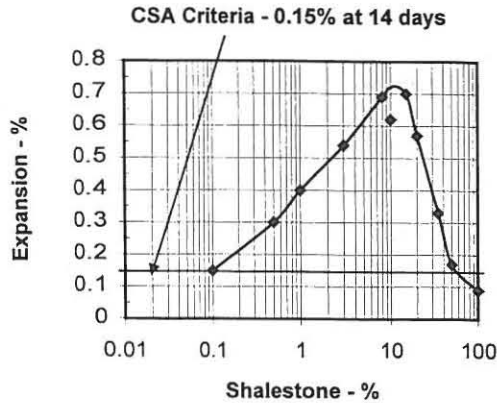
Mortar Bar tests also indicated a pessimum shalestone proportion of about 10 % (Fig. 5). As this proportion is significantly different from the results obtained using the Mortar Bar test (ASTM 1958(T)) conducted prior to and during construction (Fig.1), it is felt that the pessimum proportion may be more representative of the test's more severe exposure conditions.

Fig. 5. Pessimum effect of shalestone materials using the Accelerated Mortar Bar Test (CSA A23.2-25A).

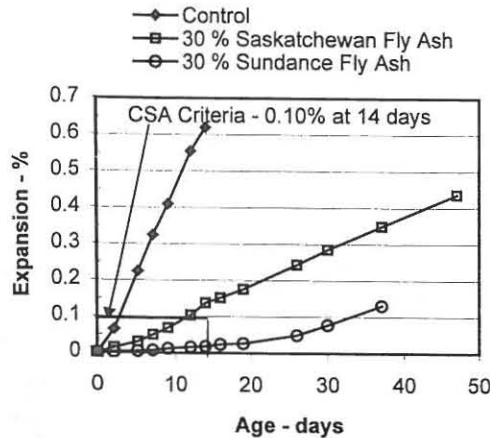
Fig. 6 shows the relative expansions for the control mix, 30 % Saskatchewan fly ash and a low-alkali Alberta fly ash (30%). Both fly ashes significantly reduced expansion. When the length of the test was extended beyond the 14 day standard test period, expansion continued at an increased rate.

Fig. 6. Effect of cement replacement with 30 % Saskatchewan and Alberta fly ashes using the Accelerated Mortar Bar Test (CSA A23.2-25A).

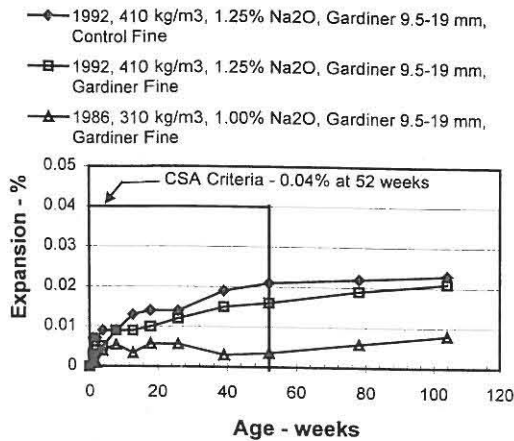
Fig. 7 shows three Concrete Prism Test (CSA 1994b) results using a variety of aggregate combinations. In all cases, the coarse aggregate used was the Gardiner Dam material that had been processed by heavy media flotation. Both the 1977 (CSA 1977) and 1994 (CSA 1994b) versions of the Concrete Prism test showed minimal expansion ranging from 0.008 to 0.023% at two years.

Fig. 7. Concrete prism (CSA A23.2-14A) expansion data using processed Gardiner Dam aggregate.
