## REHABILITATION OF A MAJOR 38 YEAR OLD STRUCTURE CHARACTERIZED BY SEVERE ALKALI-AGGREGATE REACTIVITY

John Ryell and Rick Mlynarczyk  
Trow Consulting Engineers Ltd.  
1595 Clark Boulevard Brampton, Ontario, L6T 4V1

Robert Falcioni  
The Regional Municipality of Sudbury  
200 Brady Street, P.O. Box 3700, Station A, Sudbury, Ontario, P3A 5W5

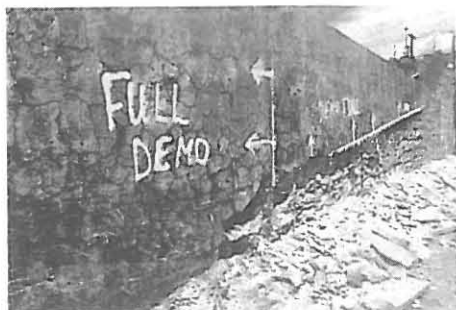
In 1997 when a decision was made by the owner to rehabilitate the structure some concrete components were affected by severe deterioration; the worst examples were the exposed retaining walls (Fig. 1). It is clear that the main contributing factor in the deterioration process is alkali-silicate reaction (ASR). Freeze-thaw damage of the cracked concrete and surface spalling caused by corrosion of the steel reinforcement has served to accelerate the rate of deterioration..

Figure 1: Severe AAR deterioration in structure retaining wall. Generally the outer face steel reinforcement is corroded.

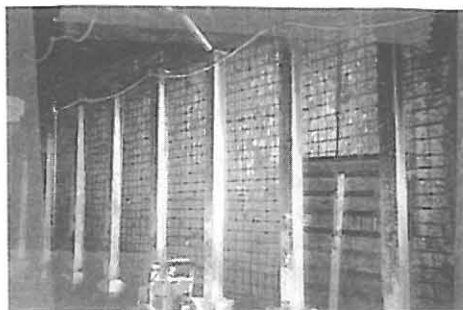
Figure 2: Commencement of formwork erection to the CPR structure abutment. At this stage the outer 200 mm of deteriorated concrete has been removed and the epoxy coated steel reinforcement and mechanical anchors are in place. Note the temporary steel structure supporting the bridge deck beams under the CPR rail lines.

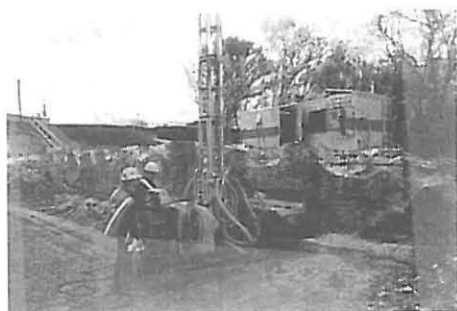
Figure 3: Removal of concrete by hydrodemolition

The remaining deteriorated concrete, approximately 100 to 200 mm in thickness, was removed by hydrodemolition using a one man hydraulically operated robotic device with a water pressure of 86 MPa (Fig. 3). The hydrodemolition equipment, using water at approximately 190 liters per minute, removed up to approximately 0.5 cubic meters of concrete per hour. A total of 393 cubic meters of concrete was removed by hydrodemolition using approximately 17 million liters of water. Following the major removal operation by mechanical means and hydrodemolition, only minor amounts of fractured or loose concrete remained; these were removed by a hand held water lance operated at pressures of approximately 50 to 60 MPa (Fig. 4).

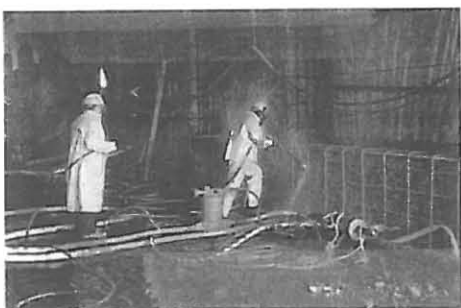
Fig. 4: Water blasting clean up and surface preparation of the roadway crash wall and piers prior to concrete refacement. Typically the outer 75 mm to 100 mm of deteriorated concrete has been removed and some steel reinforcement has been replaced.

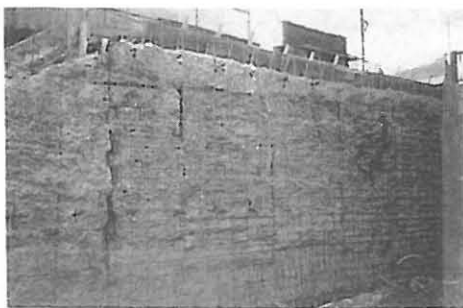
Fig. 5: Placement of epoxy coated reinforcing steel in retaining wall. At this stage the outer 300 mm of deteriorated concrete has been removed and the mechanical anchors and form ties have been installed.

Mechanical dowel anchors were installed to tie in the refacement concrete to the existing concrete in the abutments and retaining walls. The anchors were spaced at 1 m centres vertically and horizontally and grouted to a depth of 300 mm into the existing concrete. A mat of epoxy coated reinforcing steel was installed near the outer face of the abutments and retaining walls and tied to the dowel anchors (Fig. 5).

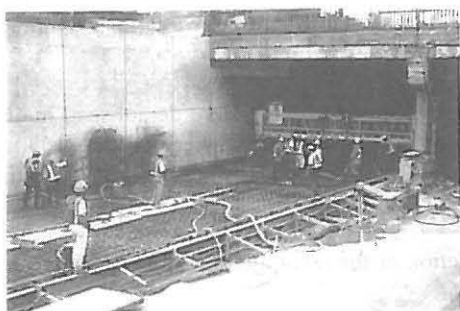
Fig. 6: Replacement of concrete road slab using epoxy coated reinforcing steel. At this stage the refacement of the structure abutments and retaining walls is complete but the Elgin Street deck slab has not been replaced (note the significant AAR deterioration on the exposed face).

It was specified that the Brady Street road slab could not be removed prior to the removal of the braced CPR deck load from the footings. Once the refacement of the abutment walls was completed and the shores removed, the full thickness of the road slab over the transverse strut beams was removed by hydrodemolition. Following this operation, the slab reinforcement was cut by torch and the slab sections were lifted out by loader. Removal of debris and minor areas of deteriorated concrete from the strut beams and footings, placement of new granular materials, followed by conventional bridge deck concrete placement

techniques were used to complete the new concrete road slab (Fig. 6). A total of 780 cubic meters of concrete was placed in the road slab and medians.

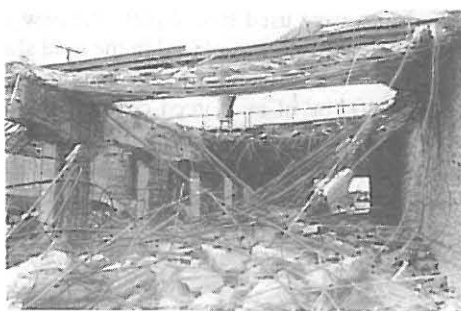
Fig. 7: Demolition of Elgin Street cast-in-place deck slab. The CPR structure is in the background.

The 200 m<sup>3</sup> of reinforced concrete in the Elgin Street deck slab were demolished in 10 hours using a Hoe Ram (Fig. 7). The deck replacement consisted of eighteen precast 0.54 m thick concrete beams cast at a local precast plant and installed by crane (Fig. 8) plus waterproofing and a bituminous pavement.

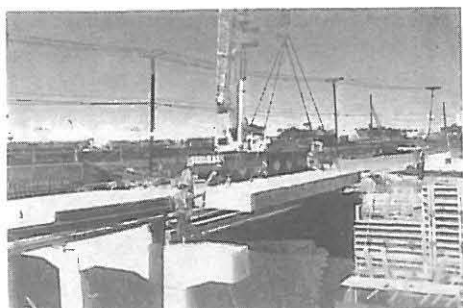
Fig. 8: Installation of precast concrete deck units, Elgin Street Overpass. The CPR structure is in the background.

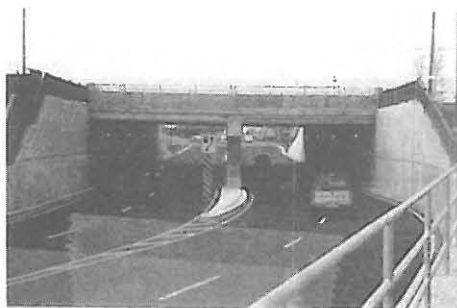
Fig. 9: Rehabilitated structure, November 1998. The replaced Elgin Street deck slab is in the foreground.

The Brady Street structure, following completion of the rehabilitation work is shown in Fig. 9.
