# A PROPOSAL FOR REHABILITATION OF ASR-AFFECTED BRIDGE PIERS WITH FRACTURED STEEL BARS

Takeshi Daidai\*, Kazuyuki Torii

Kanazawa University, Kakuma-machi, Kanazawa, Japan

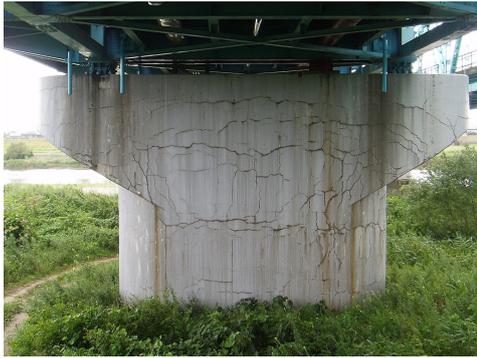
The Arisawa Bridge, which was completed in 1972, is the Warren-type steel structure one having seven spans across the Jinzu River in Toyama prefecture in Japan. The super structure is supported by seven reinforced concrete hammerhead piers with an oval cross sectional shape across the river. Although the time when the cracks have initiated due to ASR is not reported, the piers were subjected to the coating on surface and partially injection into large cracks in 1989 at the time when 17 years have passed after construction. The surface coating was carried out in accordance with the technology development project supported by the Ministry of Construction, which included injection into cracks with an epoxy resin; the category of soft and thick type coating of A-1 was applied. Table 1 presents the specifications for the soft and thick type coating materials for ASR-affected structures at that time. However, in intermediate piers P<sub>2</sub> and P<sub>4</sub>, the visible cracking on coating was observed within 5 years after repairing. This is attributable mainly to the drainage water going into the upper portion of pier from the joint of decks. In this region, during the winter, a lot of deicing salts, mostly sodium chloride (NaCl), are used on the bridge decks in order to assure the safe traffic conditions. Thereafter, the cracking of bridge piers rapidly extended to all coated surfaces. Figure 1 shows the external appearance of P<sub>2</sub> bridge pier.

In the hammerhead beam of P<sub>2</sub> pier, the cracks pierced through the 0.5 mm thick surface coating, where the horizontal continuous cracks with the width of 1 to 2 mm were the most prominent. On the other hand, in the column, the cracks with the width of 2 mm occurred along the longitudinal steel bars as well as the small map cracking. Moreover, the water leakage from the gap of expansion joints was observed near the beam soffits and on the side surface of the column. This may suggest that the deterioration of concrete due to ASR is accelerated especially at the portion of bridge piers where the water is always supplied from the deck. Figure 2 shows the cracking along the lower edge of hammerhead beam of P<sub>2</sub> pier. Surprisingly, the very large cracks of 20 mm width and gap of 10 mm occurred, where the partial spalling near large cracks was also observed. Figure 3 shows the comparison between the cracking inspected in 1989 and in 2004, respectively. The location of cracking at the inspection did not necessarily coincide, presumably because the cracks injected by the epoxy resin in 1989 had widened and extended in 2004. Table 2 presents the density of cracks of 0.4 mm and larger in width at various portions of P<sub>2</sub> and P<sub>4</sub> piers. In the column of pier P<sub>4</sub>, the crack density on the ground was higher than that in the air atmosphere, where large cracks of 1 to 2 mm and larger in width occurred. It is therefore inferred that the deterioration of bridge piers in the river may be strongly affected by the water supply from the river itself.

Figure 1: Cracking of P<sub>2</sub> pier after repair

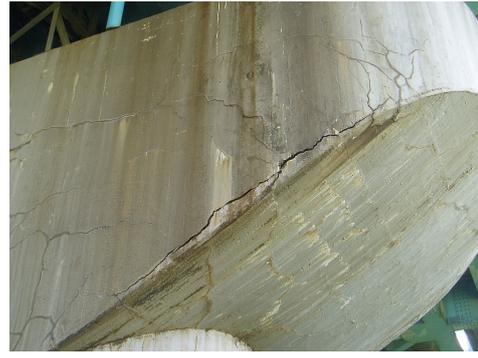
Figure 2: Cracking along beam soffits

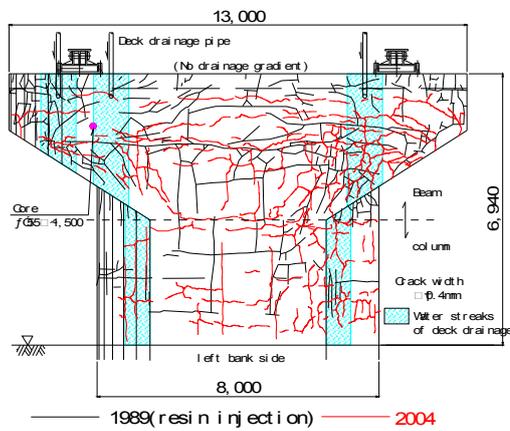
Figure 3: Comparison of cracking in P<sub>2</sub> pier in 1989 and 2004

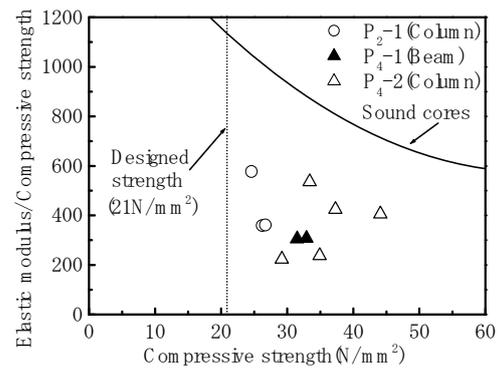
Figure 5 shows the relationship between the compressive strength and the static modulus of elasticity in cores drilled from the hammerhead beam, column and caisson of piers. As shown in Figure 5, the reduction in the elastic modulus of cores taken from ASR-deteriorated piers was more significant compared with that in the compressive strength, all values obtained being under the theoretical curve estimated for the sound concrete specified in the Standard Specifications for Road Bridges. In particular, the elastic modulus of cores in the hammerhead beam was particularly lower than those of columns, presumably because of the low steel reinforcement ratio for confinement and the high water supply from the superstructure. Figure 6 shows changes in the compressive strength of cores drilled from the beam. A significant reduction in both, the compressive strength and the elastic modulus of cores was observed even after repairing.

Figure 5: Relationships between compressive strength and elastic modulus of cores taken from RC piers

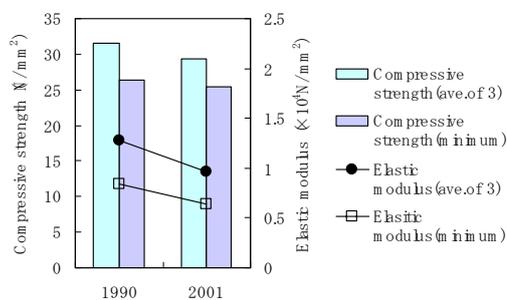
Figure 6: Changes in compressive strength of cores with time

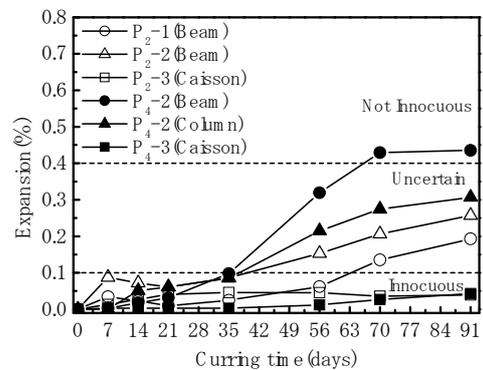
Figure 7 shows the expansion behaviors of cores in accelerated curing test immersed into a saturated NaCl solution at 50°C, Danish method. In this accelerated method, the expansion of more than 0.1 % is judged as the core has a residual expansion capacity [3]. The cores taken from the beam or the column of bridge piers continued to expand, while those from the caisson were very low and almost constant, even in the accelerated curing condition.

Figure 7: Expansion behavior of cores stored in saturated NaCl solution

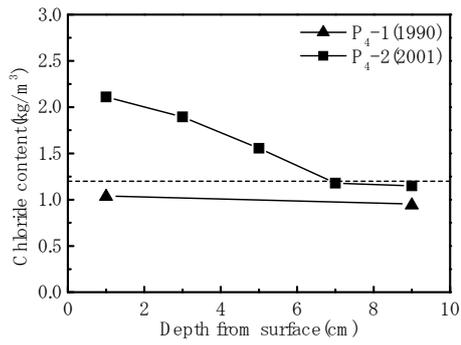
Figure 8 shows the total chloride ion content of cores drilled from the hammerhead beam of P<sub>4</sub>. The chloride ion content of concrete remarkably increased from 1990 to 2001, where the value at surface was as high as 2.1 kg/m<sup>3</sup>. Judging from the fact that in Japan, the restriction on studded tires was enforced in 1990, this can be attributed to the influence of deicers sprayed over the road decks during the winter. It is also necessary to investigate the degree of steel corrosion in bridge piers, as the chloride content is beyond the limit in which the steel corrosion can onset at the location of steel bars.

Figure 8: Chloride content of concrete

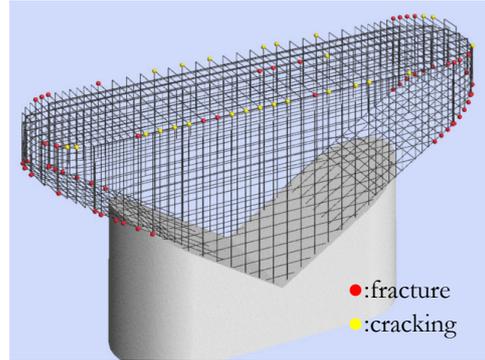
Figure 9 and Figure 10 show the external appearance of fracture of steel bars and the typical fractured surfaces of a D16 mm stirrup, respectively. The fracture of steel bars is concentrated on the beam soffits which are geometrically vulnerable to the rainwater or leakage water. In the hammerhead beam of P<sub>2</sub> pier, the percentages of fractured bars were as high as 43% and 63% for the stirrups and main bars, respectively. Interestingly, the fracture of steel bars was more remarkable on the compression side of beams. Steel corrosion was also observed on the surface of fractured steel bars. This indicates that time has already passed since they fractured. It is inferred that the fracture of steel bars in the beam with a low reinforcement ratio may weaken the confinement by steel reinforcement, which leads to a successive fracture of steel bars along the entire beam. It is also inferred that the stirrup in the center of beam has been easily fractured by the stress relaxation due to the removal of cover concrete or the vibration of breaker at demolition. On the other hand, the fracture of transverse steel bars was not found at all because they do not have the bending corner of 90°. Although the fracture of steel bars has occurred mostly at the bending corner of 90° or 135°, for the curved steel bars, the probability of fracture is inferred to be very low. Figure 11 shows the typical appearance of cracked steel bar at the inside part of bending. The location of cracked steel bars tended to scatter, which has no relation with the cracking on the concrete surface. Thus, the presence of cracked steel bars is also considered to be an important problem for the load-bearing capacity of structures at the earthquake.

Figure 9: Portion of fracture of steel bars in the beam of P<sub>2</sub> pier

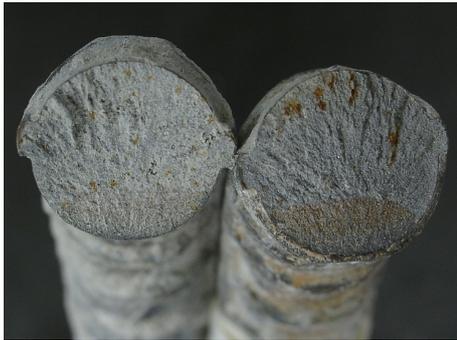
Figure 10: Surfaces of fracture of steel bars

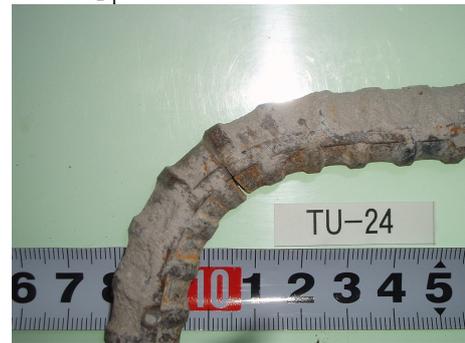
Figure 11: Side view of steel bar with crack at bending

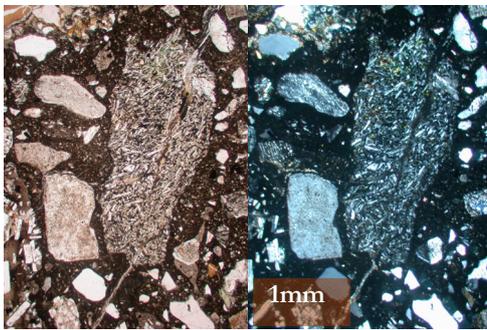
The aggregates used in concrete were river sand and river gravel supplied from the Jouganji river in Toyama prefecture, which contains a certain amount of volcanic stones. Figure 12 shows the result of polarization microscopy. A representative view shows that there are multiple cracks near the andesite particles, and that reaction rims exist around andesite particles in both river sand and river gravel. It is observed that the andesite particle is the most reactive one, which contains the cristobalite, opal and volcanic glass as reactive components. The high alkali-silica reactivity of river sand used is very similar to that of river gravel, presumably resulting in the severe deterioration of bridge piers due to the successive expansion of concrete.

Figure 12: Observation of thin section of core by polarization microscopy (left: with plane polarized light, right: with crossed polars)
