THE DEGRADATION OF THE BRIDGE DECK SLABS IN BELGIUM MAINLY INVOLVES ALKALI-AGGREGATE REACTIONS

Since 1995, serious concrete deterioration has been observed in more than 70 bridges in the Walloon Region in Belgium. This new phenomenon locally named “decay of the deck slabs” undergoes different stages of evolution, which may ultimately lead to perforation of the deck slab.

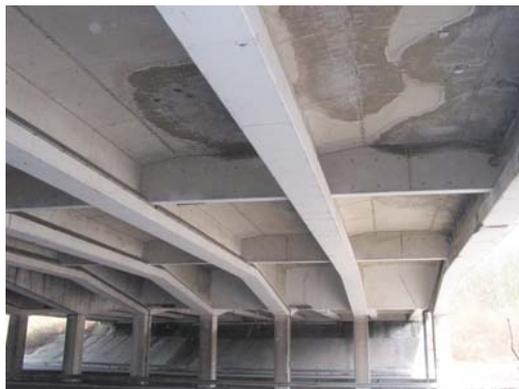
Figure 1: view of a bridge showing the “decay of the deck slabs” phenomenon.

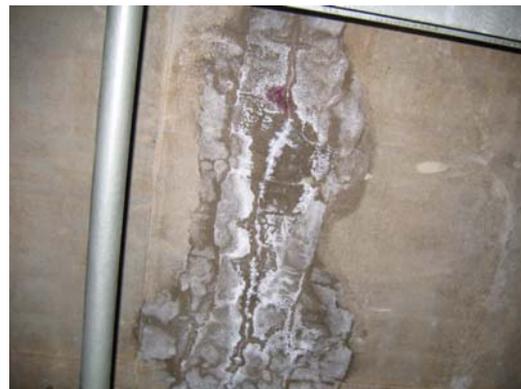
This phenomenon has locally been named “decay of the deck slabs” and presents different stages of evolution as shown by the following macroscopic observations: small to large white or dark patches on the lower face of the deck (whatever the moisture environment may be) (Figure 2); planar cracking with whitish deposits (specifically observed on the drilling cores – Figure 3); crumbling of the concrete into a gravel consistency on the upper surface of the deck (“potholes”) and ultimately the perforation of the deck (Figure 4).

Figure 2: example of a typical patch on the lower surface of a bridge slab.

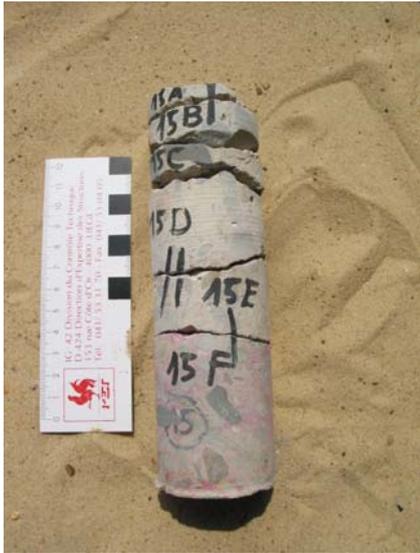
Figure 3: concrete core drilled through a deck slab and showing a severe delamination.

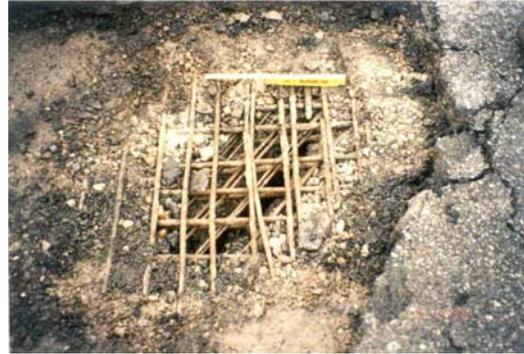
Figure 4: Perforation of a bridge deck slab.

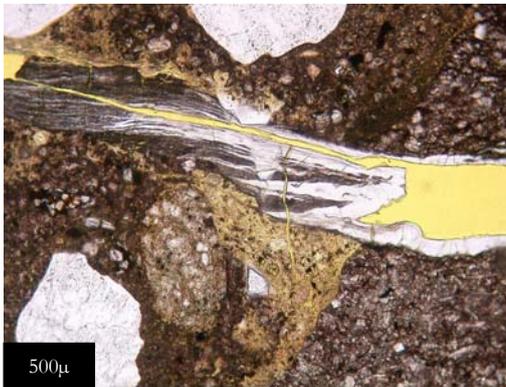
Presence of reactive aggregates in all deteriorated slabs. Aggregate lithologies were identified including phyllitic sandstone, silicified and non-silicified limestone (the latter did not include secondary silica, but very fine reactive detrital microquartz embedded within the clayey matrix) [3] (Figure 5), porphyritic quartz-rich microdiorite and finally porous and non-porous flints.

Figure 5: ASR with a non-silicified Devonian limestone. Alkali-silica gel is observed infilling the crack.
Plane polarized light.

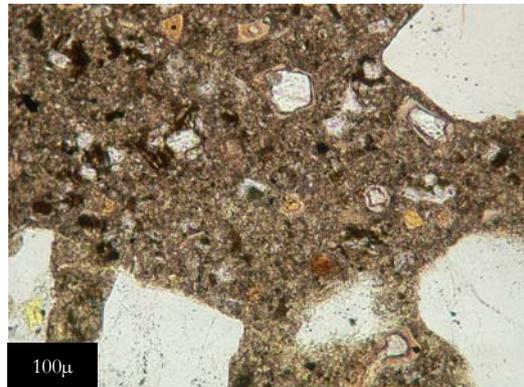
Two types of cement were observed: Portland cement and a blended cement with a medium content of blast furnace slag, roughly estimated between about 10 and 40 % (Figure 6).

The concretes were all composed of either Portland cement or blended cement with a high total alkali content. The amount of slag in the blended cements has been roughly estimated by petrography at between about 10 and 40 %. This content of slag is not high enough to inhibit ASR, as showed in this study. This is in accordance with the opinion generally accepted that the mineral admixtures like slag counteracts the ASR, particularly when the slag replacement is higher than 50 % [6,7].

Figure 6: blended Portland cement with a medium content of slag ; clinker relics are also observed.
Plane polarized light.

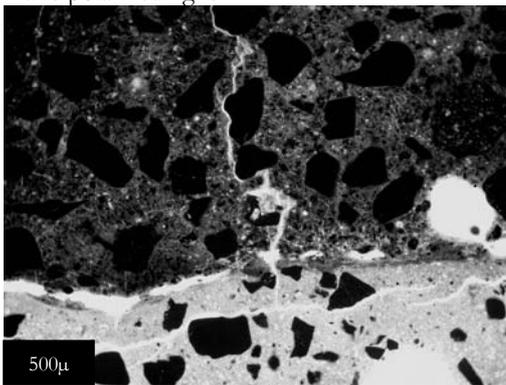
Water-cement ratios were high and varied between 0.50 and 0.70 (Figure 7).

Figure 7: interface between the upper concrete and the lower concrete of a slab : W/C ratio of the lower part is very high. Planar and transverse cracking is observed.
Fluorescent light.

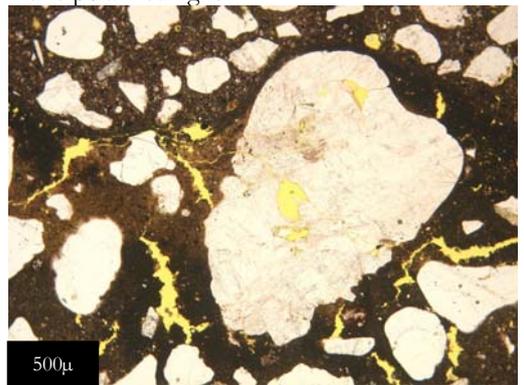
Water additions (retempering) have been revealed by the presence of large water pores and bleeding channels (Figure 8).

Figure 8: presence of a lot of water pores located within the lower concrete of a slab.
Plane polarized light.

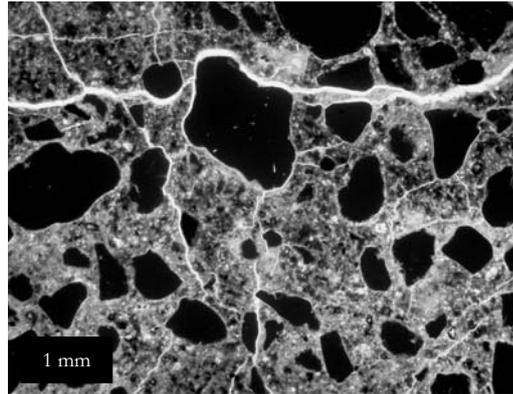
Planar cracking were often observed in the upper part of the slabs, connected with transverse cracks (Figure 9).

Figure 9: high density of planar and transverse cracks. Fluorescent light.

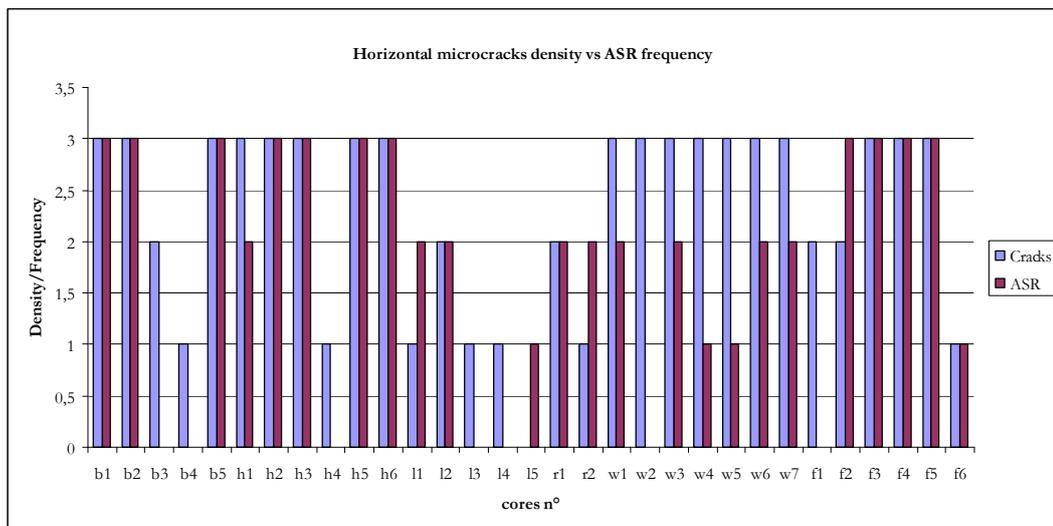
A good correlation was observed between the degree of cracking and the ASR frequency in the whole cores (Figure 10).

Figure 10: Correlation between the planar micro-cracking degree and the ASR frequency measured on thin sections from concrete cores.

In all cases, when the ASR was present, planar cracking was observed at nearly the same proportion, except for the core L5 in which the ASR was present without any planar micro-cracking. In this case, the reaction was in its early stage and the cracks were not yet fully developed.

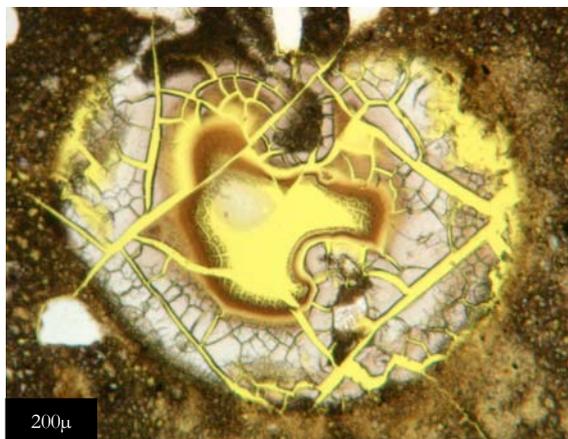
Alkali-silica gels were present in all deteriorated slabs (Figure 11).

Figure 11: cracked alkali-silica gel infilling an air bubble. Plane polarized light.

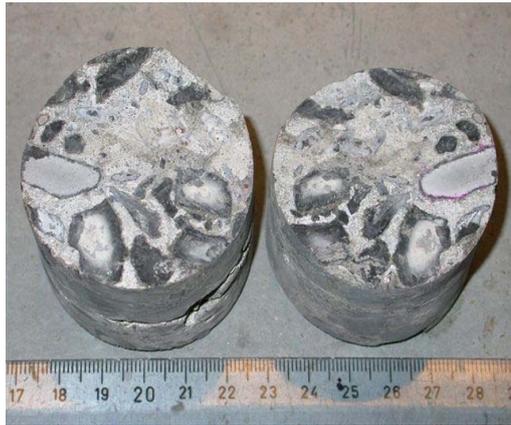
Figure 12: cores of concrete containing alkali-reactive aggregates with reaction rims around.

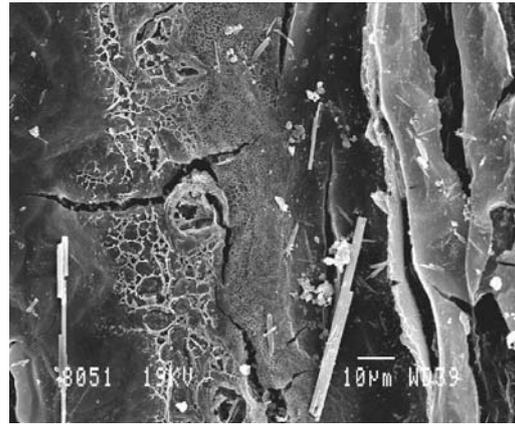
Figure 1 : superposition of alkali-silica gel layers.

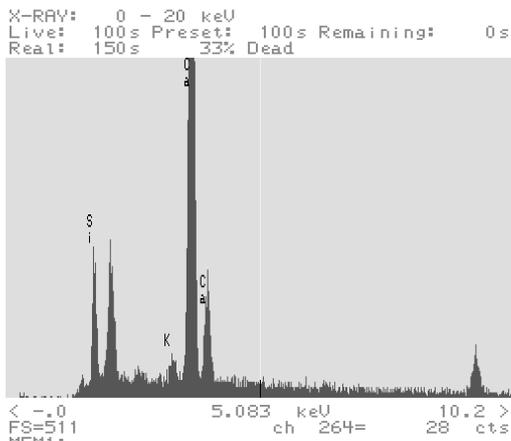
Figure 14: EDX spectrum of a K-rich alkali-silica gel.

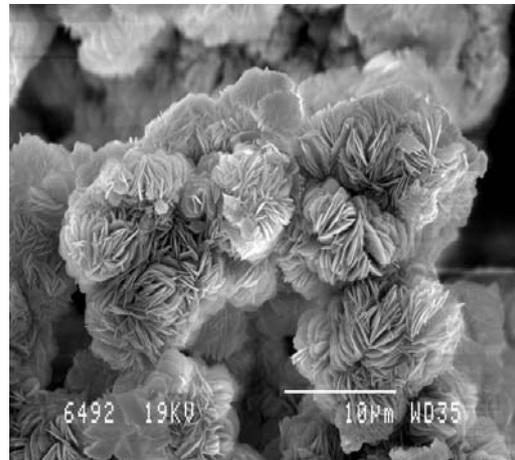
Figure 15: alkali-silica gel recrystallized in rosette-like minerals.

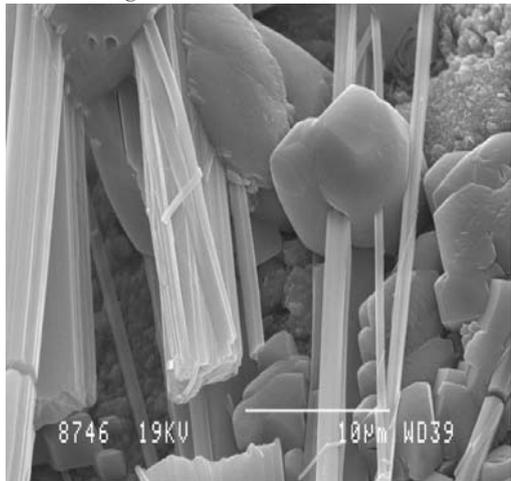
Figure 16: needle-like secondary ettringite minerals.

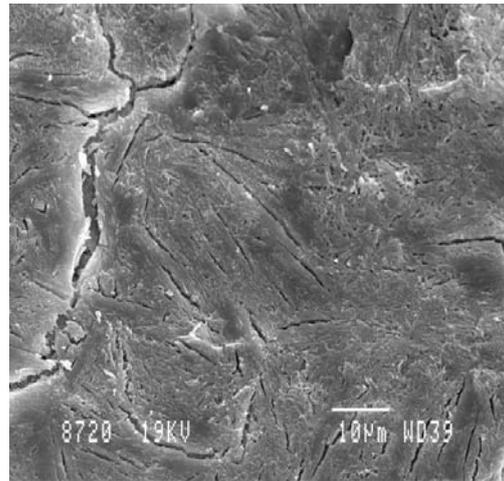
Figure 17: massive silica-ettringite with micro-cracks.
