EXPERIENCES FROM EXTENSIVE CONDITION SURVEY AND FEM-ANALYSES OF TWO NORWEGIAN CONCRETE DAMS WITH ASR

This paper presents the experiences from an extensive condition survey and FEM-analyses of two about 40 years old Norwegian concrete dams with ASR, one slab concrete dam and one arch dam. The background for the project was that the slab in the mid corner of the slab dam suddenly lifted from the supporting pillar due to expansion. In 2006 this slab concrete dam was rehabilitated, and in 2008 a monitoring program is planned to be established.

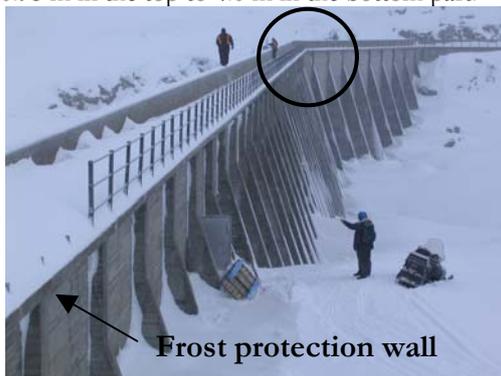
The visual inspections have showed that map cracking occurs on both dams. However, the extent of cracking over the structures varies a lot. On the arch dam (Votna 1 - see Figure 2) the most pronounced map cracking was observed in the railing (concrete wall). Expansion of the arch dam is also documented over several years by deformation measurements in the top.

On one of the sides of the arch there is a 17 m high arch pillar and a smaller slab concrete dam – see Figure 2. On this side the forces from the arch is not diverted directly to the rock foundation, but via this arch pillar. The ASR in the arch creates additional internal forces as it does for the rock foundation. The stability analysis performed with high E-module shows that this arch pillar does not have a satisfying safety factor with respect to sliding. It is our opinion that the forces will be considerably lower than this first estimate and that the arch has the ability to distribute these forces in an alternative manner directly to the rock foundation, but this has to be documented later in a separate FEM analysis.

Figure 2: Overview of the upstream face of the arch dam (Votna 1). On the nearest side there is a 17 m high arch pillar and a smaller slab concrete dam in the end of the arch.

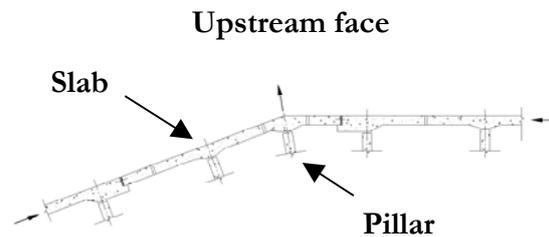
During a normal dam visit in May 2003 the dam owner discovered an alarming happening in the corner of the slab concrete dam (Votna 2), where the dam has a change of direction of about 22°. At the pillar in the corner and the two neighbour pillars the front slab had been lifted away from the pillars – see Figure 4. At the top of the dam there was a gap of about 50 mm between the pillar and the front slab. This gap decreased towards zero at the bottom of the dam. The cause of this movement was expansions of the slab. Without being noticed by the owner, the slab had expanded due to ASR leading to closed joints between the slab elements (each with a length of about 10 m). Thus there was no more space for expansion of the slabs when the temperature of the concrete increased on a warm sunny day with a low water filling of the magazine (about 15 m below the maximum approved water filling level).

Figure 3: Overview of the downstream face of the slab concrete dam (Votna 2). The circle shows the “problem corner” of the dam where the slab lifted from the supporting pillars.

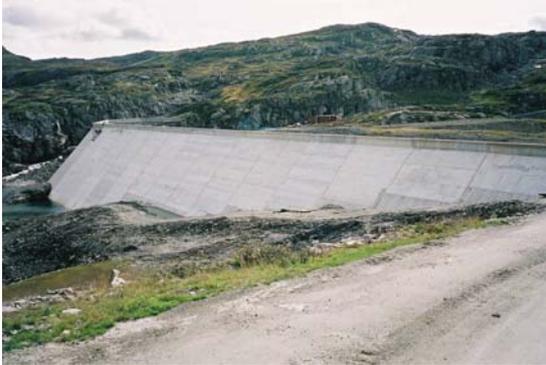
Figure 8: Votna 2. A drainage system was established by drilling several holes through the bottom part of the old slab (below the membrane).

- A drainage system was established by drilling several holes through the bottom part of the old slab (underneath the lower part of the membrane – see Figure 8). Thus any water leaking through the new slab is allowed to drain through the old slab.

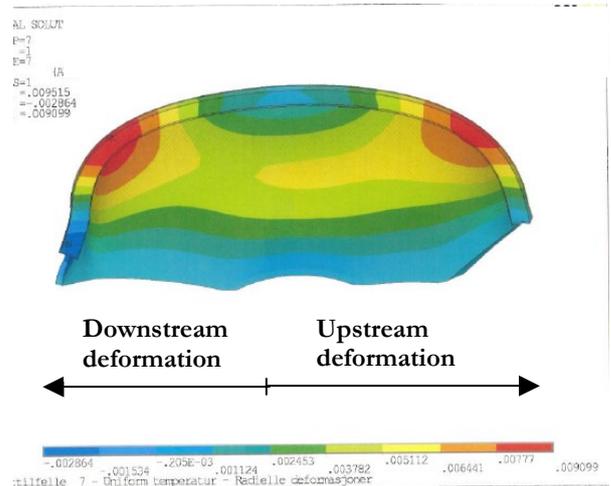
Figure 11: Votna 1. Location of the measuring bolts and the calculated horizontal deformations due to uniform temperature load.
