PETROGRAPHIC STUDY OF A BUILDING DETERIORATED DUE TO ALKALI-SILICA REACTION, IN BUENOS AIRES CITY (ARGENTINA)

Silvina A. Marfil^{1,2,*}, Pedro J. Maiza^{1,3}

The columns of a building from 1935, located in Buenos Aires city, show cracks that have put the whole structure at risk. A petrographic study was carried out in order to determine the origin of concrete deterioration.

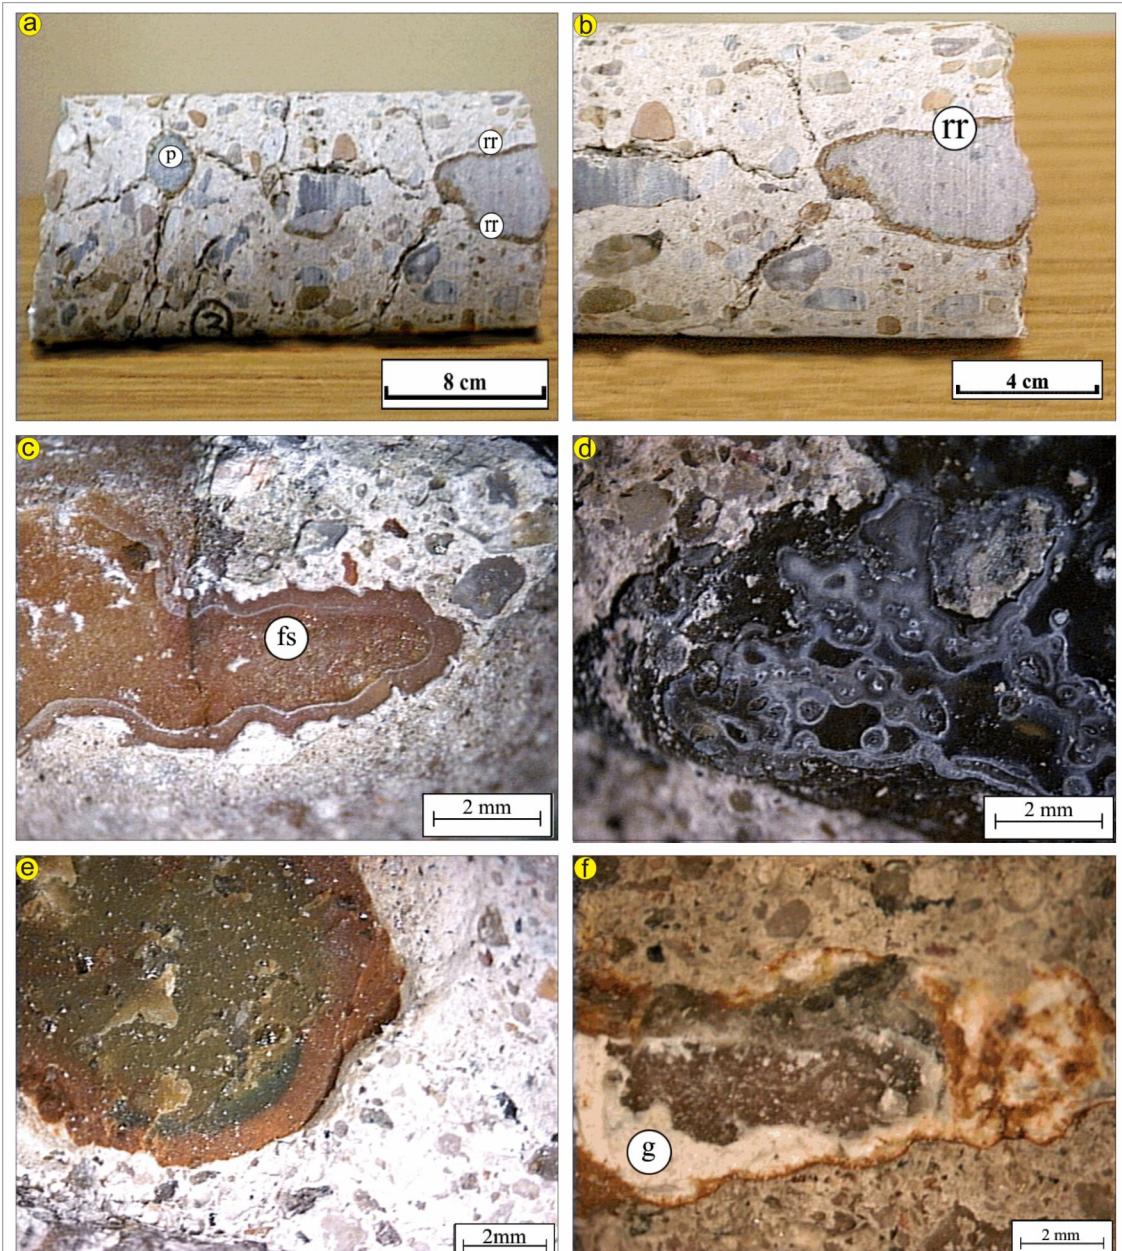
The morphological characteristics of the lithic components with reaction rims (rr) of the coarse aggregate are shown in Figure 1a. A particle (p) that has expanded after core drilling is shown; cracking is significant. Figure 1b is a detailed view of Figure 1a showing reaction rims (rr) in a gravel grain and cracking in three directions.

Figure 1c shows a sand grain of ferruginous sandstone (fs) with abundant reaction product in its boundary area. A gel mass that partially covers a reddish brown sandstone particle is depicted in Figure 1d. Figure 1e shows an aggregate particle with development of abundant reaction product. The surrounding cement paste is cracked, causing the detachment of the particle. Abundant gel (g) that has developed in the reactive aggregate-cement paste interface is shown in Figure 1f.

Figure 1: a. Core showing particles (p) with reaction rims (rr) and significant cracking. b. Detailed view of Figure 1a. c. Sandstone particle (fs) with development of reaction products around it. d. Siliceous sandstone with abundant reaction product (gel). e. Reaction rim on a sandstone clast. f. Gel (g) developed from a reactive aggregate particle.

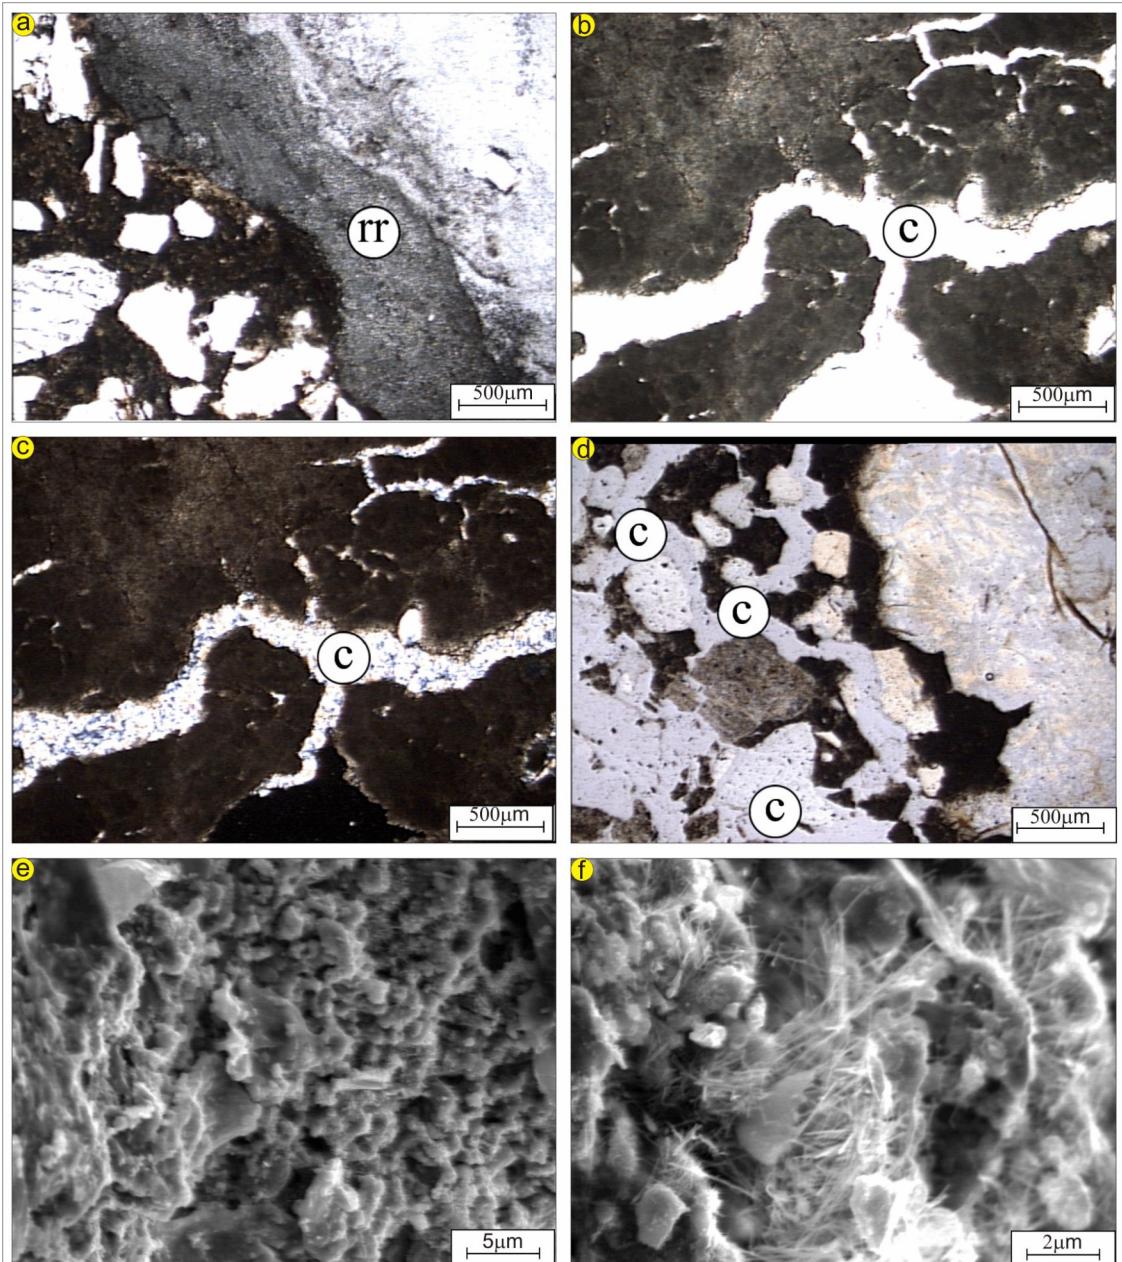
An aggregate-cement paste interface with reaction rim (rr) development is shown in Figure 2a. A crack (c) in three directions (viewed under plane polarized light) is depicted in Figure 2b. Figure 2c depicts the same crack viewed with cross polarized light to show that it is filled with an anisotropic reaction product that due to its optical properties can be assigned to zeolites with associated calcium carbonate (calcite). Figure 2d shows a highly cracked mortar area (c) with its texture completely obliterated.

The material analysed was developed at the reactive aggregate-cement paste interface and inside the microcracks. Figure 2e shows a SEM image of the ASR product. In the EDS analysis Si, Al, O, Ca and minor amounts of K and Na were identified (Figure 3a). A zeolitic structure belonging to the clinoptilolite-heulandite group ($\text{KNa}_2\text{Ca}_2(\text{Si}_{19}\text{Al}_7)\text{O}_{72} \cdot 24\text{H}_2\text{O}$) comparable to the ICDD card number 39-1383 was determined by X-ray diffraction [1]. The main reflections were identified at 8.90 Å and 3.97 Å. The diffractogram is presented in Figure 3b. Figure 2f shows the material developed inside air voids and cracks. Its chemical composition, analysed by EDS, is S, Al, Ca and O (Figure 3c). An ettringite structure ($\text{Ca}_6\text{Al}_2(\text{SO}_4)_3(\text{OH})_{12} \cdot 26\text{H}_2\text{O}$) comparable to the ICDD card number 41-1451 was identified by X-ray diffraction. The main reflections appear at 9.7 Å and 5.6 Å (Figure 3d).

Figure 2: a. Aggregate-cement paste interface showing the development of a reaction rim (rr). b. Microcracking in three directions (c) (viewed under plane polarized light). c. The same image as the above viewed with cross polarized light. d. Cement paste with significant microcracking. e. Gel morphology viewed with SEM. f. Ettringite morphology viewed with SEM.

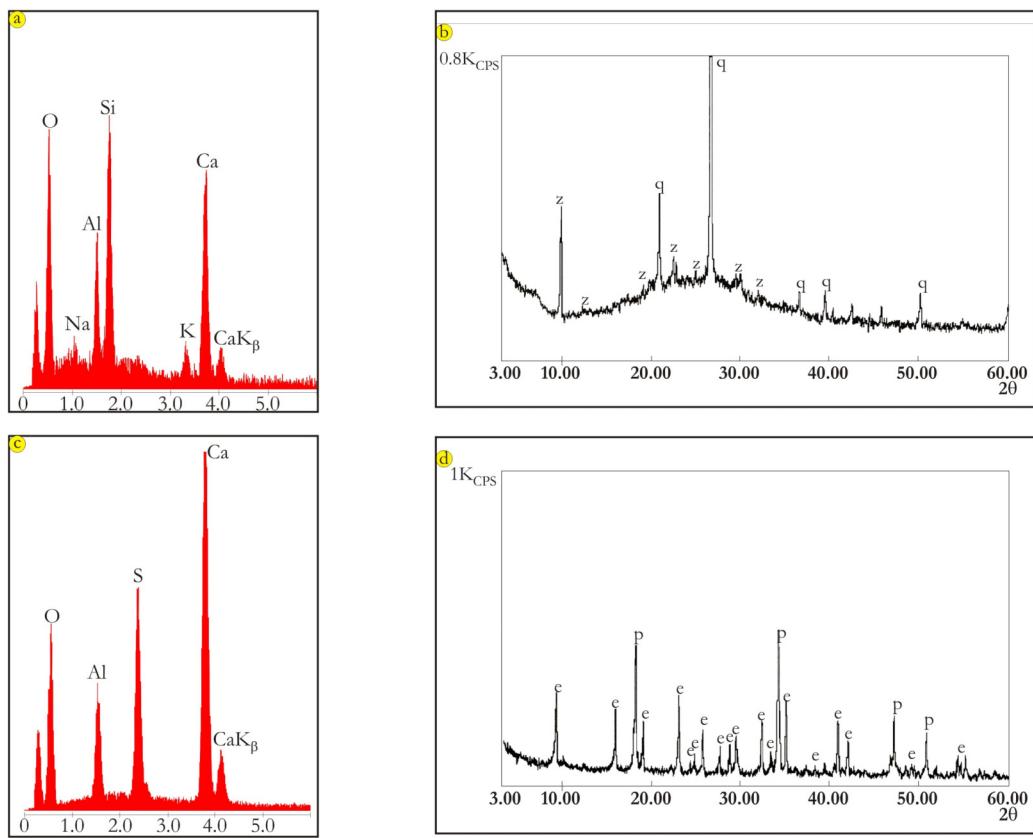
Figure 3: a. EDS of the material observed in figure 2e. b. XRD of the product of ASR. z: zeolite, q: quartz. c. EDS of the material observed in figure 2f. d. XRD of ettringite (e) with portlandite (p) development on the concrete surface.
