EARLY DAMAGES DUE TO ALKALI AGGREGATE REACTIONS IN A SWIMMING POOL – DIAGNOSIS AND RATE OF EXPANSION

Eva Rodum^{1,2,*}, Jan Lindgård², Hans Stemland², Marit Haugen², Ola Skjølsvold²

²SINTEF Building and Infrastructure, N-7465 TRONDHEIM, Norway

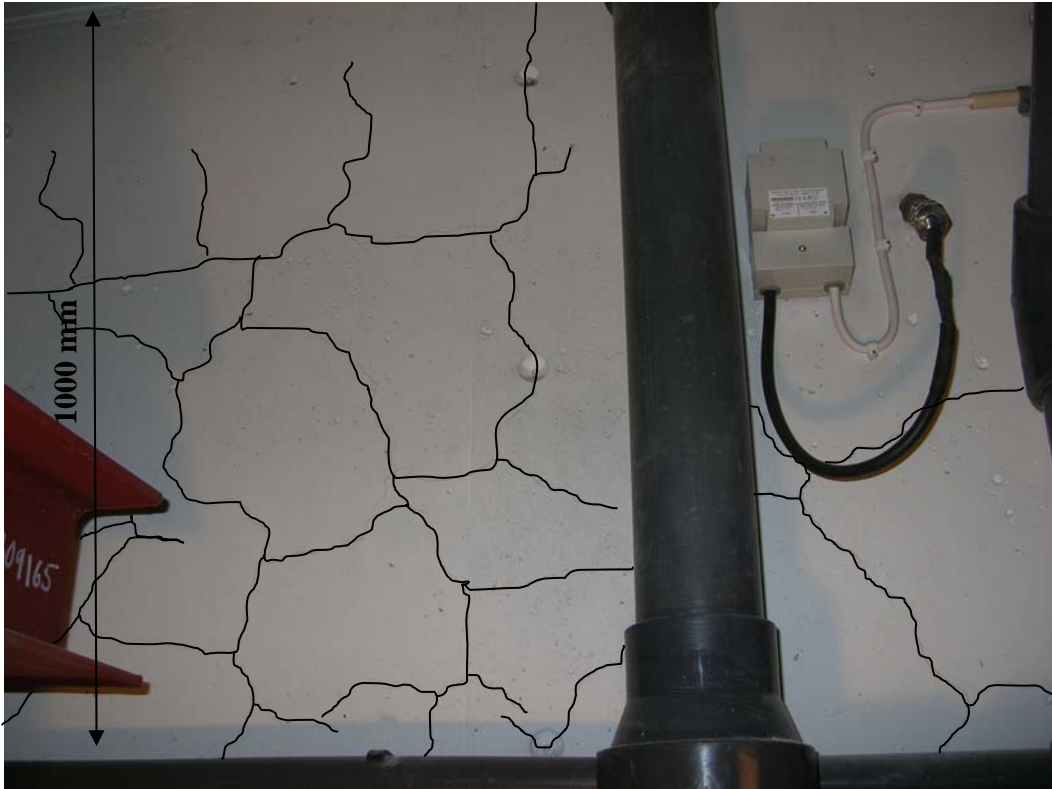
Cracks are observed in almost all outside faces of the pool walls, both as single cracks and map cracking. The crack formation is observed to be dependent of the height of the wall, e.g. single cracks in lower walls (< 0.7 m) and map cracking in higher walls (about 1.5 m). An example of map cracking is shown in Figure 1.

- Larger, free concrete areas in both the pool bottom and the walls have characteristic map cracking. The crack formation is compatible with multiple direction tensile stresses in the outer parts of the concrete due to expansion of the concrete near the pool water.

Figure 1: Map cracking on the outside face of the pool wall. Note that the cracks are intensified by drawings on the photo.

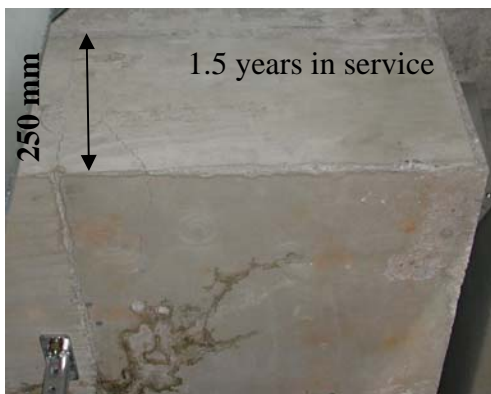
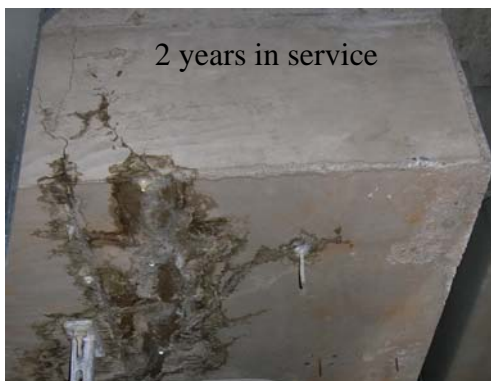
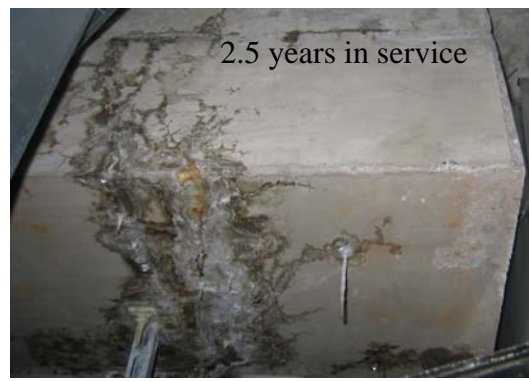
Cracks are also observed in all visible areas of the underside of the pool bottom, mainly as map cracking. On the underside of the water gutters, cracks are observed as single cracks perpendicular to the pool walls. Extensive cracking with water leakage is observed in one gutter corner, accelerating from May 2006 to June 2007 (i.e. from 1.5 to 2.5 years in service), see Figure 2.

Visual registrations on the underside of the water gutter (Figure 2) document an increase in the extent of damage over the period May 2006 - June 2007. Visual inspections from inside the pool also show an increase in damage by increasing crack widths (Figure 5) and an increasing number of broken/loose tiles.

Figure 2: Visually evaluated increase in water leakage through cracks in the water gutter. Photos taken in May 2006 (upper), November 2006 (left) and June 2007 (right).

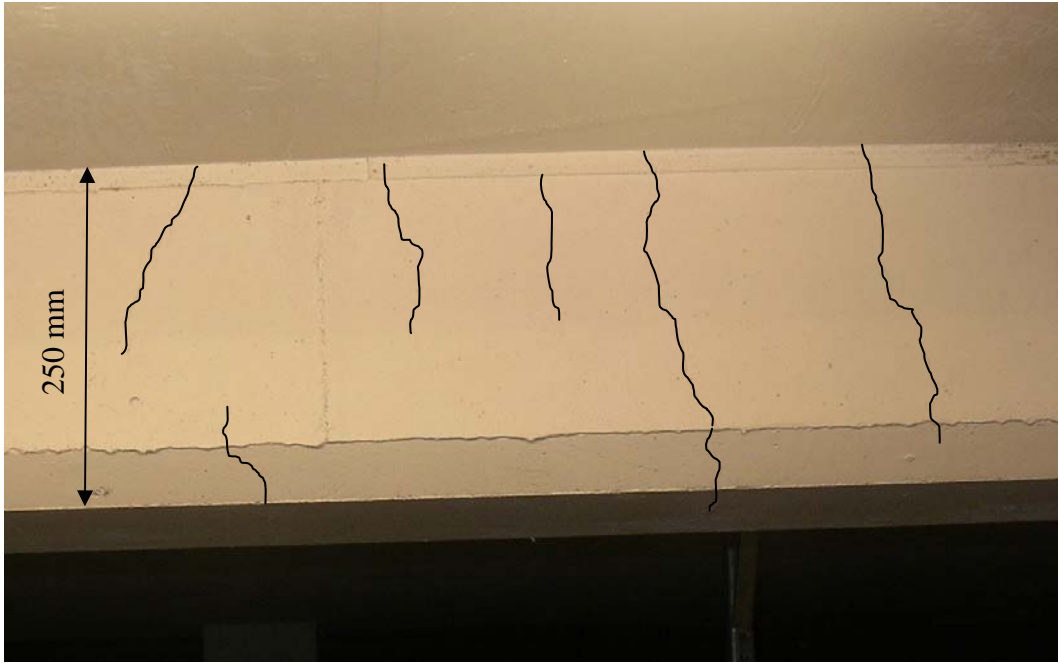
One beam is supporting the bottom plate in the longitudinal direction, almost in the middle part. This beam has several vertical cracks, see Figure 3. The cracks diverge from cracks typically caused by bending moment, by running from the upper top of the beam side.

- The beam supporting the bottom plate has vertical cracks running from the top of the beam to the bottom, indicating that the beam is loaded by tension due to expansion of the bottom plate.

Figure 3: Vertical cracks on the supporting beam. Note that the cracks are intensified by drawings on the photo.

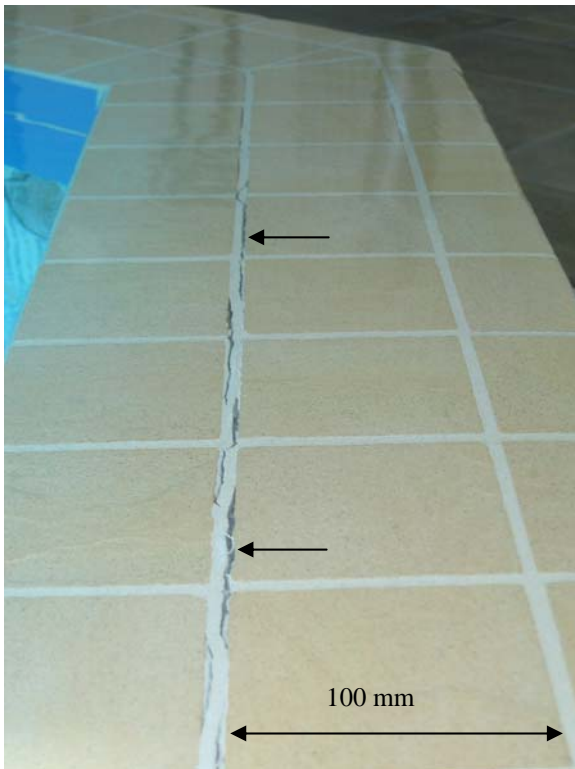
- The upper parts of the concrete walls are heavily cracked. This is probably due to high water content in the concrete (exposed from three sides) and easy access for expanding (not restraint)

Figure 4: Longitudinal crack in the horizontal top surface of the wall.

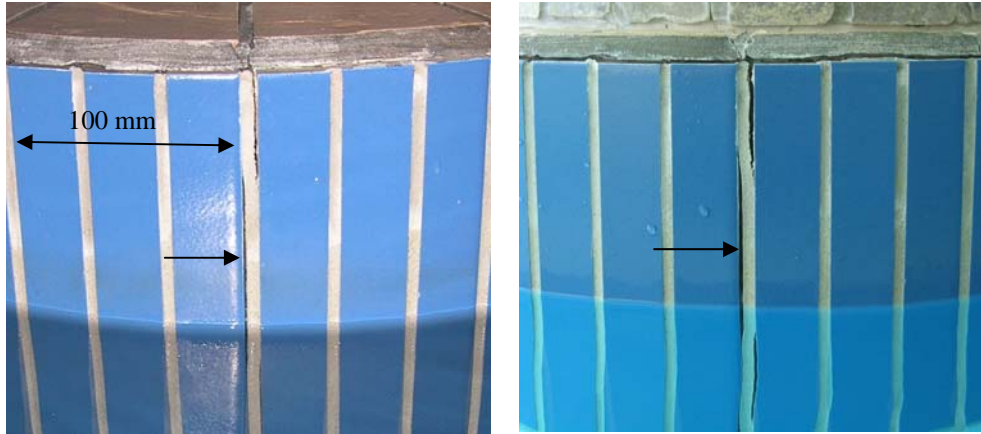
Figure 5: Increasing vertical crack in the tiled pool wall. Photos shot in November 2006 (left) and June 2007 (right), respectively.

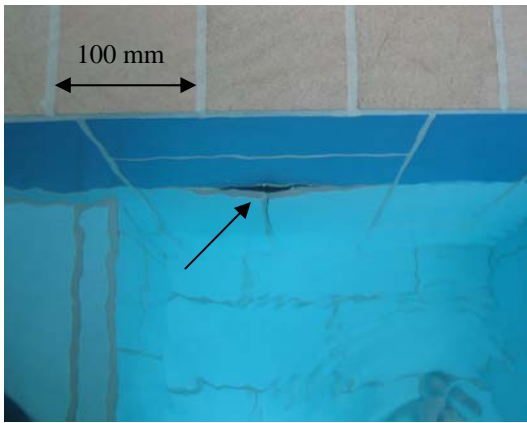
- Tiles on the concrete near the water gutters are falling off. This is probably due to shear and tensile stresses caused by expansion of the concrete.

Figure 6: Loose tiles on the pool wall.

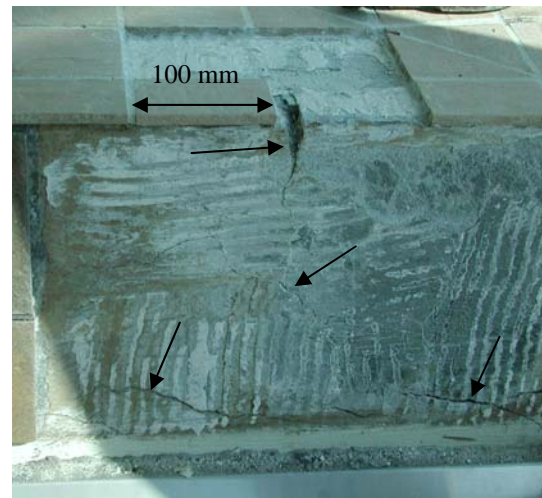
Figure 7: Cracking of the concrete behind the tiles on the vertical surface near the top of the wall, above the water gutter (see Figure 11).

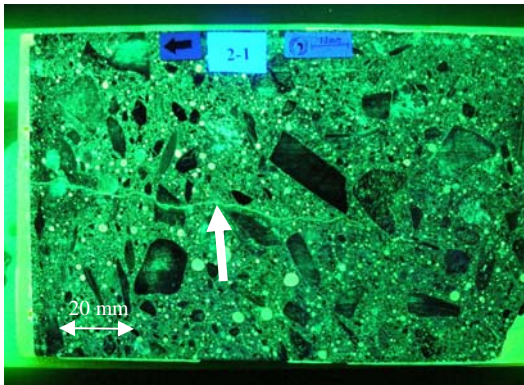
Figure 11: Plane polished section in UV-light, prepared from the core drilled from the outside (dry) surface of the 250 mm thick pool wall. Crack with depth 117 mm from this surface.

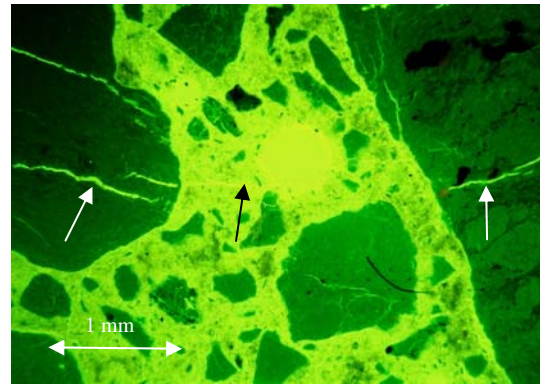
Figure 12: Thin section in UV-light, prepared from the inner part of the concrete core from the pool wall. Cracks in aggregate particles and in the cement paste.

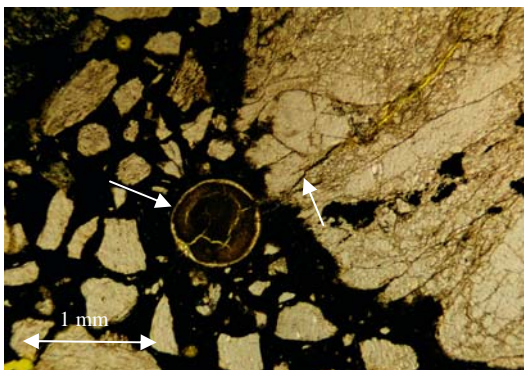
Figure 13: Thin section in normal light, prepared from the inner part of the concrete core from the pool wall. Alkali gel in crack and air void. The reacted aggregate particle is mylonite.

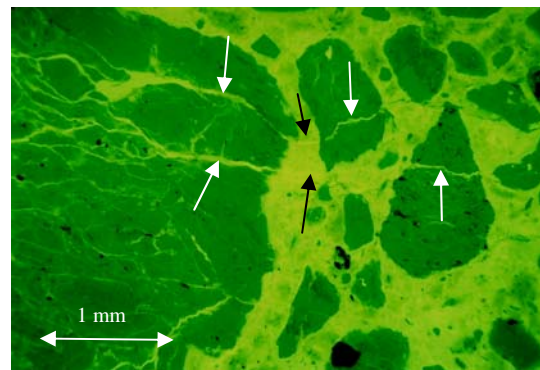
Figure 14: Thin section in UV-light, prepared from the concrete core from the top of the pool wall. Cracks in aggregate particle continue into the cement paste and further into other aggregate particles.
