A SURVEY ON ASR-AFFECTED BRIDGE PIERS WITH FRACTURE OF STEEL BARS ON NOTO EXPRESSWAY

Kazuyuki Torii^{1,*}, Shingo Wasada², Teruhiko Sasatani³, Toshihiko Minato⁴

The brittle fracture of steel bars caused by an excessive expansion of concrete due to alkali-silica reaction (ASR) has recently been discovered in large numbers of bridge piers on the Noto expressway. At present, the maintenance and rehabilitation for such severely damaged bridge piers are a great concern especially for bridge engineers in Japan. The authors have been carrying out the series of investigation on both the deterioration of concrete and the fracture of steel bars in ASR-affected bridge piers with reactive andesite stone. The paper describes the investigation in field on seven bridges with the fracture of steel bars and their rehabilitation on the Noto expressway. The asset management for ASR-affected bridges on the Noto expressway is also discussed.

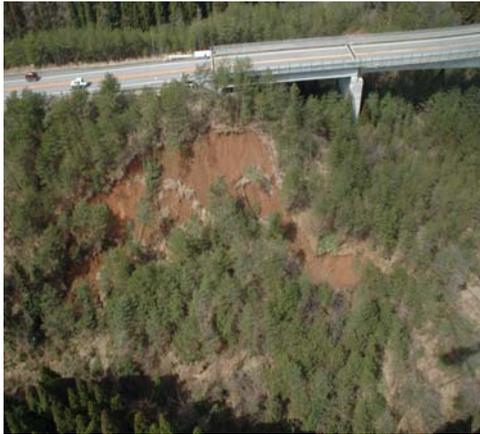
Accidentally, in March 2007, the big earthquake of magnitude 6.9, which is named the Noto peninsula earthquake, has occurred over the Noto peninsula. Fortunately, the Noto expressway could be available within one month of a easy repairing work since bridge piers were not significantly damaged by this earthquake, because all severely deteriorated bridge piers had already been strengthened and/or reconstructed until this earthquake occurred. Furthermore, until March 2008, the countermeasure for other bridge piers without strengthening will have similarly been done using the urgent budget by the government. By this earthquake, the embankment and slope near bridges collapsed in many places. Figures 2 and 3 show the damage near the Noto Bridge which is the longest one on the Noto expressway. The wing element of abutment in the Noto Bridge was partially broken by the earthquake, resulting in the settlement of road surface of 50 to 100 mm.

Figure 2 :Land slide occurred around Noto Bridge.

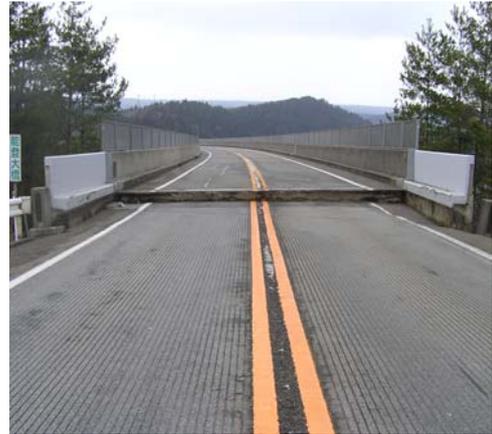
Figure 3: Settlement of road surface in Noto Bridge.

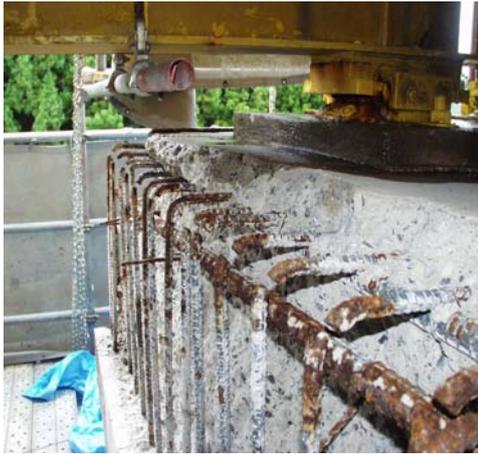
regular intervals, the fracture of steel bars was discovered in the pillow beam of three bridges, Azumi Bridge, Tokuda No.2 Bridge and Kashima Bridge. Figure 8 shows the feature of fracture of steel bars in pillow beam of bridge pier. In these bridges, the large horizontal crack of several millimeters and the gap on the side surface were observed along with the main steel bar, as shown in Figure 9. Surprisingly, when removing the cover concrete, the stirrup steel bars of D 19 or 22 mm of pillow beam fractured at a high probability of fracture of 30 % to 50 %, while some bending-up steel bars of D 32 or 35mm also fractured. It is made clear that the fracture of steel bars occurs mostly at the bending corner of 90 degrees, and that they fracture with no elongation and little corrosion. In some cases, the main steel bars of D 35mm fractured at weld points only in Tokuda No.2 Bridge. This may be attributed to the insufficient melting of attached surfaces in steel bars at the construction work.

Figure 8: Fracture of steel bars in pillow beam (Azumi Bridge).

In the pillow beam with the fracture of steel bars, the partial or full reconstruction was basically selected according to the existence of weld points of main steel bars. Only the cantilever portion of pillow beam was reconstructed for the pillow beam without weld points of main steel bars, while the whole portion of pillow beam was reconstructed for the one with weld points of main steel bars. In the work of reconstruction, it should be taken into considerations that the Noto expressway is the only main transportation road through the Noto peninsula, for this reason, the reconstruction must be carried out along with making sure the common use of all traffics on road. So, after the decks were supported by the steel frame bent, the deteriorated concrete of pillow beam was demolished by a concrete breaker, followed by installing the new steel reinforcement and then by placing the new concrete of 24 N/mm², as shown in Figures 14 and 15.

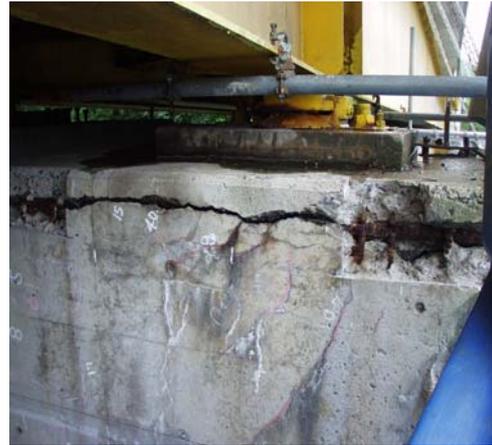
Figure 9: Horizontal crack and gap on side of pillow beam (Azumi Bridge).

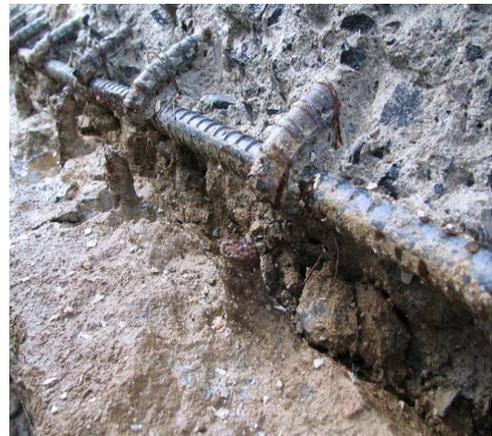
In the excavation work for strengthening around bridge pier, the serious damage was also detected in the foundation where the ground water level was high. The fracture of steel bars was detected in the footing of three bridges, Tokuda No.2 Bridge, Omatagawa Bridge and Kumakigawa Bridge. Figure 11 shows the feature of fracture of steel bars in the footing of bridge pier. In the most serious case of Tokuda No.2 Bridge, all steel bars of D 19 mm fractured along the upper side corner of footing with a low steel reinforcement ratio, leading to extend large cracks from the side corner to the interior of foundation, and consequently to lose the integrity of a whole footing due to the reduction in the confinement force of internal concrete by steel bars as shown in Figure 12.

Figure 11: Fracture of steel bars in footing (Tokuda No.2 Bridge).

In the strengthening design of footing, the stability against seismic force as well as load bearing capacity was taken into consideration. After removing the weak concrete on surfaces and installing the new steel reinforcement, the original concrete element of footing was vertically prestressed at the stress of 0.3 N/mm² by forty eight prestressing steel bars of D 32 mm, SWPD, and horizontally

prestressed around the footing by eight prestressing steel wires of D 5 mm, SWPR, as shown in Figures 18 and 19. A monitoring system for the tensile stress induced in prestressing steel bars and prestressing wires is presently set up to monitor the behavior of footing before and after strengthening.

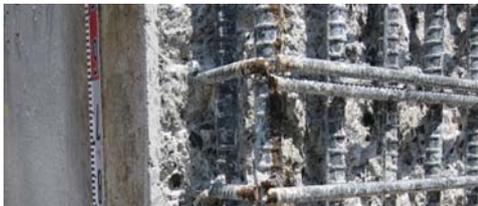
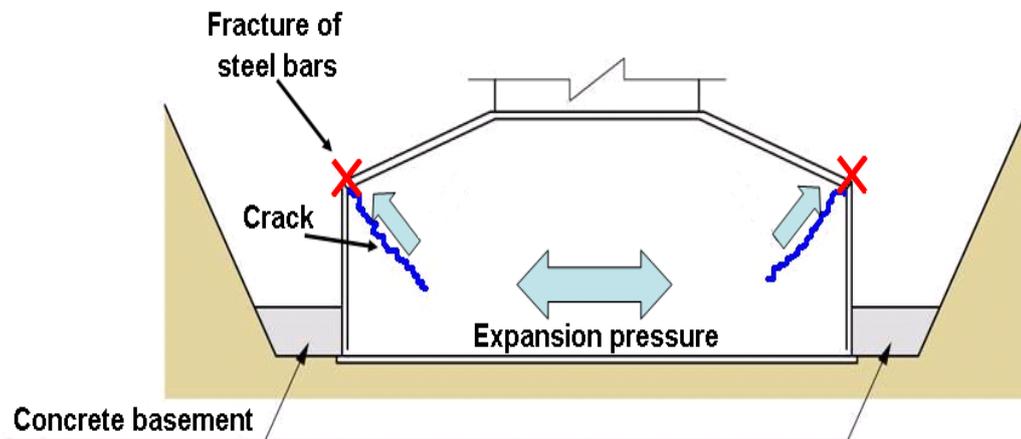
Figure 12: Schematic diagram of ASR expansion in footing.

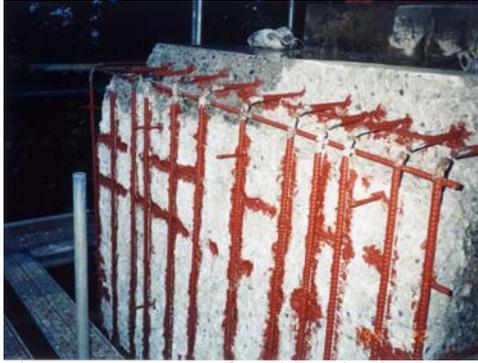
The deterioration of abutment due to ASR was often accelerated by the water from the joint of deck. The fracture of steel bars was detected in the abutment of three bridges, Azumi Bridge, Toyokawa Bridge and Omatagawa Bridge. Figure 13 shows the feature of fracture of steel bars of abutment. In the case of Toyokawa Bridge, all steel bars of D19 mm fractured along the upper side corner of abutment, resulting in the development of diagonal large cracks towards the interior of abutment.

Figure 13: Fracture of steel bars in abutment (Toyokawa Bridge).

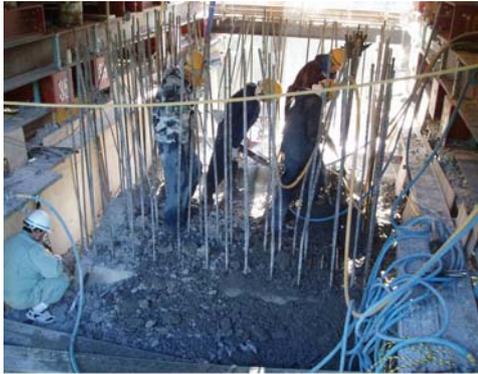
Figure 15: Demolishing old concrete by breaker (Kashima Bridge).

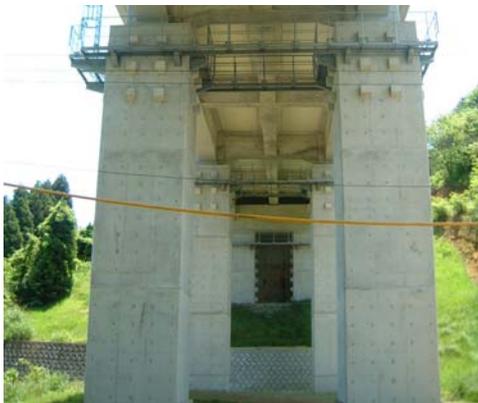
Figure 17: Strengthening of pier by reinforced concrete (Tsuchikawa Bridge).

In order to increase the load bearing capacity of column against the seismic force, the column of bridge pier on the Noto expressway was usually strengthened by the steel plate bonding method or the PC confined method, where the type of strengthening method was selected depending on the type of foundation; the steel plate bonding method for pile foundation and the PC confined method for spread foundation, as shown in Figure 16 [5]. Furthermore, in the case of Tsuchikawa Bridge, which is a rigid frame concrete bridge, the strengthening by reinforced concrete was only adopted, where the upper and lower part of column was prestressed by prestressing steel rods, as shown in Figure 17.

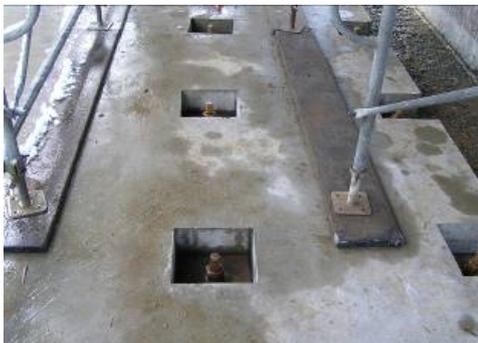
Figure 19: Strengthening of footing by prestressing steel rods (Tokuda No.2 Bridge).

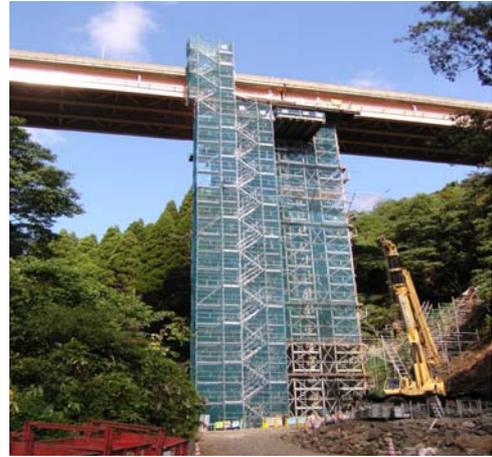
Figure 14: Supporting by steel frame bent (Kashima Bridge).

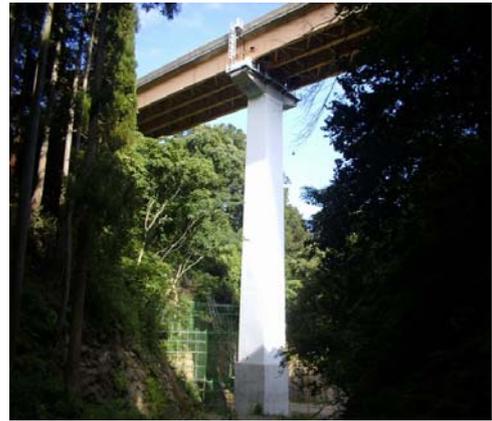
Figure 16: Strengthening of pier by steel plate bonding (Kashima Bridge).

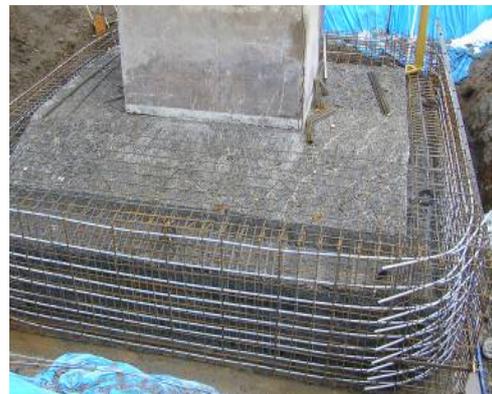
Figure 18: Strengthening of footing by prestressing steel wires (Tokuda No.2 Bridge).
