INJECTIONS OF MICROCEMENT IN PILE CAPS CRACKED BY ALKALI-AGGREGATE REACTION

Geovani Almeida da Silva^{1,*}, Romilde Almeida de Oliveira²

The alkali-aggregate reaction affects durability and mechanical resistance of concrete structures provoking cracks. Despite these pathological manifestations it cannot be said that the final stage cannot be reached even if reaction is slow. The occurrence of such phenomena on foundation blocks is rarely described in the literature and it was recently identified in foundations of buildings in the metropolitan region of Recife, constituting a cause for concern for the community of technicians and the civil construction industry. Pile caps affected by the AAR may suffer interventions with adequate recovery techniques for each situation. Thus, microcement injection in cracks on foundation blocks affected in the metropolitan region of Recife has been studied and services have been monitored with a view to inspecting the procedures adopted. The collection of cores, cleaning procedures and the closing of cracks filled superficially with epoxy, the application of the microcement and coring after the injections made it possible to verify if the cracks we

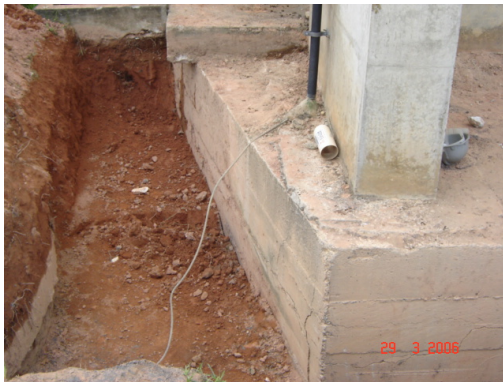
Figure 1: Start of excavation around the AAR-affected foundation block.

Excavation must be performed according to recommendations and safety standards to prevent landslides on the workers and ensuring enough space for superficial cleaning of the external faces of the blocks using a high pressure washer (Figures 1 and 2) for better visualization of the cracks

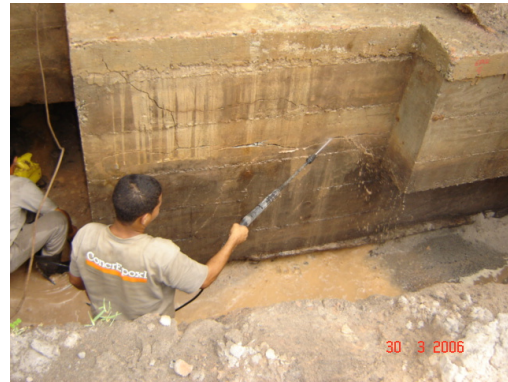
Figure 2: Cleaning of the block face using high-pressure washer, with a capacity of 400 kilopascal and flow of 360 liters/hour.

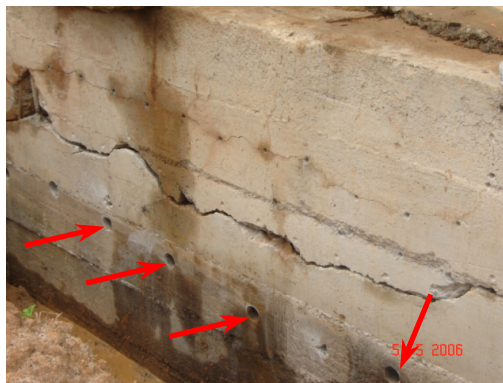
Figure 3: 2"-diameter holes (arrows) under the main crack for removal of materials deep in the cracks.

The procedure of opening 2-inch diameter holes below the main crack (Figure 3) - common to all the blocks - was extremely important to remove materials (sand, clay and other materials originating from the embankment) from inside the cracks.

It is important to emphasize that the execution of those holes was adopted after several frustrated attempts to remove materials which were seated deep into the cracks. With the presence of embankment materials inside the cracks the microcement grout injection was compromised by the lack of space.

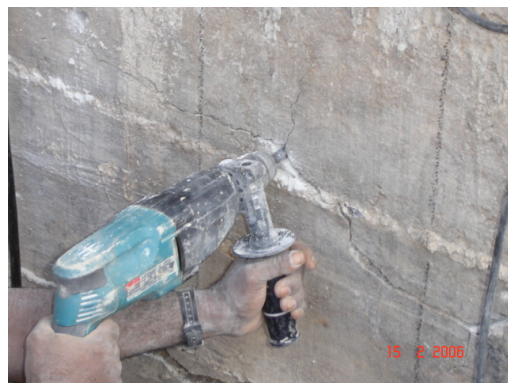
Figure 4: 1/2"-diameter and 4"-length holes using impact drill in cracks with smaller openings.

To perform the washing procedure inside the cracks and the microcement grout injection it was necessary to install 3/8-inch diameter pieces of hose (which will be named purges) around the border of the cracks. Because some of those cracks were not wide enough for the purges to be directly installed, holes of 1/2 inch in diameter and with approximately 4 inch in length were made using an impact drill (Figure 4).

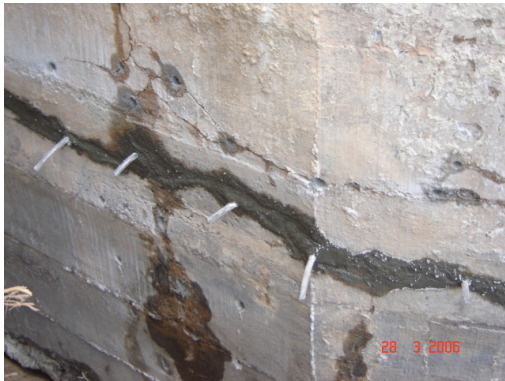
Figure 5: Non-fluid grout application in the cracks with opening larger than 10 mm and fixation of purges.

Despite its apparent simplicity, the accomplishment of this stage required plenty of ability, especially regarding the superficial closure of the cracks. Cracks thicker than 10 mm had to be closed with non-fluid grout where this mortar penetrated up to 20 mm (Figure 5). The application of this mortar aimed to minimize the use of great amounts of epoxy resin due to its high market price.

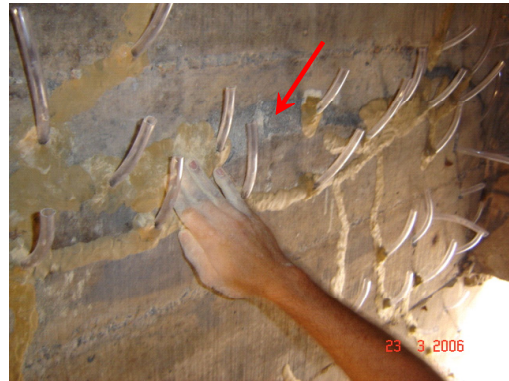
Figure 6: Superficial closure of the cracks and fixation of the purges using epoxy resin mixed with kaolin. The cracks closed with grout were also covered with epoxy (arrow).

Epoxy Resin was also used for the superficial closure of cracks provided they were not larger than 10 mm. Fixation of the purges was also performed using this type of material (Figure 6) to prevent air escape when the water used for washing or the cement grout were injected through the purges.

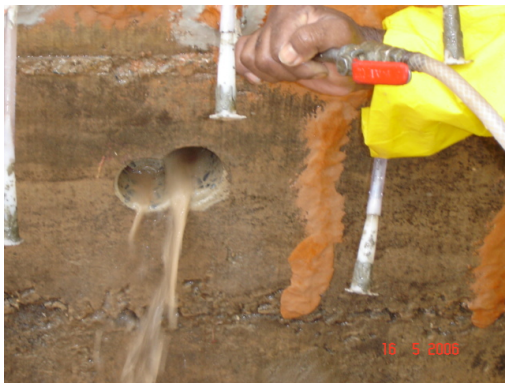
Figure 7: Washing of cracks using water injected under pressure and exit of dirt from the 2."-holes.

The internal washing of the cracks resulting from the AAR consisted in injecting water through the purges until all the material was removed from their interior. The removal of sand and clay from the bottom of cracks was only possible thanks to the 2-inch holes previously made for this purpose.

To this end, it was necessary to force the water injected under pressure to flow through the 2-inch holes, while closing all the purges placed on the block face (Figure 7).

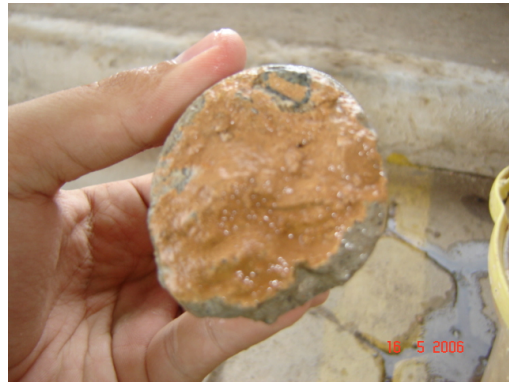
Figure 8: Removal of specimen before washing with the inner face of the crack soiled by clay material.

With a view to ensuring that the washing procedure was effective 2-inch diameter cores were drilled before and after washing (Figures 8 and 9).

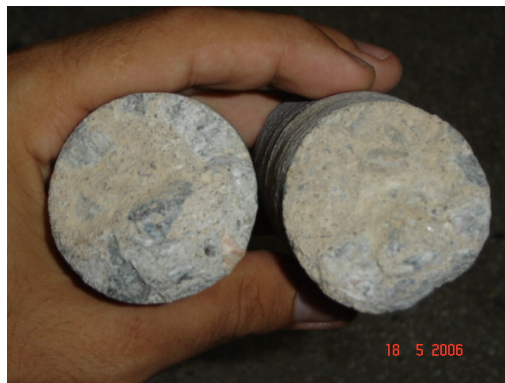
Figure 9: Specimen taken after washing of cracks showing the inner face of the crack free of material originating from the embankment.

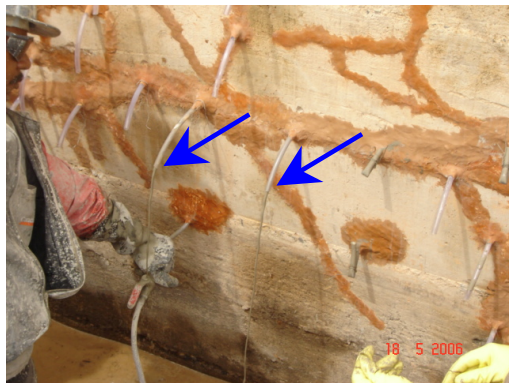
Figure 10: Grout injection through lower purges, where the arrows show the exit of the grout indicating that the cracks were filled.

When injecting the microcement, some care must be taken to avoid emptying the interior of the cracks. Therefore, the microcement injection must always start from the lowest points. If this procedure is adopted the interior of the cracks is more uniformly filled in, thus minimizing the emptying of spaces.

The filling in of the cracks must be performed from the lower side as shown in Figure 10, since the material entering expels the air from the higher purges enabling the microcement grout to fill all the voids inside the cracks.

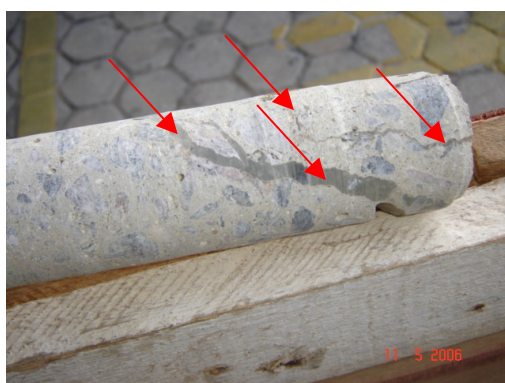
The coring aimed to verify whether the cracks provoked by the AAR expansion had been filled by the injected material. As expected, at the points from which 2-inch diameter cores were drilled

(totaling four units per block, corresponding to one core for each face), all the cracks were filled with the injected microcement and featured consolidated crack faces (Figure 11).

Figure 11: Specimen extracted after microcement injection and with all the cracks filled (arrows).
