# CHARACTERIZATION OF ASR PRODUCTS IN A 40-YEAR-OLD HIGHWAY. PROVINCE OF CÓRDOBA, ARGENTINA

Francisco Locati<sup>1\*</sup>, Silvina Marfil<sup>2</sup>, Pedro Maiza<sup>3</sup>, Edgardo Baldo<sup>4</sup>

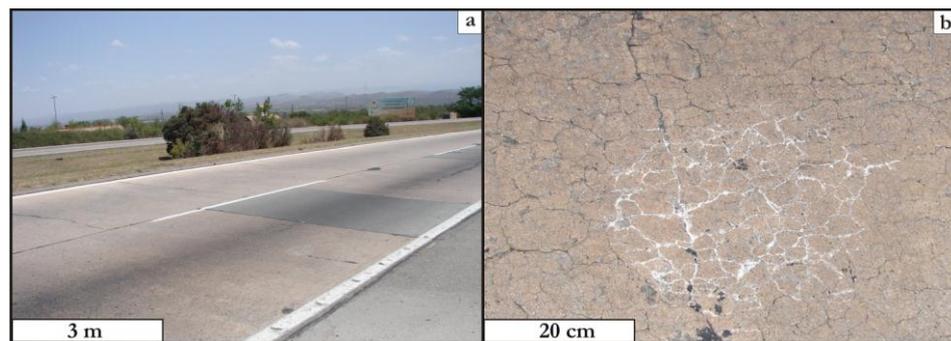
The second sector shows more deterioration. Concrete slabs show transverse joint faulting, broken areas next to transverse and longitudinal joints, longitudinal and transverse cracking, broken corners, intense cracking in transverse joints (in dowel bars), map cracking and areas with polished aggregates due to loss of the superficial mortar. Different works were made in these sectors involving partial or total replacement of slabs (Figure 2a) and localized areas repaired with asphalt mixtures.

In severely cracked areas such as the middle zone of slabs and next to transverse joints, white materials filling cracks 2 to 3 mm thick are seen (Figure 2b). In other sectors of the highway, the slabs present color variations, with a whitish central zone and boundaries with a yellowish color of lustrous shine.

FIGURE 2: Photographs of the structure. a) Sector of the highway without asphalt cover with partial slab replacement. b) Map cracking with white material filling fissures.

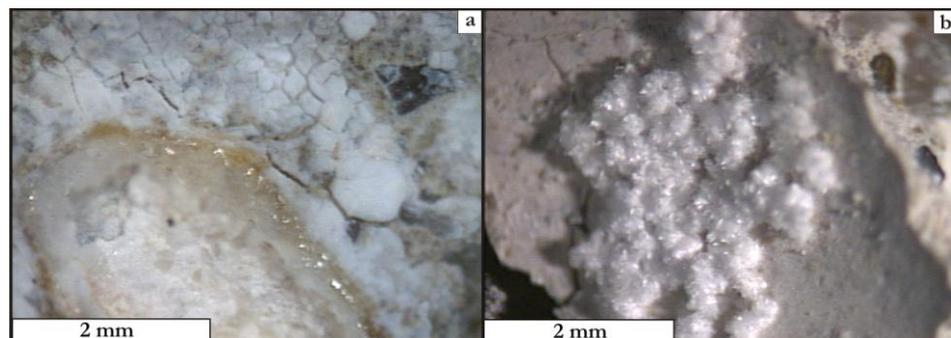
In Figure 3a an aggregate totally covered by a massive and white material can be seen. It turns shiny at the boundary of the aggregate and translucent and brown at the mortar-aggregate interface. Finally, a massive, white and cracked material covers the surface of the surrounding mortar. In Figure 3b a white and crystalline material of needle habit can be seen.

FIGURE 3: Photographs of concrete samples under the stereomicroscope. a) Aggregate covered and surrounded by reaction products. b) Air void partially filled with a white and crystalline material forming groups of radial crystals of needle habit.

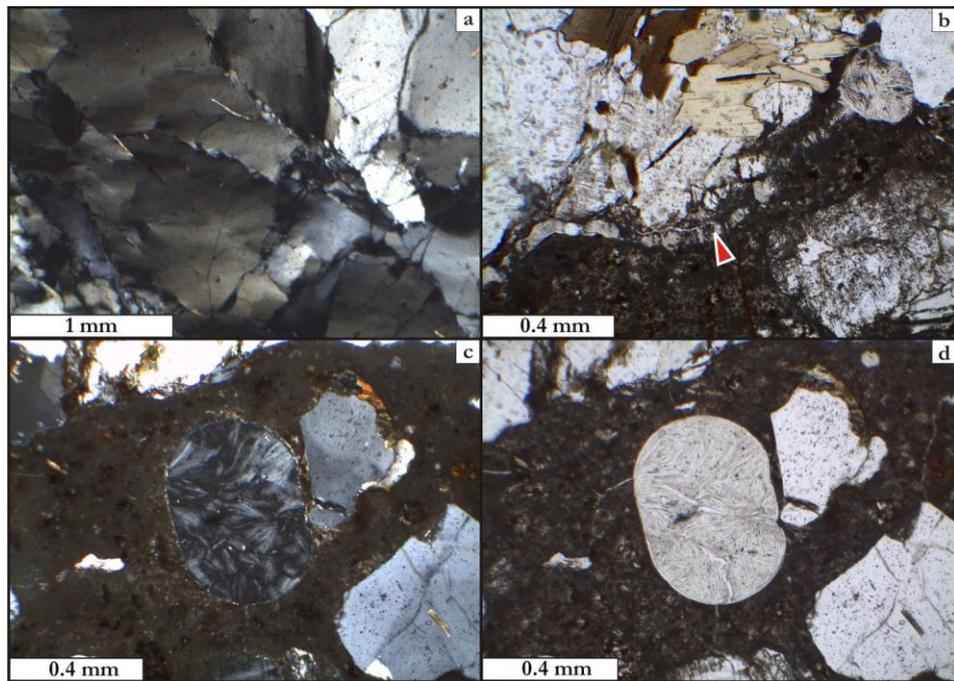
Concrete aggregates are mainly composed of biotitic gneisses with minor quantities of migmatites, amphibolites, granitic intrusives and marbles. The first group shows marked sin-metamorphic foliation and evidence of posterior deformation. The content of quartz is above 50% and presents a lot of microstructures associated with brittle deformation (small particles due to cataclasis) and brittle-ductile deformation (undulating extinction, deformation bands and subgrains, Figure 4a). The grain size ranges from a few millimeters to some dozen micrometers.

The mortar shows intense microcracking. A fibrous material crystallized perpendicular to fissure walls can be seen and it becomes bigger in air voids crystallizing radially to the interior of the cavities (Figure 4b).

Some materials in the cavities show fissures like “mud cracks” possibly due to dehydration and contraction processes. Air voids are partially or totally filled with ettringite (Figures 4c and 4d).

FIGURE 4: Photomicrographs. a) Gneissic aggregate showing quartz crystals with undulating extinction, deformation bands and incipient subgraining. Crossed nichols. b) Microfissure in the mortar-aggregate interface (red arrow) filled with a fibrous material. At the end of the fissure the material crystallizes in an air void of larger size. Parallel nichols. c) Air void filled with ettringite. Crossed nichols. d) The same picture with parallel nichols.

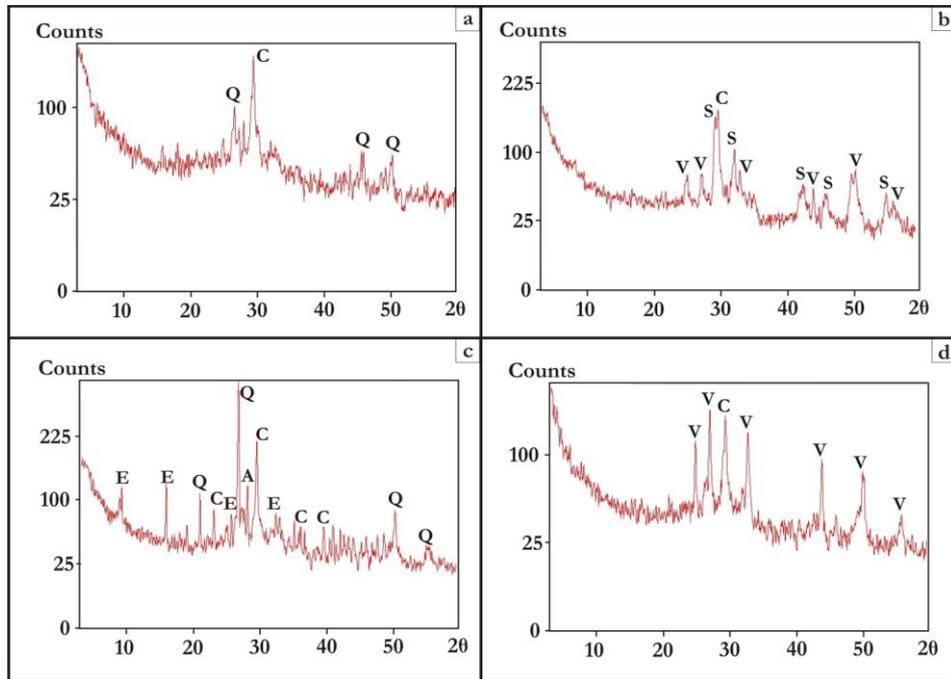
The massive and white material of low hardness and cracked, which covers air voids and the mortar, was identified as calcite (C) (Figure 5a). Another massive and white material of low hardness filling air voids was identified as a mixture of vaterite (V) ( $\text{CaCO}_3$ ), calcite and a calcium silicate hydrate (S) with reflections coincident with tobermorite mineral (Figure 5b). The white material of low hardness but more compact in the mortar-aggregate interface was identified as a mixture of calcite and ettringite (E) (Figure 5c). In this sample, there are some reflections coincident with a calcium aluminum silicate hydrate (A) with zeolitic structure (gismondine). In the diagram there is only one reflection that is not superimposed with the other phases. The translucent and shiny material was identified as vaterite (Figure 5d).

FIGURE 5: XRD diffractograms. a) Material that covers air voids and mortar. b) Material filling air voids. c) Material in the mortar-aggregate interface. d) Translucent and shiny material in the mortar-aggregate interface. Calcite (C), quartz (Q), vaterite (V), calcium silicate hydrate (S), ettringite (E), calcium aluminum silicate hydrate (A).

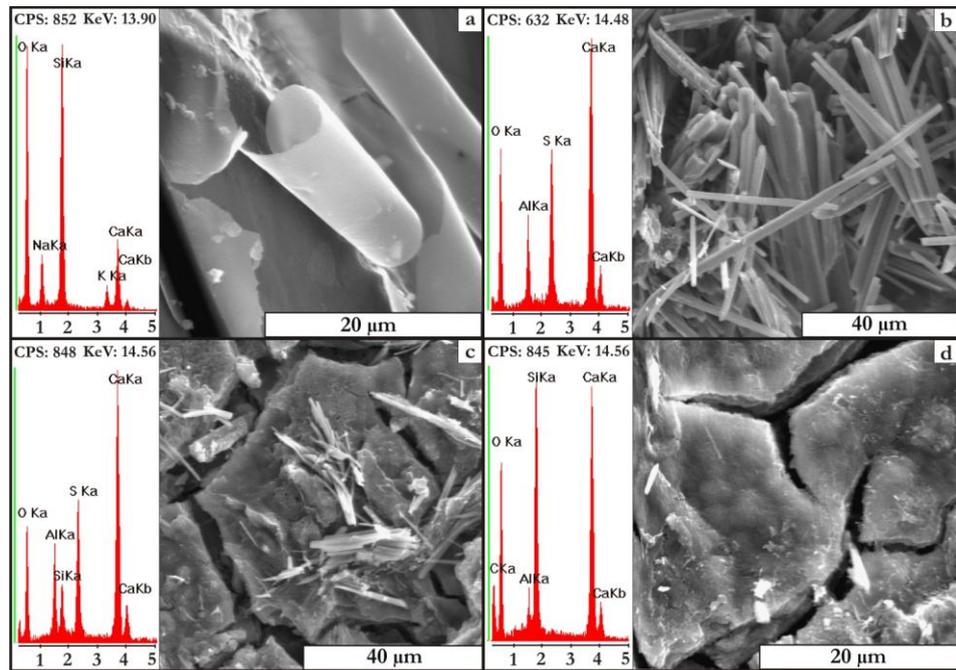
A laminar material that is detached from the concrete surface and forms tubes is observed (Figure 7a). It is composed of Si, O, Ca, Na and K. Due to its low percentage in the sample, XRD determination was not possible.

Filling cavities and on the mortar surface, prismatic crystals of needle habit were observed. They are composed of S, Al, Ca and O (Figure 6b). This material was identified as ettringite through XRD analysis.

A massive and cracked material at the mortar-aggregate interface and in the mortar was observed (Figures 6c and 6d). Over this material some prismatic crystals forming radiated groups were also identified. This prismatic material is composed of S, Al, Ca, O and Si (the latter possibly being a contribution from the massive material in the background). The massive product consists of Si, Ca, O, Al and C. All these materials

FIGURE 6: SEM-EDS determinations. a) Laminar material that is detached from mortar forming tubes. b) Prismatic crystals of ettringite in air void. c and d) Massive and cracked material on the mortar surface. Radiated groups of prismatic crystals over the massive and cracked material are also observed (c).
