JAGUARI HYDROPOWERPLANT – EVALUATION, DIAGNOSIS AND CONTROL OF A STRUCTURE AFFECTED BY ALKALI-AGGREGATE REACTION

Abstract

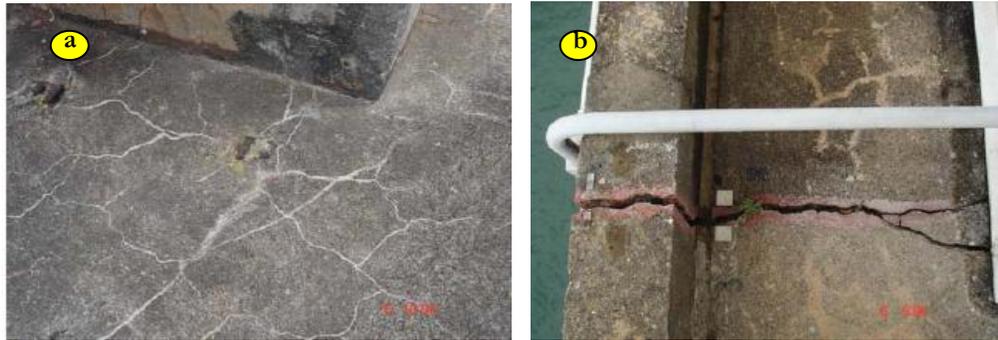
A detailed visual inspection was performed on the water intake to evaluate its structural aspects and concrete cores were extracted and subjected to mineralogical and petrographic analysis. The most important aspects noticed during the inspections were: occurrence of severe map cracking; presence of leaching products from the hydrated cement paste and probably AAR gel on the concrete surface, with the formation of white precipitate that filled various cracks in the water intake slab, as shown in Figure 3; cracks in the water intake slab, bypassing the columns of the travelling crane, with openings of up to 10 mm. The emerged part of the water intake shows severe random cracking with most of them presenting openings in the order of millimeters. The columns, with rectangular section, that support the crane also show vertical cracks on all sides. Data collected from the triortogonal meters showed increase in the openings of 0,5mm/year. Petrographic and mineralogical analysis confirmed that AAR led to the cracking of the structure.

Figure 3: Intense map cracking at the slab showing cracks filled with white material (a) and a severe crack with opening of 10mm (b).

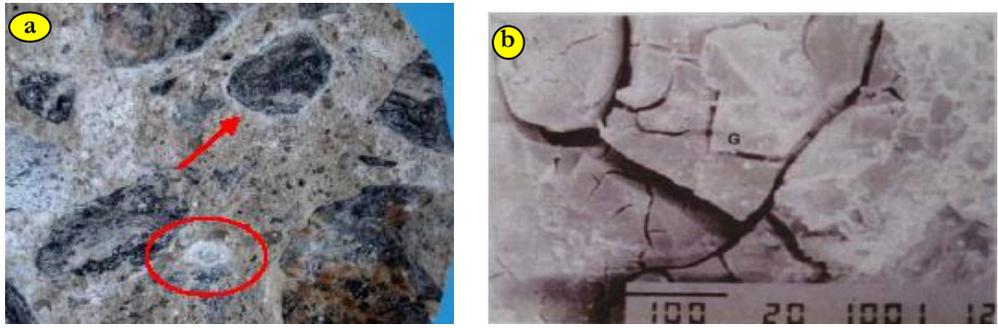
Concrete cores were visually inspected in the laboratory with naked eye and with magnifying glass in order to verify the possible presence of typical AAR elements such as pores filled with reaction products, cracks (both in the aggregate and the mortar), reaction rims, dark spots on the mortar or around the aggregates, detachment between the aggregate and the paste. Such elements are shown in Figure 4.

Aggregates were classified according to their petrographic analysis and mineralogical description, identifying deleterious minerals according to their textural and structural shape. The coarse aggregate has as main minerals quartz and feldspar, as secondary minerals mica, amphibole and opaque, showing as reactive components quartz and feldspar with undulatory extinction and fine quartz. It was classified as a biotite hornblende granite gneiss cataclastic, presenting reaction rims and was considered as potentially reactive. The fine aggregate has as main minerals quartz and feldspar and did not present reaction rims. With respect to the concrete cores, the investigation aimed to determine the existence of AAR, through the occurrence of reaction rims around the aggregates, gel contained in the pores and microcracks caused by the expansion of the gel. Typical features of alkali-aggregate reaction, such as expansive white blueish gel filling pores of concrete, gel at the edges of the aggregates, gel in microcracks and also dispersed in the hydrated cement paste were identified in the concrete cores. The analysis showed that the coarse aggregates were obtained by crushing gneissic rocks. From the standpoint of physical and mechanical characteristics the aggregates used can be classified as of high quality, due to their high tenacity and to the fact that there was no change of its constituents. However, from the standpoint of their chemical stability, the deformation materialized by the undulatory angle of extinction of quartz in this particular rock favors the triggering of expansive reactions of alkali-silicate type. To better tailor the microtexture of the extracted cores of concrete and in particular to more precisely identify the presence of AAR products, analyses were performed at the scanning electron microscope (SEM). Studies in concrete proved the occurrence of alkali-aggregate reaction in all samples, based on the identification of expansive gel, amorphous and cracked, as displayed in Figure 4.

Figure 4: Reaction rims and pores filled with gel. On the right side cracked gel (G), generated by alkali-aggregate reaction, identified by SEM in concrete (150x magnification).

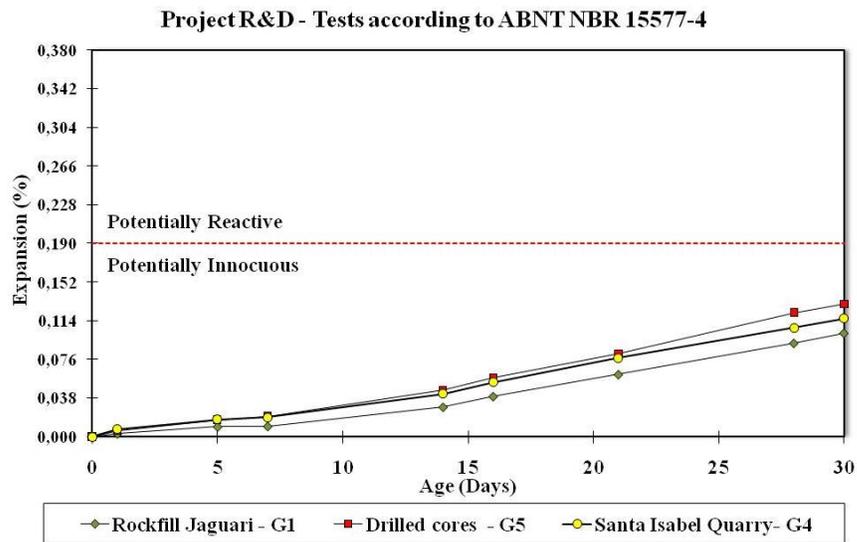
Accelerated mortar bar tests (AMBT) following the Brazilian Standard NBR 15577-4 [5] were performed on rocks collected from the dam's riprap, on material from a nearby quarry and in rock from the foundation, obtained by drilling through the concrete of the water intake. This Brazilian test is similar to the ASTM C-1260 [6] with some modifications, such as the test up to 30 days. Results obtained are shown in Figure 5 and it can be clearly seen that these aggregates can be considered as potentially innocuous. Figure 6 presents tests performed on concrete prisms (CPT), at 38°C and also show aggregates considered as potentially innocuous since their expansion falls below 0,040% at 365 days. Tests performed on concrete prisms at 60°C presented odd results as can also be seen in Figure 6.

Figure 5: Accelerated mortar bar test (AMBT) according to the Brazilian Standard ABNT NBR 15577- 4 (similar to ASTM C-1260).

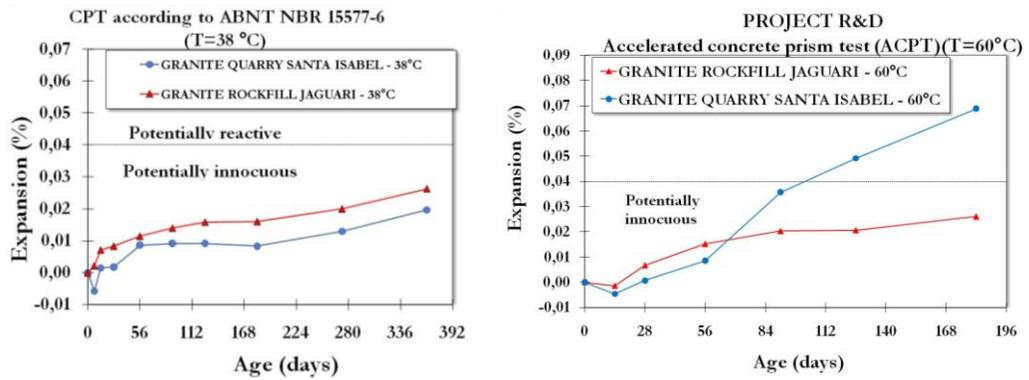
Figure 6: Concrete prism test (CPT) according to Brazilian Standard ABNT NBR 15577- 6 (at 38°C), similar to ASTM C-1293, and CPT tested at 60°C.

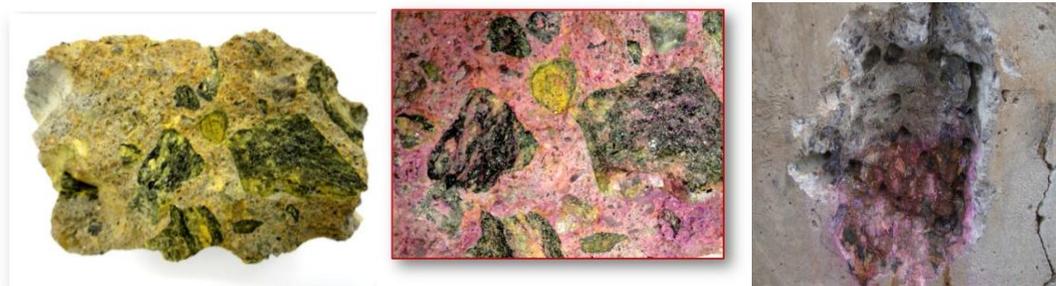
A staining technique developed at the Los Alamos National Laboratory [7] that uses sodium cobaltinitrite and rhodamine, was successfully tested. The method allows to check very rapidly whether a concrete presents AAR, since the staining with sodium cobaltinitrite produces a bright yellow precipitate on the gel surface while the rhodamine reacts with calcium-rich portions of the gel to form a pink stained gel (see Figure 7).

Figure 7: Staining technique applied at the Jaguari HPP concrete.

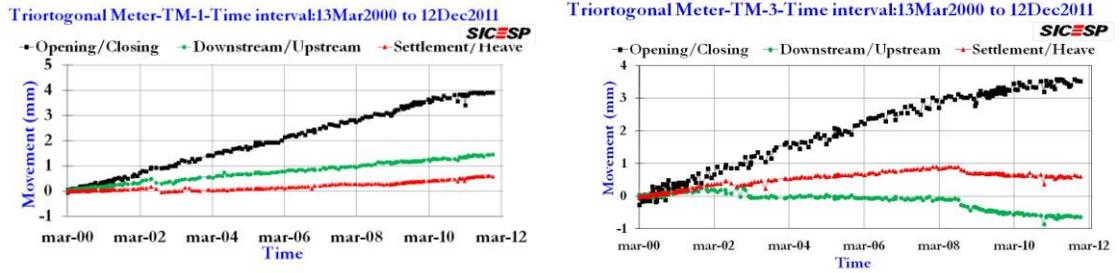
Seven triortogonal crack meters (TM) were installed to monitor cracks movements: opening and closing, vertical displacement and horizontal displacement. Three meters were located on the slab of the water intake, two in the downstream part of the powerhouse and two in the upstream part of the powerhouse. Figure 8 shows the location of some triortogonal meters installed in 2000 while the results are shown in Figure 9. The monitoring of cracks in the slab of the water intake indicates increasing trend of crack opening, about 4mm in ten years, suggesting that the alkali-aggregate reaction is evolving. The opening movement is linear and increasing, with no tendency to stabilize yet.

Figure 9: Displacements measured by triortogonal crack meters TM 01 and TM 03.

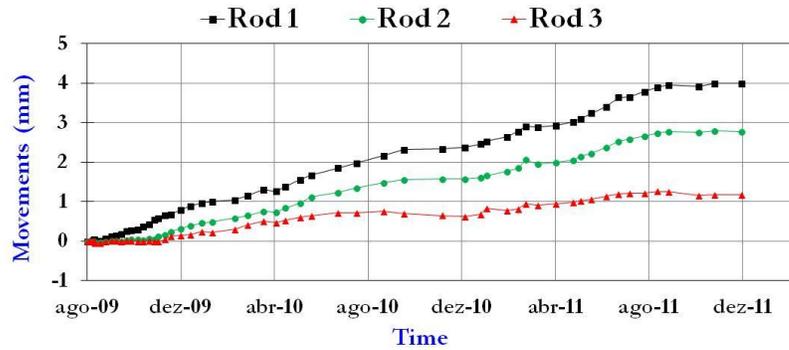
The rod extensometer EH-1 is composed by three rods that were installed in a 62,7m deep hole with a diameter of 100mm drilled through the concrete and 1,6m through the foundation rock. The length of Rod 1 is 64,48m, of Rod 2 is 40,18m and of Rod 3 is 13,68m. Figure 10 presents displacements measured by the rod extensometer EH-1 where it can be seen that in almost two years of observations the expansion reached almost 4mm upwards, considering the total height of the intake. An inverted pendulum was supposed to be installed in another hole having a diameter of 152mm. However after drilling 42m the drill bit was diverted due to the presence of steel bars. Therefore, instead of the pendulum another rod extensometer, the EH-2, with two rods was installed in this hole.

Figure 10: Displacements measured by the rod extensometer EH-1.

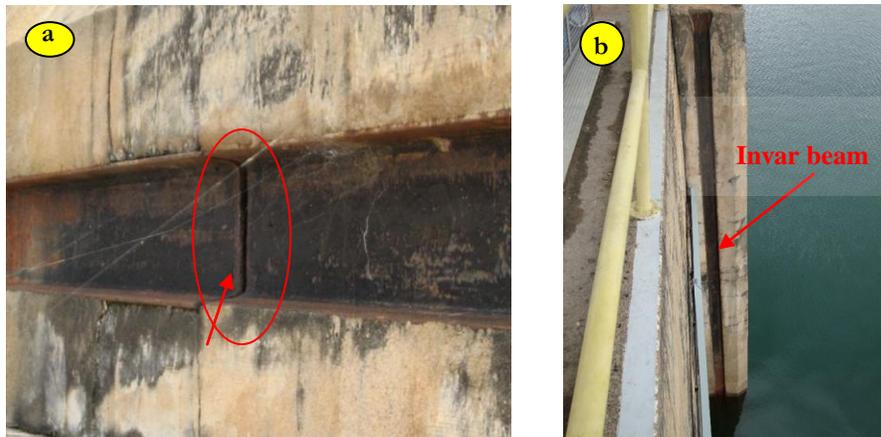
The level of deterioration shown by this structure requires extensive monitoring, mainly between the walls of the trashrack steel guide. The deformation at this location, coming from the AAR is likely to misalign and jeopardize in the long term the movement of the trashrack and of the stoplog. A possible differential displacement of the steel guide can be seen in Figure 11. To monitor and provide an estimate of relative motion between the walls a new device was installed. It consists of a laser sensor with analog and digital outputs and the measurements are based on laser triangulation sensors that operate with a laser diode which projects a visible light spot onto the surface of the measurement target. The sensor weights 100g, the measuring range is 50mm and its resolution is 10 μ m. As the distance between walls is 6,3m an invar steel beam was built and the sensor was fixed in one end, as shown in Figure 11. The readings are transmitted by wiring to an electronic data acquisition, which manages the readings using customized software. Three thermometers based on platinum sensors were installed in the invar beam to allow corrections due to temperature changes. Their results are shown in Figure 12. Displacements measured during one year are shown in Figure 13.

Figure 11: Detail of displacement at the steel guide (a) and view of the invar beam and laser sensor during installation (b).

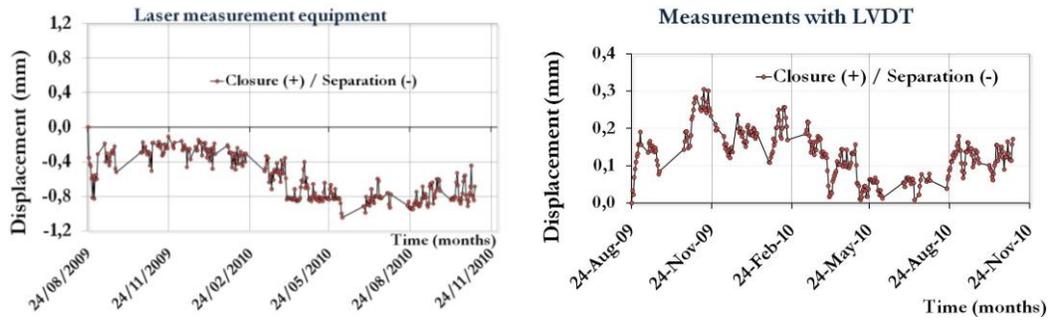
A steel beam carrying in one end a LVDT-Linear Variable Differential Transformer was installed between two walls at the stoplogs storage compartment in order to check concrete expansion and its effect in the distance of these walls. Figure 13 shows the values for displacements measured from August 2009 to November 2010.

Figure 13: Displacements measured with the laser equipment and with the LVDT from 2009 to 2010.
