# THE FEATURE OF CRACKING IN PRESTRESSED CONCRETE BRIDGE GIRDERS DETERIORATED BY ALKALI-SILICA REACTION

Kazuyuki Torii 1\*, Irfan Prasetia 1, Toshihiko Minato 2, Kouji Ishii 3

<sup>1</sup>Kanazawa University, Kanazawa, Ishikawa, Japan

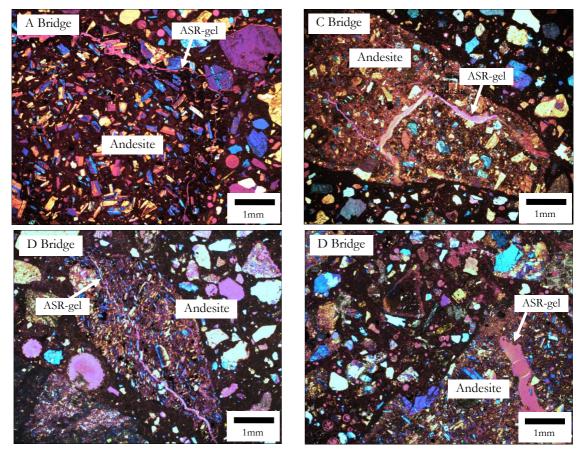
The ASR deterioration level judging from the cracking level both in visual inspection of PC girder and in microscopic observation of thin section of cores is presented in Table 2. It is well recognized that the river gravel and river sand supplied in the Hokuriku district usually contains the volcanic rock stones of the andesite and the ryolite, and the sedimentary rock stones of melted tuff, chert and sand stone as the reactive ones. The most reactive stone in them is likely to be the andesite stone, where the reactivity of river gravel is proportional to the content of andesite stone in their geological compositions. The content of reactive andesite stone in the concrete examined in the petrographic work increased in the following order of the Kurobe river, the Kuzuryu river, the Sho river and the Joganji river. As shown in Figure 16, it is observed from the thin section sample of ASR-deteriorated cores that the andesite stone particles in the river gravel around them extensively develop to the cement paste, resulting in a formation of continuous microcrack net. It can be concluded that the evaluation of ASR deterioration level by the polarizing microscope is very useful for the diagnosis of concrete core, which is also almost consistent well with that obtained from the visual inspection for PC bridge.

Figure 16: The petrographic observations for thin section of cores by porlizing microscope (crossed nicol with gypsum filter).
