## ASSESSMENT OF ALKALI-AGGREGATE REACTION AT SABESP'S DAMS

Wong Sui Tung<sup>1</sup>, Selmo Chapira Kuperman<sup>2</sup>, Isael Araújo de Melo<sup>1</sup>, Carlos Roberto Dardis<sup>1</sup>

<sup>1</sup> SABESP-Companhia de Saneamento Básico do Estado de Sao Paulo, Sao Paulo, SP, Brazil

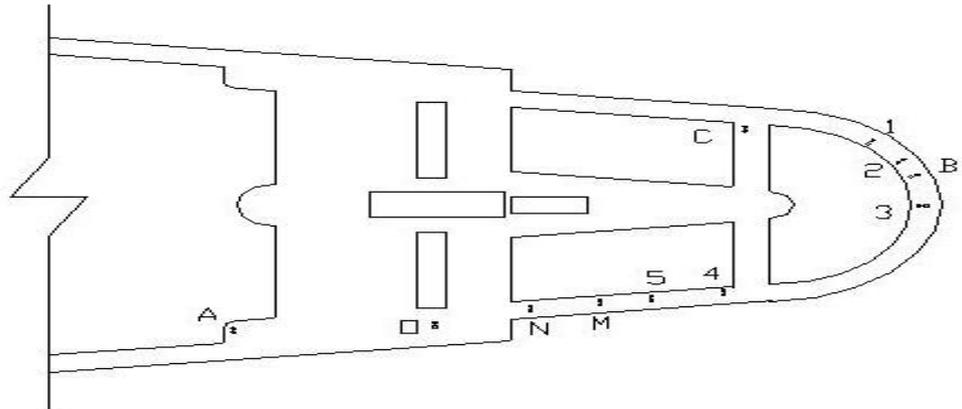
Figure 2 – Plan showing schematic location of pins at the Paiva Castro dam spillway (not on scale).

The finding of cracks led the company's technicians to install in January 1992 bolts in the most significant cracks, to allow monitoring and tracking of their openings by monthly readings with analog caliper. At that time, 15 pairs of bolts were installed in the dam, 5 being located in the spillway (1-5) and 10 in the walls of the dissipation basin (1 to 10), as shown in Figures 2 and 3.

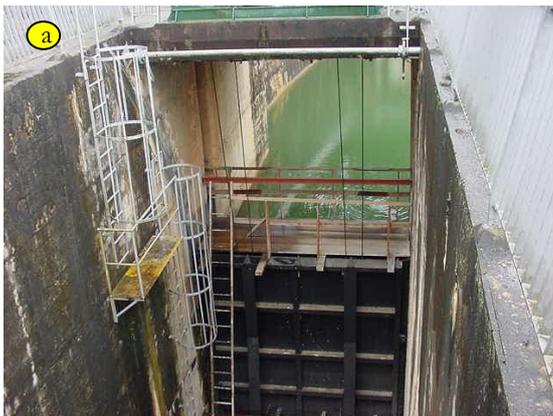
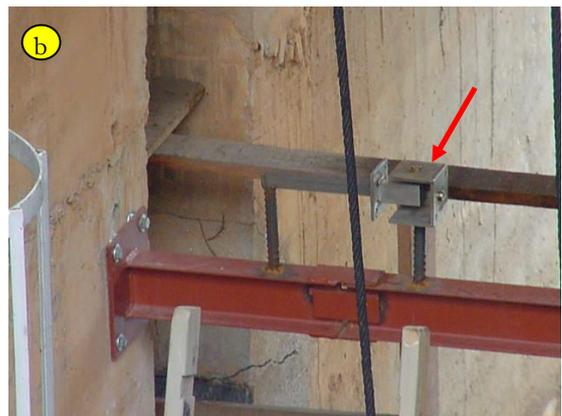
Figure 4 – Paiva Castro dam spillway showing the gate (a) and a detail of the tri-orthogonal meter (b).

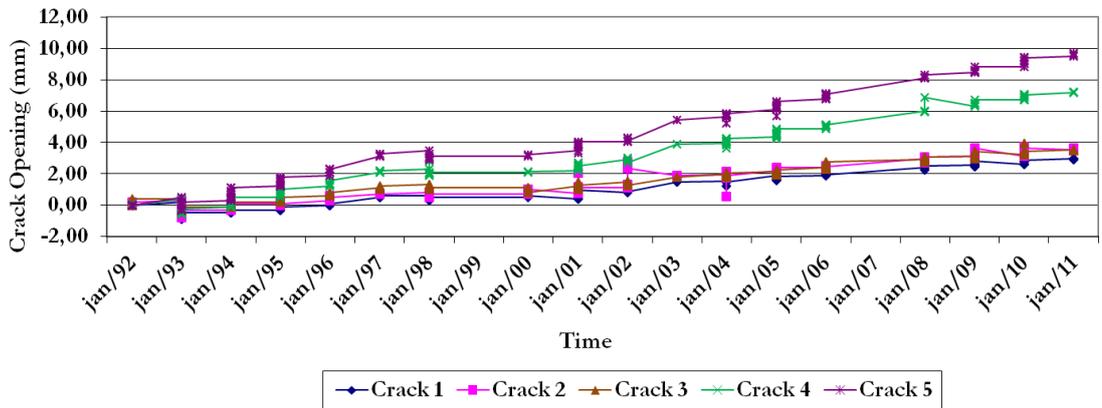
cracks. It seems that at the spillway cracks evolution continues with different opening rates, according to its location. Those localized along the right wall on the crest of the spillway, measured by pins number 4 and 5 show opening rates of 0.41mm/year and 0.53mm/year, respectively. The remaining cracks in the spillway show lower opening rates: 0.20mm/year, 0.19mm/year and 0.20mm/year for cracks 1, 2 and 3 respectively. The crack opening evolutionary process in the dissipation basin seems to be concentrated at the end of the left wall as shown by the readings of the pins 3 and 4 (see Figure 6).

Figure 5 – Evolution of cracks openings at Paiva Castro dam spillway.

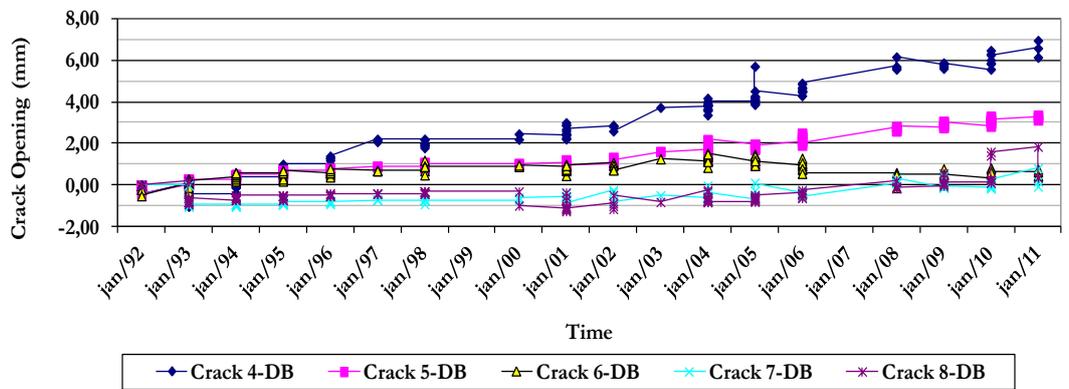
Figure 6 – Evolution of cracks openings at Paiva Castro dam dissipation basin walls.

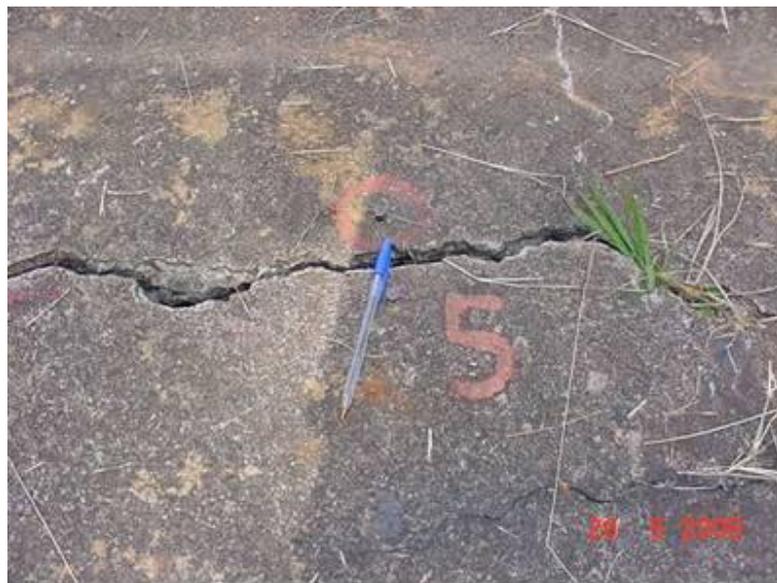
In November 2000, 11 crack-meter bases had been installed: called as "A", "B", "C" in the spillway and "D", "E", "F", "G", "H", "I", "J", "L" on the concrete walls of the dissipation basin. On this occasion the readings began to be performed with a digital caliper, whose precision is 0.01 mm and also with the elongameter with an accuracy of 0.001 mm. In addition, temperatures of the structures were recorded during the readings, through non-contact digital thermometer, whose values are obtained by infrared emission. In January 2001, during the preventive maintenance test involving the tainter gate number 02, the lifting beam of the stop-log showed evidence of being blocked, indicating a tendency of gap closure, something that never actually occurred previously. Because of this anomaly, underwater inspections were made, hydroblasting cleaning of the steel structures of the spillways number 01 and 02 was performed and measurements of the distance between guides of the stop-logs were started. Afterwards approximately 10mm at the end of the lifting beam and of the stop-logs were cut off. This prevented further blockage of the lifting beam and of the stop-log allowing their movement without difficulty. In 2004 three new elongameter bases called "M", "N" and "O" were installed in the concrete near tainter gate No. 02; also a triortogonal meter fixed with the aid of a beam was installed between the two walls of the spillway, to monitor an evolution of the gap closure. Figure 4 shows the triortogonal meter. As an example of values that have been obtained in the measurements, Figures 5 and 6 present variations of the opening of some cracks from Paiva Castro dam. Figure 7 shows detail of the

Figure 7 – Detail of pin number 5 placed at the spillway of Paiva Castro dam.
