Rehabilitation of Railway Bridge Piers Heavily Damaged by Alkali-Aggregate Reaction

ABSTRACT

This paper deals with the evaluation of the damages caused by the alkali-aggregate reaction. As the concrete above the water line had to be replaced, the bridge loads were transferred through steel columns to deeper layers of concrete.

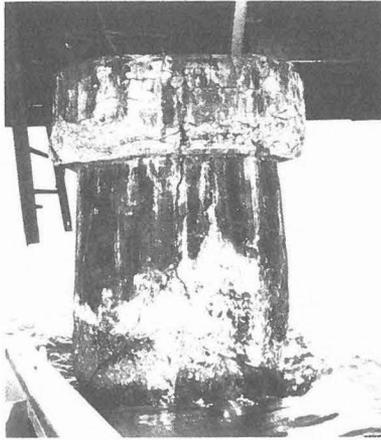
All visible parts of the piers showed considerable damage due to alkali-silica reaction causing polygonal surface fracturing aggravated by subsequent freezing and thawing. The part of concrete piers protruding above water (2 meters) was heavily cracked. In many instances the sliding bearings were

not functioning and thermal movements had cracked the piers (fig.1). In some cases, the central crack seen on the photograph was opened up to 35 mm, in winter. A detailed investigation revealed that some bearings had settled into the concrete pier tops some 20 mm.

Figure 1: Typical pier damage

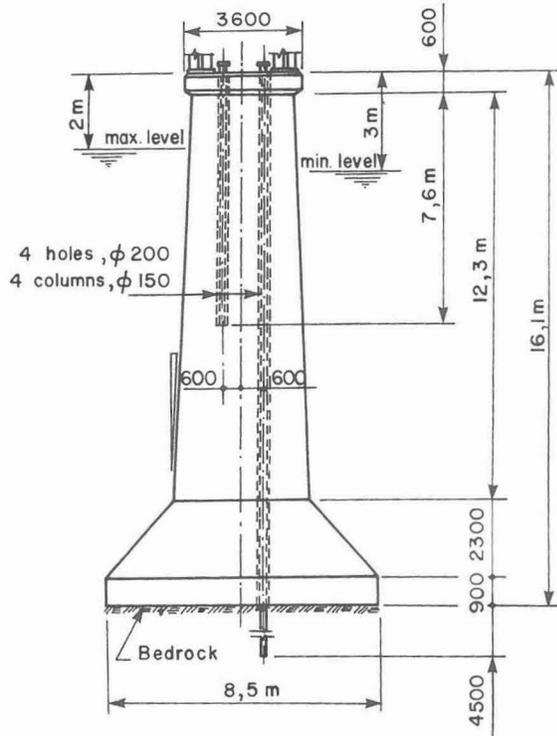
Figure 2: Proposed load transfer columns

1. Building a complete new bridge having only ten piers with a new steel superstructure; preliminary estimates reached 60×10^6 can \$.
2. Demolishing and repair of part of the concrete piers. This entailed the removal of all girders and their storing on shore.
3. Lifting the spans through specially designed supports bearing on the sound concrete of the pier, while damaged concrete was removed and replaced. The load was transferred through steel columns embedded 5-10 m deep in the coring holes (fig. 2).

Steel columns were positioned within 0,40 mm, in elevation, and within 9.5 mm in the two horizontal directions. To facilitate the handling and support operations the ends of the columns were threaded on a 330 mm length. When the grout had hardened sufficiently, the bridge girders were jacked up and lowered on temporary support beams resting on sleeves threaded to the column ends.

At that stage, concrete was removed to a depth of at least 1.5-1.8 meter, even if sometimes deterioration did not reach that level. This was done because sufficient space was needed to install the lifting mechanism which was fixed to the steel column through 4 split collars. The lifting mechanism was thus independent of the height of concrete removed and above all no lifting operation relied on the bearing capacity of the altered layers of concrete. After installation of the load transfer beam, the lifting mechanism was removed and reinforcing bars set up. Installation of the formwork reached below the water level to allow replacement of the chipped concrete around the sides of the pier.

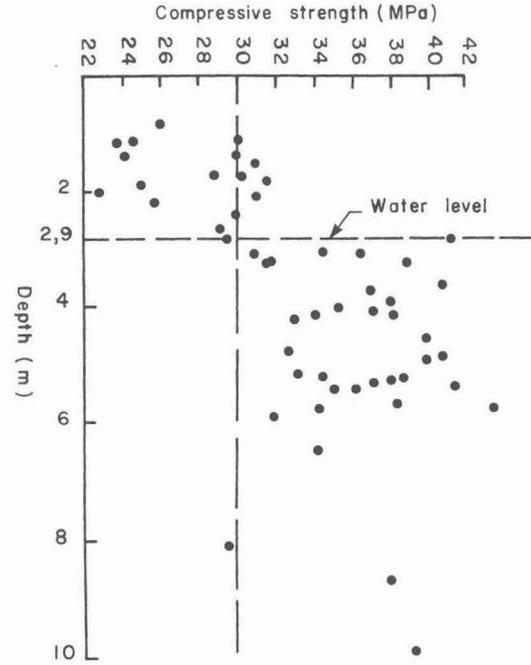
All fifty two compression test results are plotted on figure 3. Results vary from a low of 22.8 MPa up to a high of 43.6 MPa. An horizontal line representing the water level shows qualitatively that concretes above and below that line belong to two different populations.

Almost all compression results on the concrete from the upper 3 meters of the pier are below 30 MPa, varying from 22.8 MPa to 31.6 MPa. Results of compression tests for concrete situated below the water level is significantly above the 30 MPa value. Mean value for this group, which follows a normal distribution is 36.4 MPa, with a coefficient of variation of 9.8 %.

Figure 3: Variation of compressive strength with depth
