Repair of Alkali-Aggregate Reaction Damage to the Motorway Structures of the Pell Street Interchange, Port Elizabeth, Republic of South Africa

A.T. Vanderstraeten
*Hawkins, Hawkins and Osborn
Consulting Civil Engineers
Rivonia, Republic of South Africa*

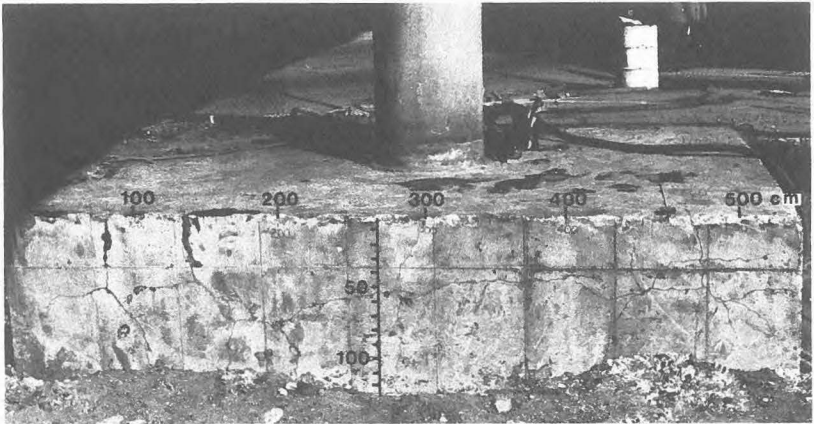
Fig.1 - Typical AAR Cracking to the Side Face of a Column Pile Cap

The observed cracking on the pile caps had widths varying from very fine up to 6 mm wide, with the larger cracks occurring predominantly on the side faces as typically illustrated in Fig. 1. Cracks on the top surfaces were generally confined to the outer edges as well as immediately around the existing columns, such areas being assessed as falling within likely zones of tensile stress development under the action of applied loading. On the pile caps undermined, cracks were observed along the undersides, although their location was such that they were suspected as being structural in origin, rather than directly attributable to AAR. The exposed surfaces of the piles themselves appeared sound and free of cracking.

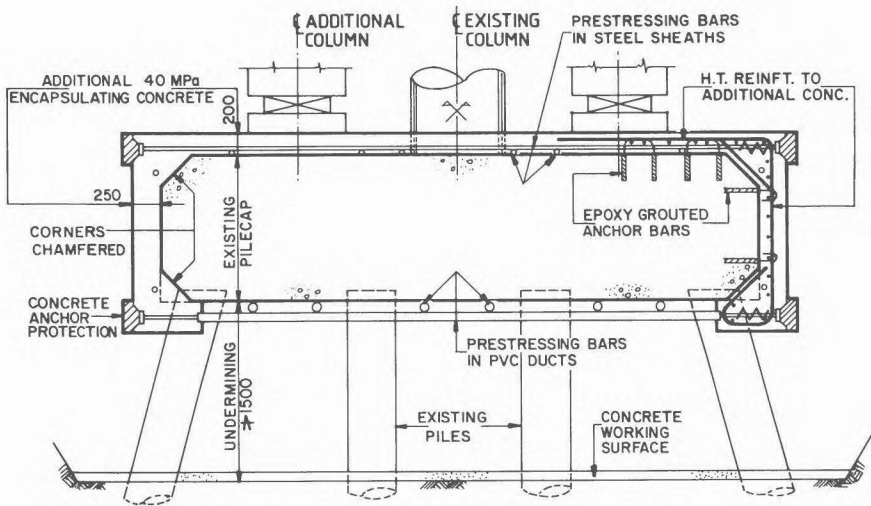
Fig. 2 - Typical Remedial Measures to a Column Pile Cap
(The additional columns shown are part of the overall upgrading)

The remedial measure adopted was to encapsulate the top and sides of the pile caps with a 200-250 mm thickness of additional high strength reinforced and prestressed concrete as typically illustrated in Fig. 2.

The remedials necessitate the complete undermining of the pile cap. As a safety precaution traffic was either stopped or restricted and monitoring of movement of the pile cap undertaken throughout the remedial operation. Once exposed, all corners of the pile cap, except in the vicinity of the piles, are chamfered to allow for transfer of prestressing forces to the existing concrete. Badly cracked concrete is locally removed from the top and side surfaces which are sandblasted for keying of the new concrete and all visible cracks on the pile cap are then epoxy injection grouted. The new encapsulation is anchored well into the main core of the pile cap through epoxy grouted anchor bars and the new concrete is reinforced with high tensile steel against differential shrinkage and prestressing splitting forces. Horizontal prestressing bars are provided to the top, side and underside of the pile cap distributed so as to give uniform and equal orthogonal prestressing. The bars are post-tensioned as soon as the requisite concrete strength has been reached, in order to achieve the maximum transfer of stress to the existing concrete. The bars to the underside are unbonded and cement grouted in oversized PVC ducting for protection. Elsewhere the bars are conventionally grouted and bonded. Final backfilling of the excavation is done using sand inundated to achieve compaction, with any remaining void to the underside being subsequently cement grouted. In the absence of coded design criteria, the degree of prestressing was derived on the basis of providing additional strength to cover the major portion of traffic loading and net confining pressures of between 0,5 - 1,0 MPa on the existing concrete.

concrete affords protection against extremes in moisture and thermal variations as well as strengthening to the weaker outer skin of the existing concrete. The horizontal prestressing provides both additional overall strength to the pile cap and active resistance to further cracking of the existing concrete from any continuing AAR. In these ways, the remedial measures adopted satisfy the stated criteria.
