Analysis of Distress Due to Alkali-Aggregate Reaction in Gallery Structures of a Concrete Dam

H.C. Visvesvaraya, C. Rajkumar and A.K. Mullick
*National Council for Cement and Building Materials
New Delhi, India*

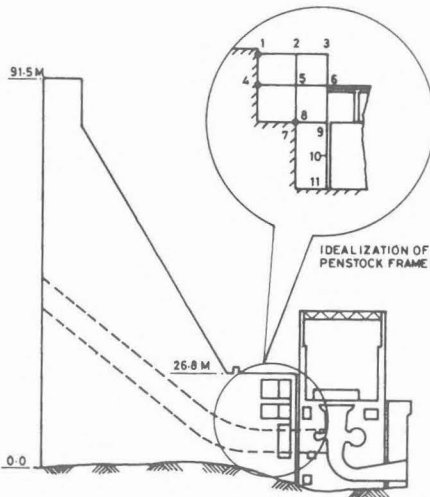
FIG. 1 SECTION THROUGH C OF PENSTOCK

The penstock gallery structure located on the toe of a 300 ft (91.5 m) high concrete gravity dam is comprised of RCC frames constructed integrally with the dam body (Fig 1). After nearly 25 years in operation, wide-spread distress was noticed in the dam and power house structures, in the form of cracks, vertical sliding of joints, jamming of gates, etc. Other associated problems noticed were: difficulties in operating the gantry crane in the power house because of the shift in the rail alignment; tripping of the generators because of the disturbance to the shaft alignment; and shearing of MS rails supporting the draft tube crane.

- Multiple horizontal cracks on the face of columns marked 9-10-11 (close to penstock) and extending to a height of 1m or so from the foot of columns.

- Wide horizontal cracks near mid height of column 9-10-11 maximum width at the gallery side and reducing in width as the cracks travel interior.
- Snapping of main reinforcement placed in column 9-10-11
- Spalling of concrete at the end section of beam 5-6
- Closing of expansion joints (design width 25mm) between gallery and scroll concrete.
- Relative horizontal shifts in the beams supporting generator floor.

There is no known method or solution to stop or to minimise the expansion phenomenon. Under these circumstances, any solution to the problem should suggest methods which will minimise its effect on the behaviour of columns in the PGF. The interaction between the PGF and the dam profile can be minimised by introducing releases at the nodes 1,4 and 8. The beams may be detached from the dam profile and made to rest on corbels with suitable bearing seats which will ensure that any further change in the dam profile is accommodated within the seating provided. This arrangement will take care

of horizontal displacements. It appears difficult to accommodate the vertical component of the movement. One possible approach is to have some arrangement at the bearing seats, suggested earlier, by which the vertical expansion is compensated. The third aspect is the non functioning of the expansion joint between the turbine block and the PGF and hence creating a pressure on the column face. This can be taken care of by cleaning the joint and by chipping off concrete to the required depth and thus making the expansion joint functional. The last aspect to be considered is the expansion of concrete within the column itself. The fractured columns can be structurally rehabilitated by procedures available in the literature. However this does not solve the expansion problem and the consequent increase in the steel stress. One possible approach is to release the current level of stresses by cutting the reinforcing steel and rehabilitating them by re-welding the same bars and if necessary with lap joints.

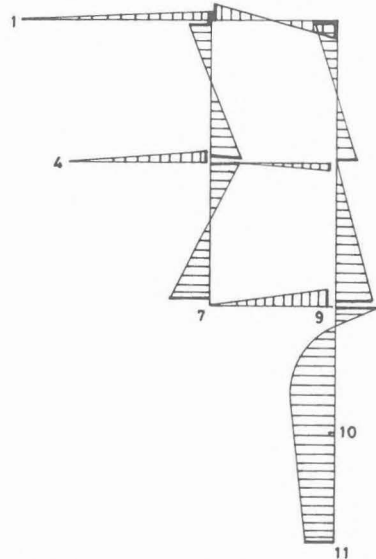
FIG. 2 BENDING MOMENT DIAGRAM FOR PENSTOCK GALLERY

An analysis was, therefore, taken up by imposing various levels of horizontal and vertical displacements at nodes 1,4,7 and 8 (Fig 1) representing the expansion in the dam body due to ASR. A systematic search was made to correlate the distress noticed and the possible combination of vertical and horizontal movements and thus the most probable combination was arrived at for further verification. Another interacting factor to be considered is the reaction from the turbine block. Though an expansion joint has been provided, over the years this has become nonfunctional. Because of various unknown factors involved, determination of the magnitude and nature of reaction from the turbine block is almost impossible. However, to take into account this interaction aspect a different approach was followed wherein the deflection of the column line was made to match an assumed deformation profile of block concrete. The results of this analysis are shown in Fig 2.

From this it may be concluded that the relative displacements due to ASR expansion can cause distress in the members of the PGF. In addition the reaction from the turbine block, which could be either passive or active can aggravate the distress in the column 9-10-11. The order of horizontal and vertical displacements imposed relative to node 11 (Fig 1) are 12.5 mm and 3 mm respectively. This will correspond to an average linear expansion rate of 0.035%. The expansion phenomenon discussed so far, relates to the main body of the dam. In addition, there is a possibility of this phenomenon occurring in the columns itself and in turbine block. Considering the possibility of ASR phenomenon occurring in all the three areas, the associated structural problems related to the PGF are summarised as follows.

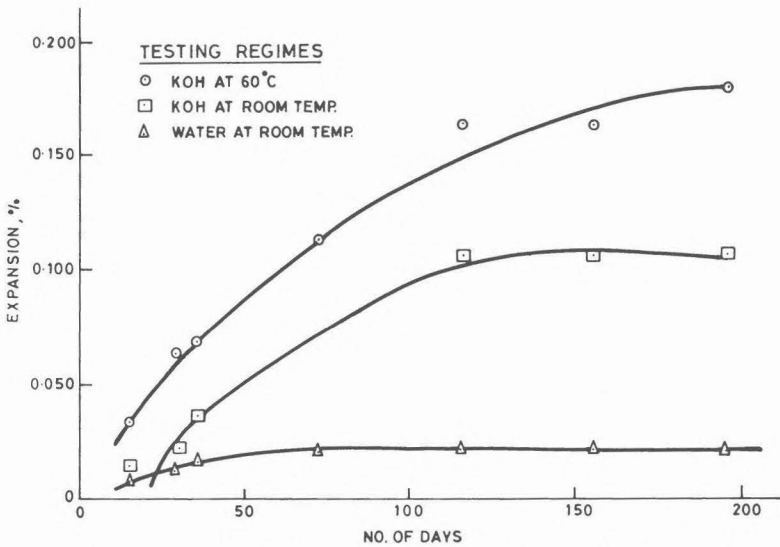
FIG.3 EXPANSION OF CONCRETE CORES IN DIFFERENT TESTING REGIMES
(LONG TERM STUDIES)

In order to ensure that the order of expansion considered had indeed occurred, recourse was taken to physical observations such as closing of expansion gap, shift of beams supporting turbine floors, etc. In addition, the order of expansion was checked with long-term expansion tests on concrete core samples immersed in water and KOH solution, both at room temperature and 60 C. The rate and the order of expansion as obtained from the laboratory studies are given in Fig 3. The results show that an expansion of the order of 0.1% is realistic. Further it was concluded that potential for further expansion still existed. This is also corroborated by the site observations.
