Deterioration processes of dams affected by concrete swelling reactions. The Portuguese experience in monitoring and rehabilitation

António Lopes Batista (1)

(1) National Laboratory for Civil Engineering (LNEC), Lisbon, Portugal, albatista@lnec.pt

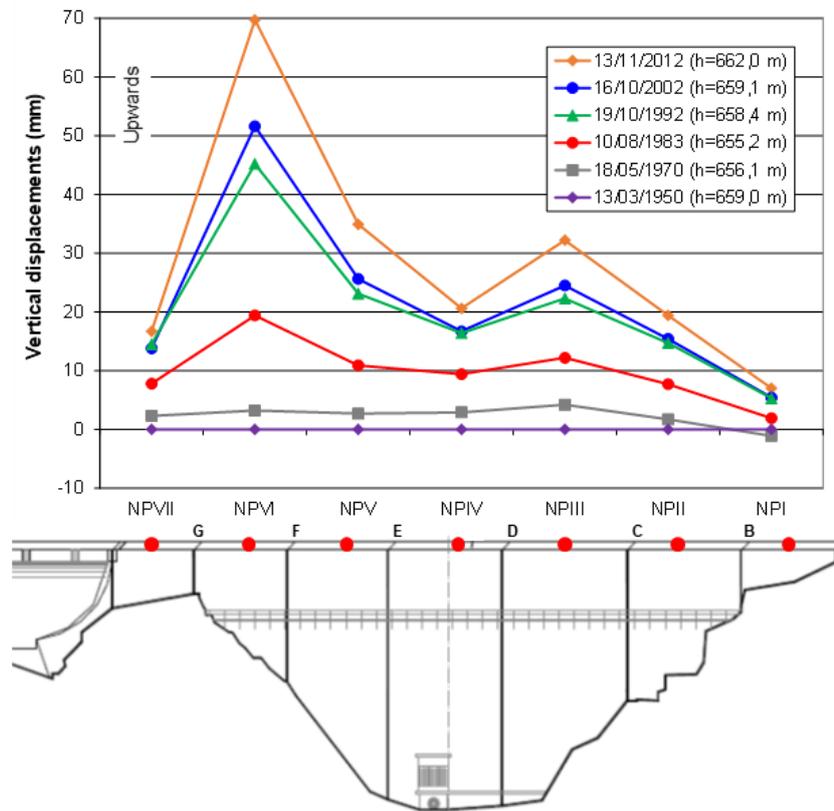
Figure 2.6: Alto Ceira dam. Vertical displacements monitored by precision geometric levelling, between 1950 and 2012

Figure 2.6 shows the evolution of the vertical displacements at the crest, obtained by precision geometric levelling, between 1950 and 2012. A tendency to blistering has been observed since the early years of operation, but rates have increased substantially since 1983. In the central zone (block DE), the accumulated vertical displacement was about 20 mm (average vertical expansion, including concrete and cracks, of about 500×10^{-6}), but in block FG, on the right bank, the displacement reached about 70 mm, which corresponds to an average vertical expansion (concrete and cracks) of about 4000×10^{-6} .

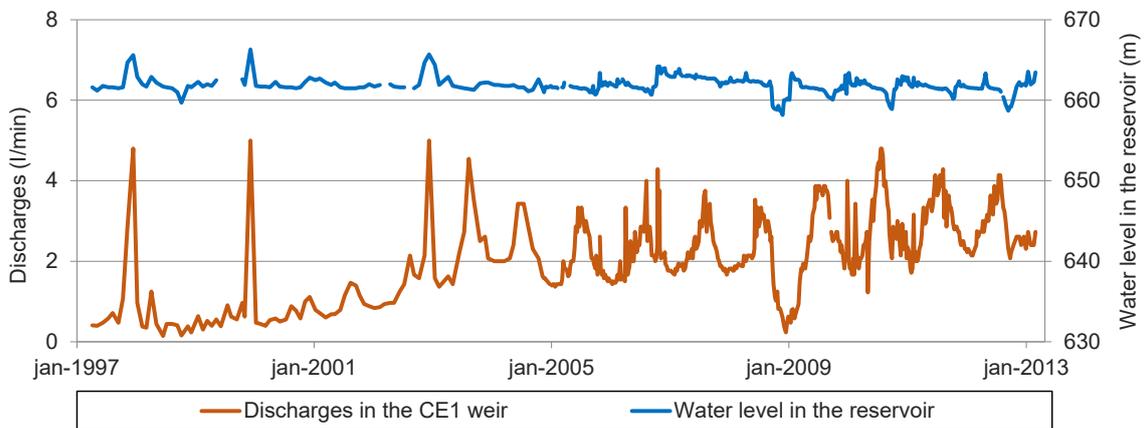
Figure 2.7: Alto Ceira dam. Discharges through cracks at the bottom of BC block, collected in the CE1 weir, between 1997 and 2013

Regarding the leakage on the downstream face, Figure 2.7 shows the evolution of the discharges in the lower section of the BC block (collected at the CE1 weir, see Figure 2.2, on the right side), from 1997 to 2013. In the last years of operation, the discharges reached maximum values of about 5 l/min, with seasonal average values between 2 l/min and 4 l/min. The passage of water through cracks enhances the degradation of the concrete.

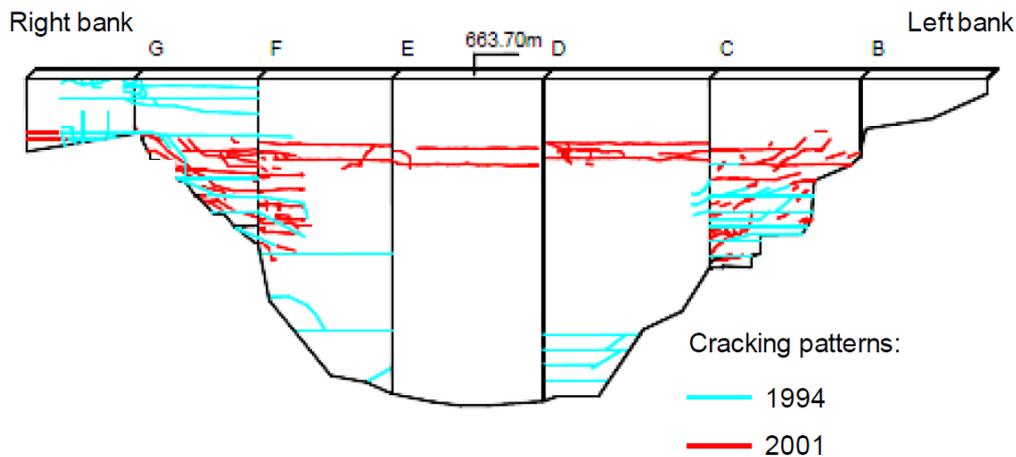
Figure 2.8: Alto Ceira dam. Main cracks on the downstream face, identified during the surveys carried out in 1994 and 2001, using traditional techniques [9]

Figure 2.8 shows the main cracks on the downstream face, identified during the surveys carried out in 1994 and 2001. The main cracks had a horizontal direction on the face, being parallel to the insertion surface in the bearing zones at mid-height. Block BC, on the left bank, and blocks FG and GH, on the right bank, were the most cracked ones.

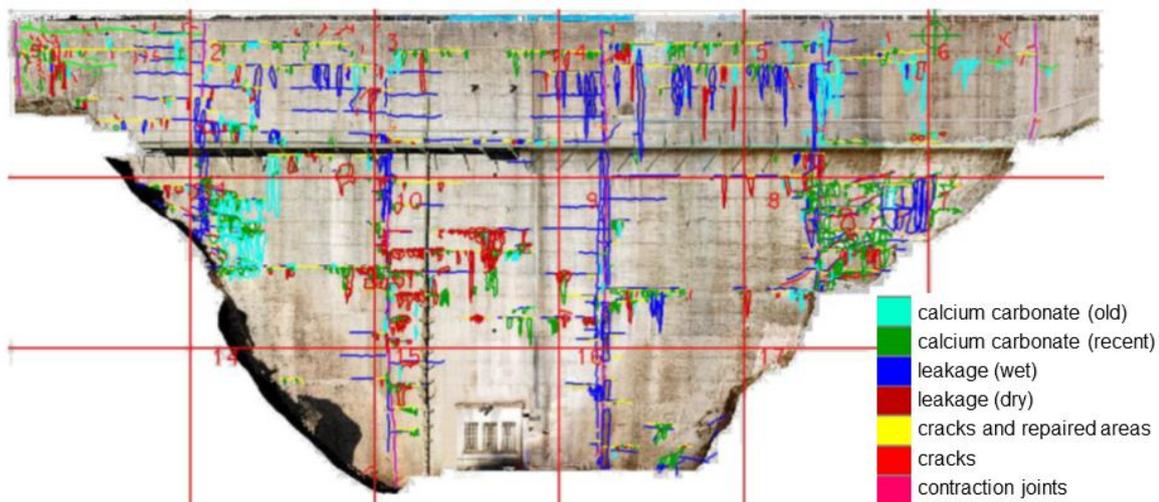
Figure 2.9: Alto Ceira dam. Results of occurrence survey of the downstream face, carried out in 2005, using georeferenced digital photography [7,8]

In 2005, a mapping of occurrences was carried out on the downstream face, using georeferenced digital photography (Figure 2.9) [7, 8]. It can be noted that the main cracks were clearly identified, as well as leakages and carbonate deposits.

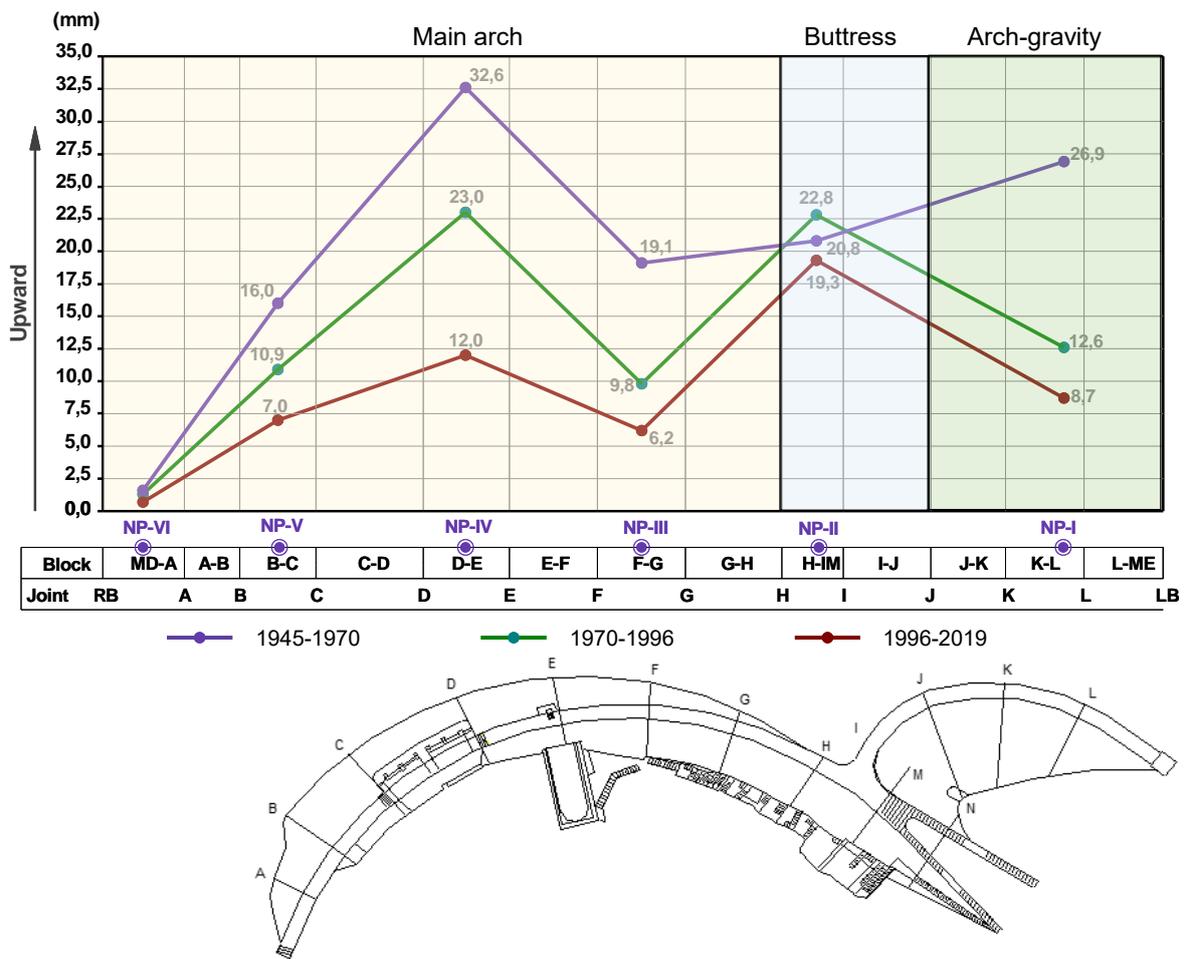
Figure 2.12: Santa Luzia dam. Irreversible vertical displacements computed for the levelling marks at the crest in the periods 1945-1970, 1970-1996 and 1996-2019 [21]

Blistering at the dam crest was detected for the first time in 1966 [13]. Radial towards upstream and upward vertical displacements had increased at constant rates between 1960 and 2000. However, in recent decades, these rates been decreasing, indicating that the reaction is exhausting. Figure 2.12 shows the irreversible vertical displacements computed for the levelling marks at the crest in the periods 1945-1970, 1970-1996 and 1996-2019, obtained by means of a quantitative analysis. It is noted that the vertical strains, corresponding to the accumulated displacements, are greater in the arch-gravity than in the arch, associated with the greater structural deterioration of that part.

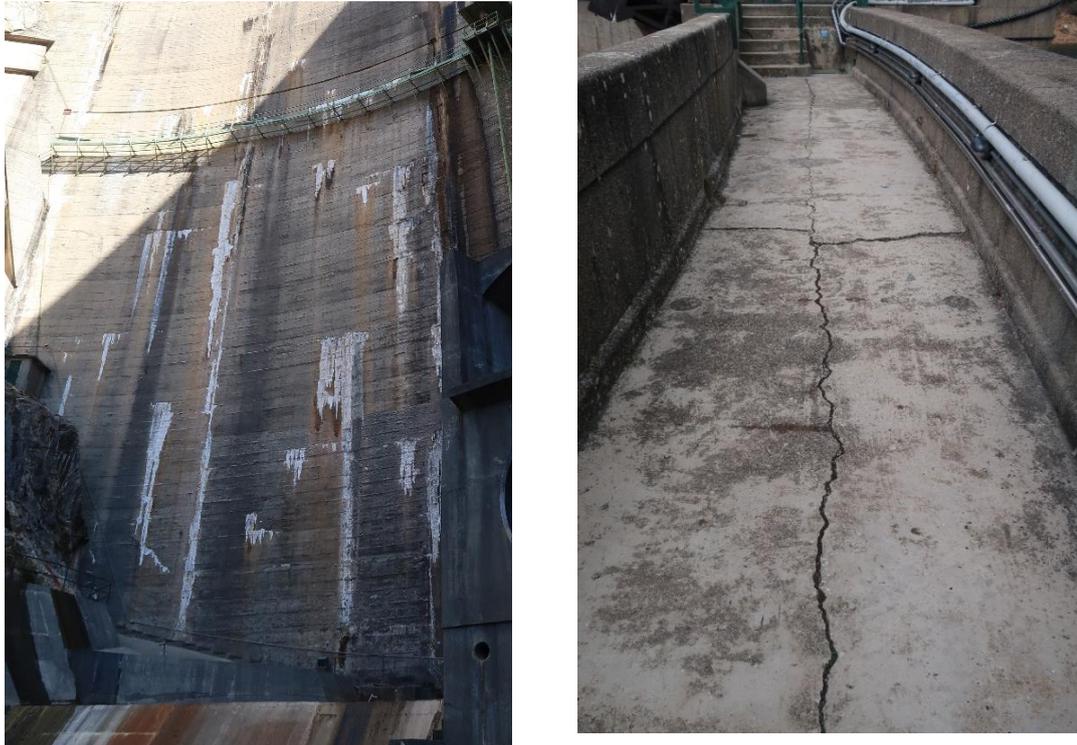
Figure 2.13: Santa Luzia dam. Cracks in the main arch, specifically along concreting joints on the downstream face, with deposits of calcium carbonate (on left), and linear cracks at the crest, on the right bank side (on right), in 2019

LNEC carried out surveys on the cracking state of the dam in 1979/1980 [14] and in 1998 [15]. Since then, these surveys have been carried out by the dam's owner. Cracking evolved up to the present, being much more intense in the arch-gravity and along the connection with the arch section. The cracking is predominantly diffuse, but there are cracks of linear development with openings of several centimetres at the connection zone and at the entire crest, and linear cracks with smaller opening on the faces of the arch and of the arch-gravity. Figures 2.13 and 2.14 show photographs, taken in 2019, of some areas of the dam where there is greater cracking in the concrete.

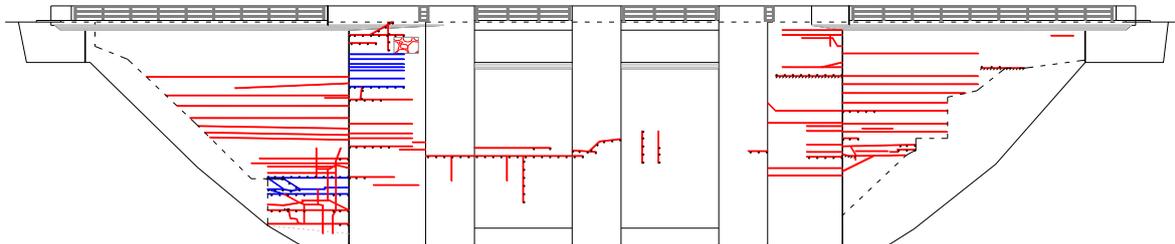
Figure 2.16: Fagilde dam. Cracking pattern of the downstream face in 2009 [29]

In 2004, a crack mapping was carried out, to establishing a reference state. The main existing cracks on the upstream and downstream faces, buttress faces and crest were characterized, with the register of their numbering, location, opening, development and average orientation. Figure 2.16 shows the cracking pattern, complemented with new cracks detected in the update survey carried out in 2009. The cracking on the faces was considerable, with most cracks opening of less than 1 mm. However, a

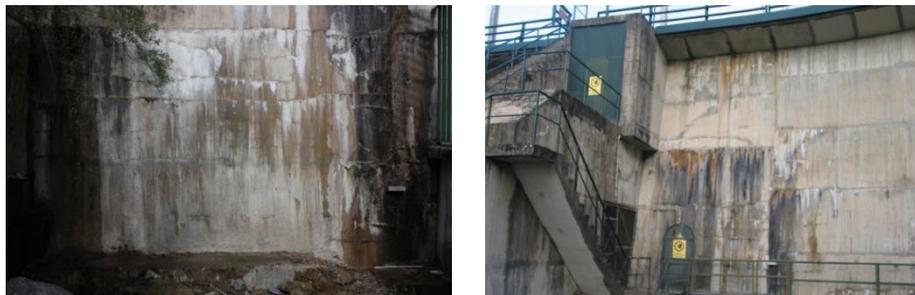
Figure 2.17: Fagilde dam. Downstream views of the bottom zone of the right arch (on left) and of the upper zone of the left arch (on right), in 2015

reduced number of cracks (the most expressive ones) had a larger opening, although always less than 10 mm. Figures 2.17 and 2.18 shows photographs, obtained in 2015 and 2016, respectively, of the concrete faces cracking of the arches and of the central buttress.

Given the concrete degradation, three alternative interventions have been pointed out, namely: i) waterproofing the upstream face and cement grouting of cracks in the arches; ii) the replacement of the two arches; and iii) the replacement of the dam itself. The first two alternatives would require detailed studies to be carried out on the dam's behavior in its new structural condition. However, due to the dam's limited capacity to supply water in the dry season, it is considered advantageous to replace the dam with a new one, located in a suitable section of the river a few hundred meters downstream.

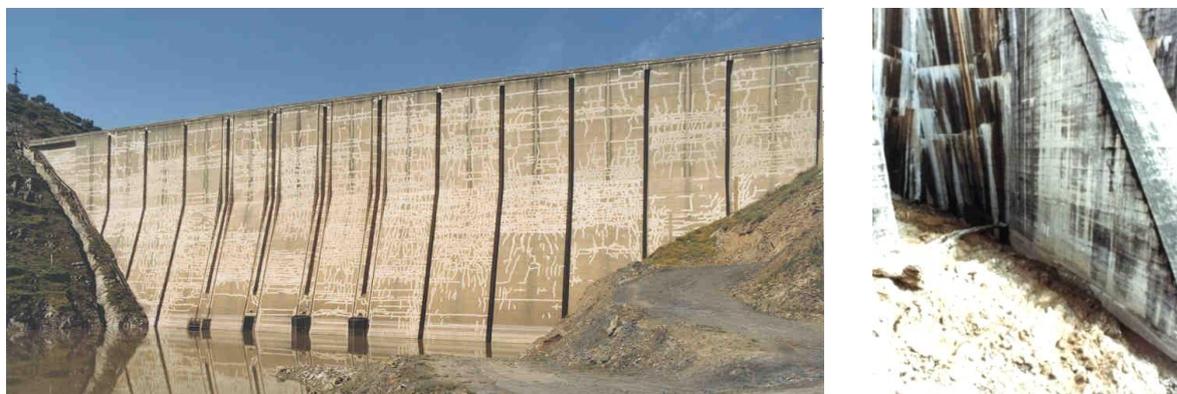
Figure 2.21: Pracana dam. Map cracking of the upstream face (on the left) and of the buttress webs (on the right) (photographs taken before the rehabilitation works)

The dam showed an abnormal behavior since it began operating, characterized by progressive displacements, in vertical and upstream-downstream directions, and rapid evolution of generalized cracking. There were significant water seepage through the dam body, essentially through horizontal cracks in concreting joints, with thick calcium carbonate deposits (Figure 2.21).

Physical and chemical tests, carried out in samples extracted from the dam's body, confirmed the existence of the ASR and the ISR, with expansions of high magnitude. Between 1980 and 1992 the reservoir was empty. The rehabilitation design was elaborated by EDP in 1985. Figure 2.22 shows some of the rehabilitation works carried out between 1988 and 1992 [33, 34, 35].

The interventions in the dam included: i) the general treatment of the concrete, for its regeneration, through the injection of cracks with epoxy resins and cement grout; ii) the installation of an impermeable membrane on the upstream face, including the construction of a foundation plinth at the upstream toe; iii) the construction of two concrete struts downstream, to lock the webs of the buttresses, one close to the downstream toe and the other in an intermediate position; iv) the consolidation of the foundation and the execution of new waterproofing and drainage curtains, the waterproofing curtain being done from the top of the new upstream plinth; and v) the recovery and reinforcement of the monitoring system. A frontal auxiliary spillway was also built on the left bank, to provide the dam with sufficient discharge capacity. The power plant was updated, which included the construction of the water intake for a new generation unit.
