Diagnosis and structural recuperation of foundation blocks under attack by AAR in a Brazilian building

Keywords: AAR; blocks; concrete; foundations; pathology

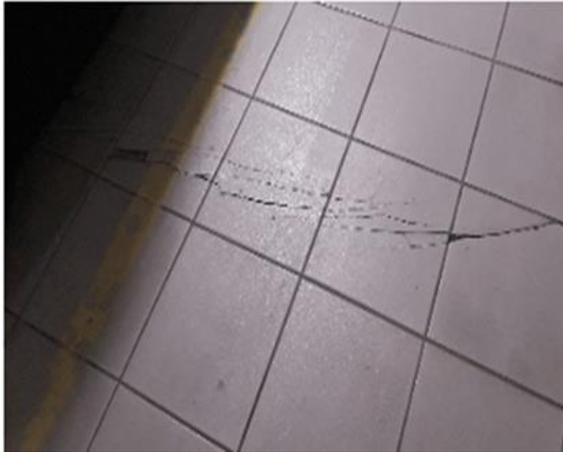
The pathology was discovered during a routine inspection contracted by the outsourced company that manages the building. The inspector became suspicious of cracks, as shown in Figure 3.1, found on the garage floor of the building's basement and requested an inspection to see what, in fact, was causing them.

Figure 3.1: Cracks on the floor

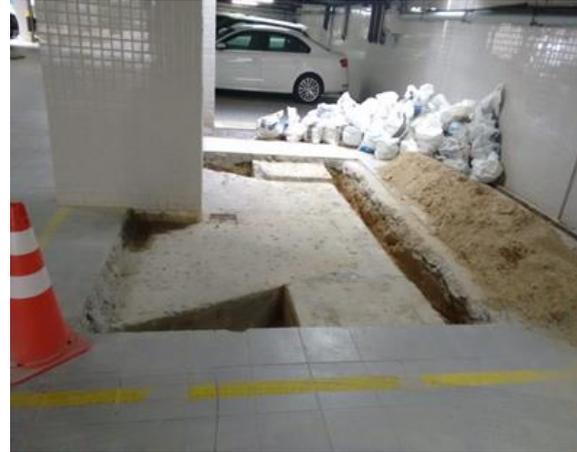
During this inspection, two foundation blocks were excavated in order to diagnose the pathology, as shown in Figure 3.2. Four samples were extracted (shown in Figures 3.3 and 3.4) and later sent off for laboratory tests to the ABCP - Brazilian Association of Portland Cement [5], in São Paulo, for diagnosis and verification of the reactive potential of the aggregates.

Figure 3.2: Partially exposed block

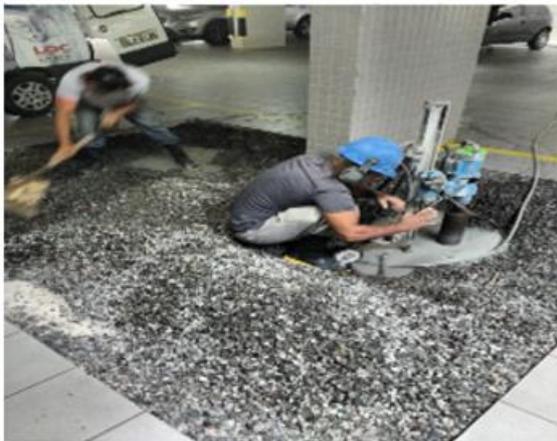
Figure 3.3: Sample extraction

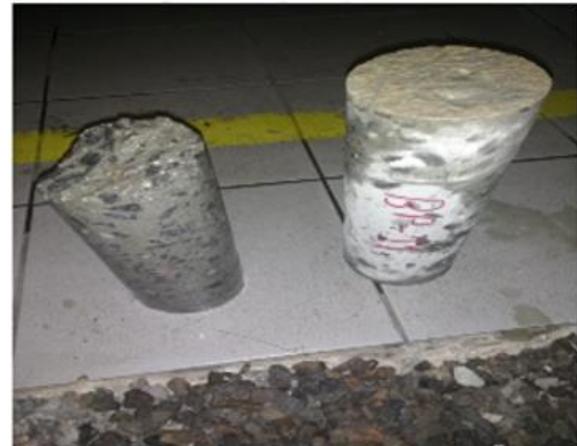
Figure 3.4: Samples

The results also indicate that the coarse aggregate has textural features that allow it to be characterized as potentially reactive to concrete alkalis. Also, according to the report, the concrete exhibits features typical of an alkali-aggregate reaction of the alkali-silica type. The aggregates exhibit well-defined reaction edges and it is possible to identify the reaction gel filling pores and voids in the mortar. The products of the reaction were characterized under an electron microscope, appearing mainly as leaf or lancet crystals deposited at the aggregate paste interface, and by the presence of expansive gel filling pores and voids [5].

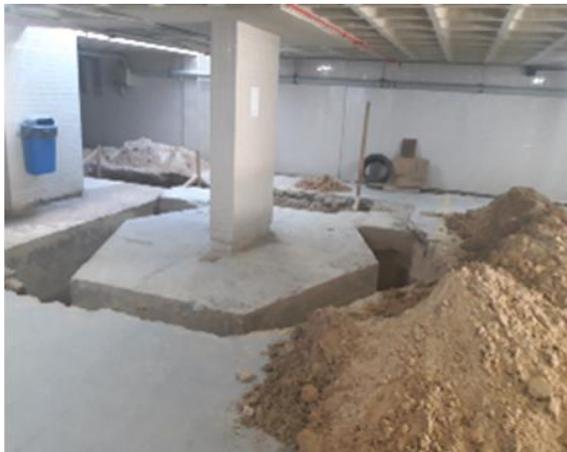
Figure 5.1: Exposed foundation block

After excavating the block (Figure 5.1), it was cleaned with a high-pressure washer in order to remove all types of residue from its surface, as shown in Figure 5.2, and to open its pores for better penetration of the structural adhesive and afterwards, better adhesion of the waterproofing.

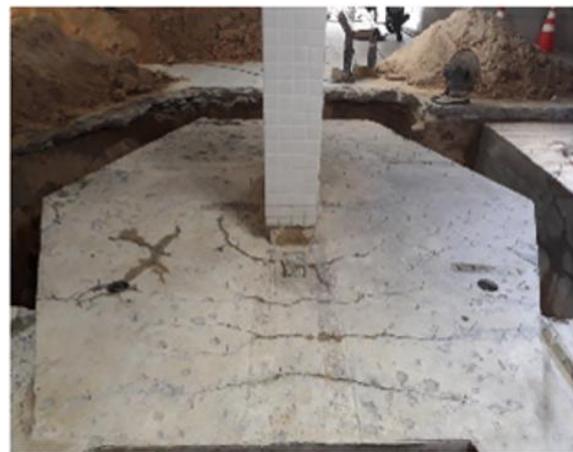
Figure 5.2: Block surface after cleaning

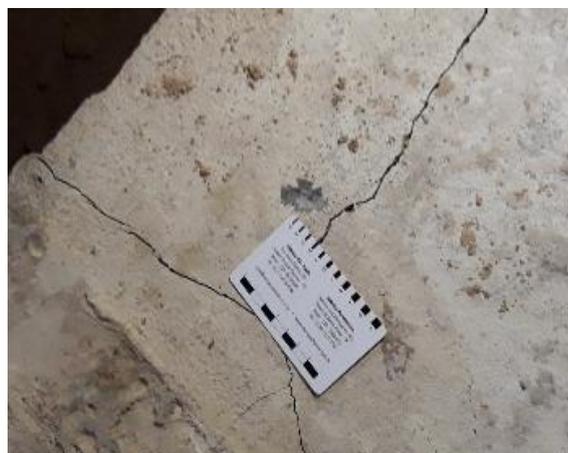
The width of the block's cracks was measured with the aid of a fissurometer and was on the order of 1.8 mm, as shown in Figure 5.3.

Figure 5.3: Crack measurements performed by fissurometer

was determined by the calculation engineer responsible for the structure. The solution recommended was to inject epoxy resin to seal the cracks, as this method would best suit the width of the cracks found in the block. The possibility of encapsulating the block was considered, as there was a possibility that the reinforcement had been exposed and lost part of its load capacity. The concrete could also have lost some strength due to the tensile forces it suffered when the block expanded.

The engineer measured the widths of the cracks on the face of each block and then divided the total width by the size of the block face. This calculation led to the conclusion that it would not be necessary to encapsulate any of the blocks because the cracks were quite narrow. It was recommended, however, that all blocks be waterproofed with a product having a greater ability to support expansion in order to ensure that any future cracks would not compromise the waterproofing of the block.

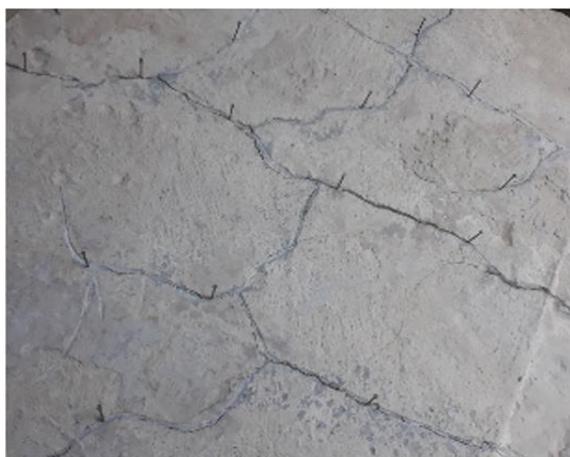
Figure 6.1: Open cracks

The width of the cracks was increased with the use of a sander to allow for greater adherence between the block and the materials used in the recuperation. Subsequently, nails were placed on the surface of the block to mark the cracks, as shown in Figure 6.1, and to allow the attachment of the adhesion nozzles shown in Figure 6.2.

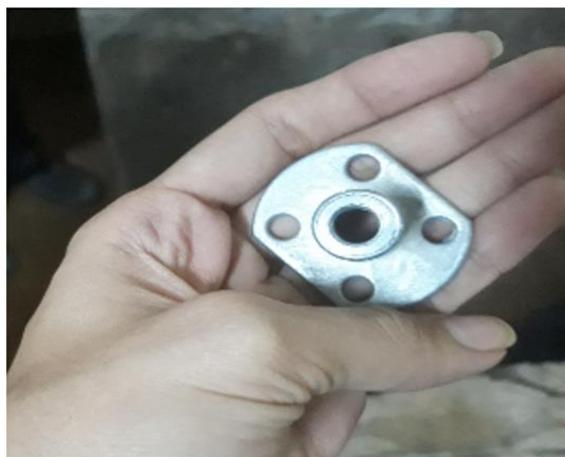
Figure 6.2: Adhesion nozzles

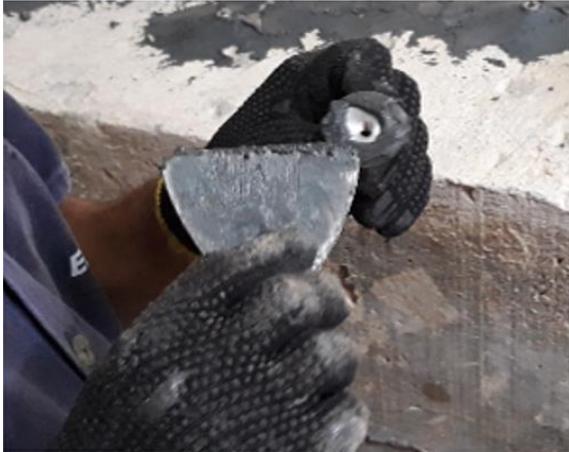
Figure 6.3: Nozzles with structural adhesive

Structural adhesive was used to fix the nozzles to the block, as shown in Figures 6.3 and 6.4. This procedure was performed on the top and sides of each block recuperated. The external cracks in the block were sealed with structural adhesive immediately after attaching the nozzles.

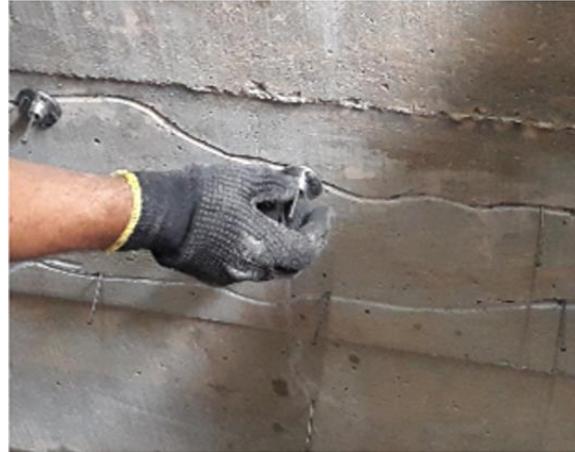
Figure 6.4: Attaching the adhesion nozzles

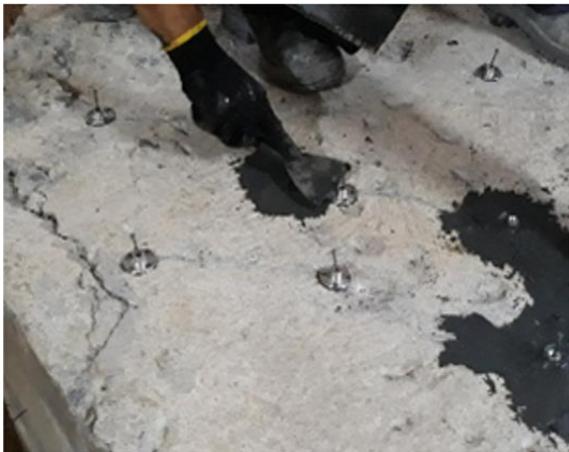
Figure 6.5: Application of structural adhesive to cracks

This adhesive (the same used to attach the adhesion nozzles) seals the cracks, preventing the escape of the filling material. The product is an epoxy-based adhesive with medium viscosity, has a compressive strength of 70 MPa after 7 days and an adhesion resistance to concrete ≥ 2.2 MPa. It is contained in two packages that were manually mixed and then applied to the block to seal the cracks using a spatula, as shown in Figure 6.5.

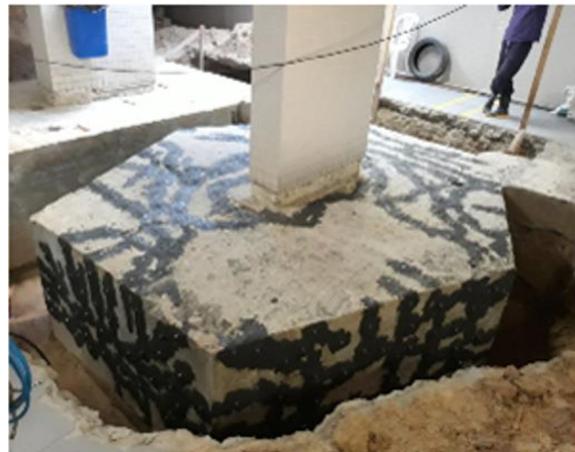
Figure 6.6: Block following crack sealing

After sealing all external cracks on the top and sides of the block with structural adhesive, as shown in Figure 6.6, epoxy resin was injected.

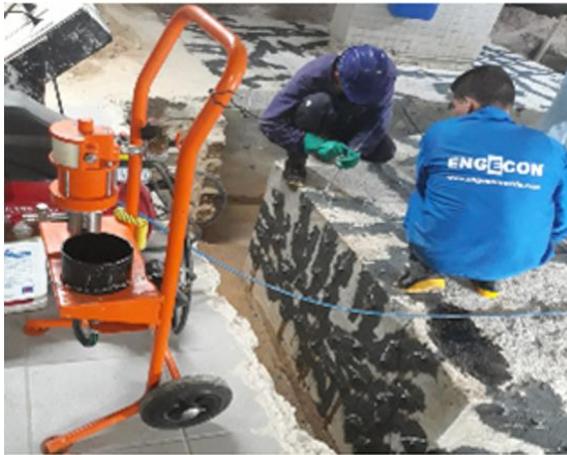
Figure 7.1: Use of Injection pump to apply epoxy resin

The epoxy resin was injected into the block with an injection pump. The resin penetrated the blocks through the nozzles, filling all internal cracks in the block, as shown in figures 7.1 and 7.2. Figure 7.3 shows the block with all cracks sealed.

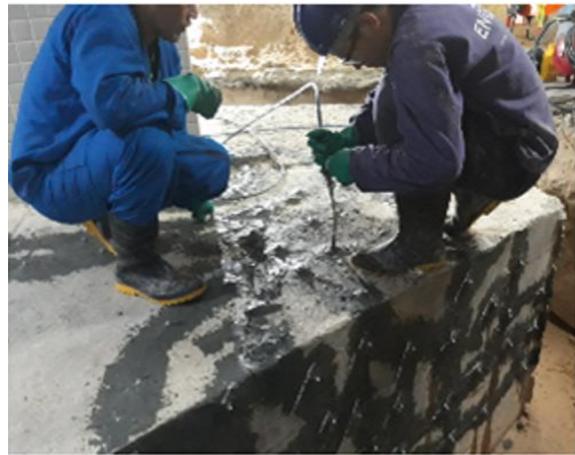
Figure 7.2: Injection of epoxy resin into the foundation block

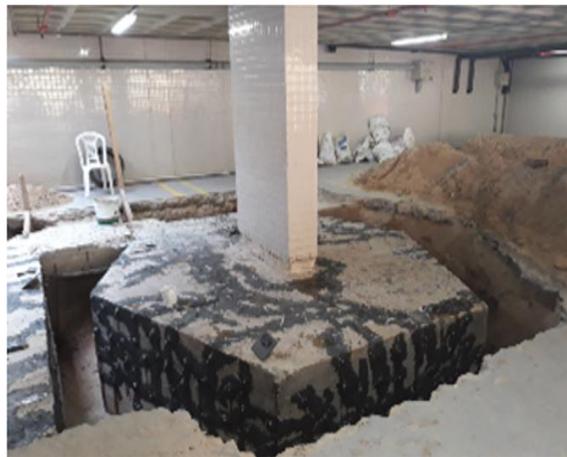
Figure 7.3: Foundation block with cracks filled with epoxy resin

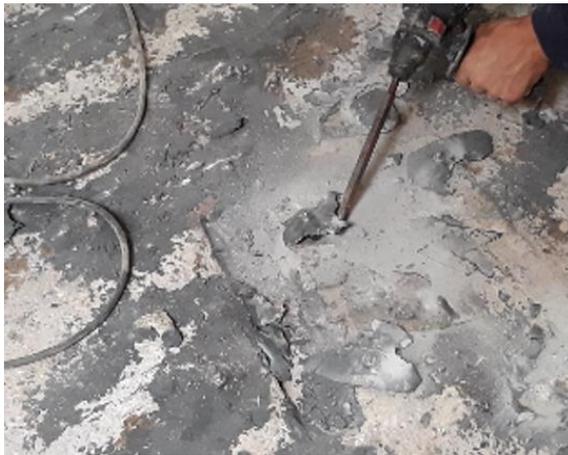
Figure 8.1: Removing the adhesion nozzles

Before applying the indicated waterproofing product, it was necessary to completely remove the adhesion nozzles (Figure 8.1), clean and regularize the surface of the block to ensure that there were no points that would perforate the waterproofing layer. The side surfaces were sanded (Figure 8.2) and then cleaned with a compressor to remove particles of dust and cement laitance from the block.

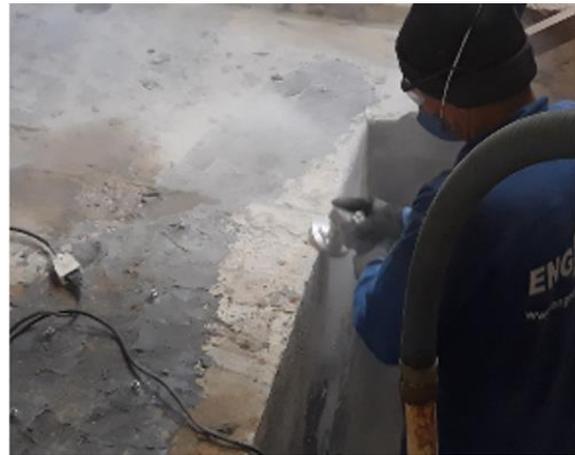
Figure 8.2: Regularization of block surfaces and corners using a sander

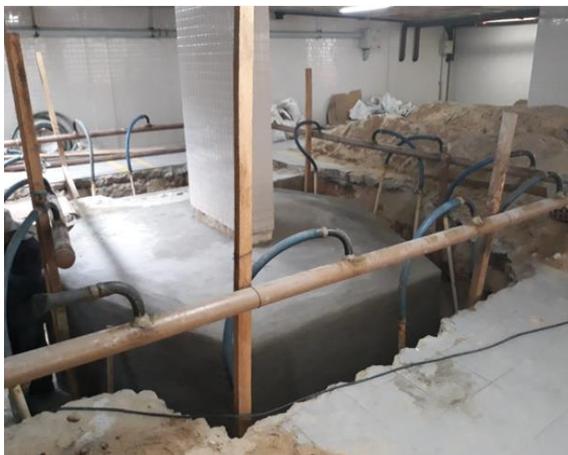
The level of the water table beneath the structure was high. Through the opening in the block, it could be seen that about 30 centimeters of the block were immersed in water and that it would therefore be necessary to lower the water table. A pump was used to ensure that the block remained dry until the end of the reinforcement process (see the drainage device in Figure 8.3). It is also possible to observe in this figure the clean and regularized surfaces, ready for waterproofing.

Figure 8.3: Groundwater lowering system

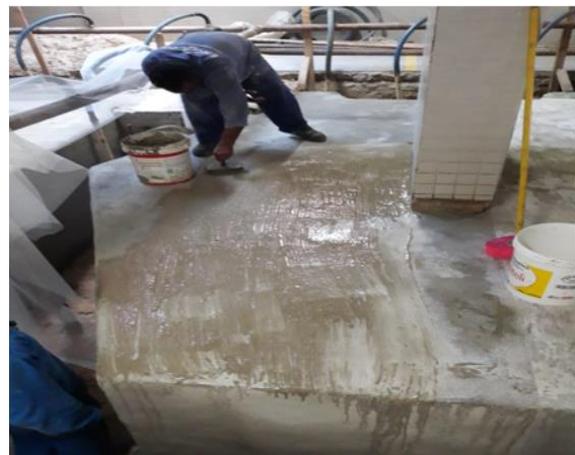
Figure 8.4: Application of waterproofing product

The waterproofing product must be applied to a clean surface with the aid of a compressor and spread with a brush. The waterproofing product (made of a liquid and a powder), must be mixed with a low-speed mechanical mixer until a homogeneous mortar is obtained. One layer of this product was applied evenly to ensure full coverage of the surface, as shown in Figure 8.4.

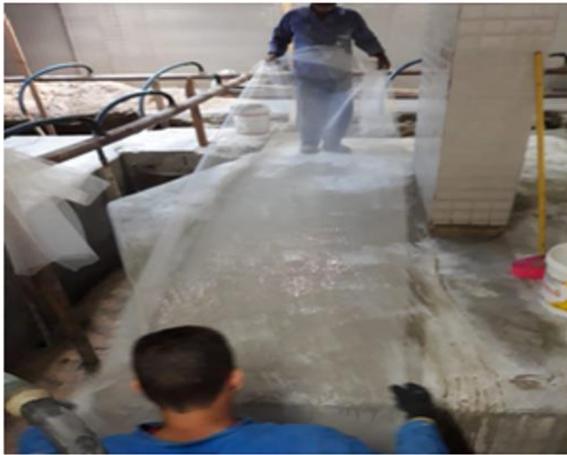
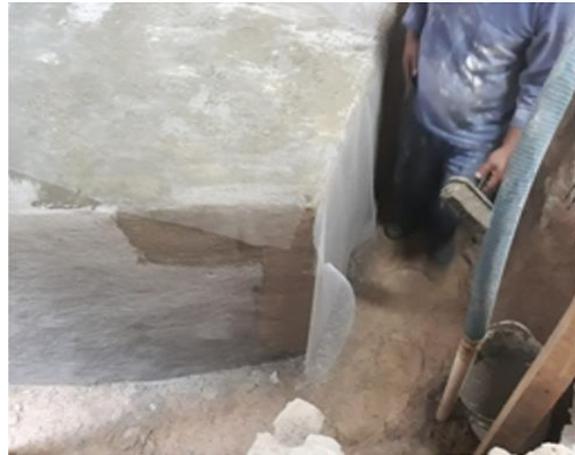
Figure 8.5: Screen being applied to the block

Figure 8.6: Screen being applied to the block corners

To maximize the efficiency of the waterproofing, a PVC-coated polyester canvas was also used. This screen was measured and cut to cover the required surface, especially the corners, and applied immediately after the first coat of the waterproofing product was applied (Figures 8.5 and 8.6).

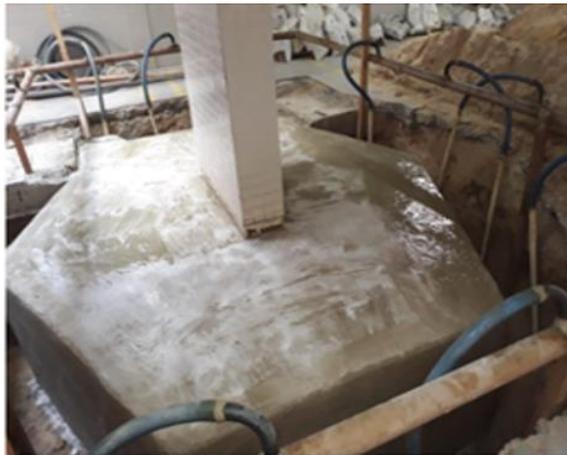
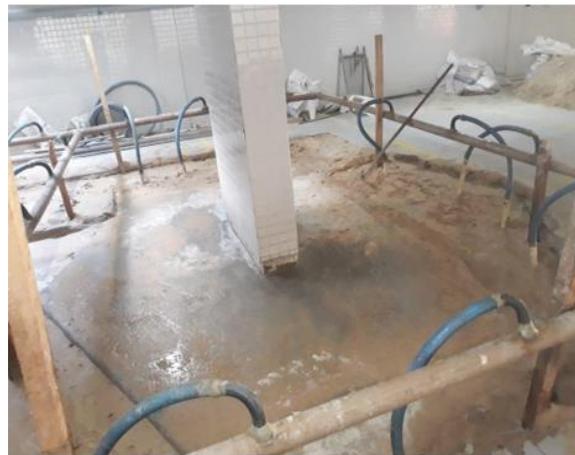
Figure 8.7: Block after waterproofing

Figure 8.8: Block finished and reburied

Subsequently, three more coats of the waterproofing product were applied, making a total of four. In Figure 8.7, the block was completed. The curing of the product was monitored for seven days and then the block was reburied (Figure 8.8).

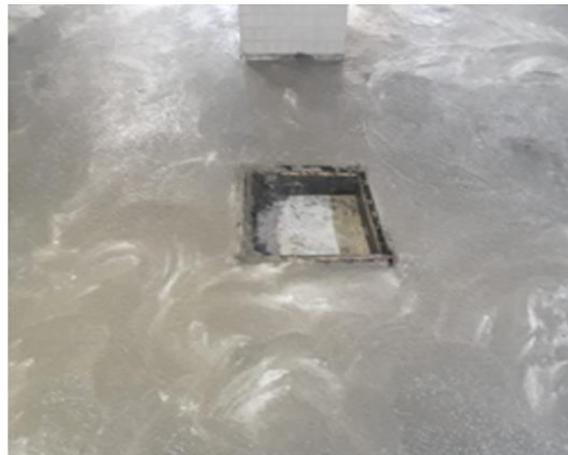
Figure 9.1: Construction of the floor and inspection window

The last step was the reconstruction of the floor and creation of the inspection window. This window is necessary because AAR is a pathology still lacking a definitive solution. Repair is palliative and it is still possible for the block to expand again. The size of the window was chosen (50 cm x 50 cm) and a wooden form was constructed so that the block would be completely exposed (the detail at the bottom of the form can be seen in Figure 9.1).

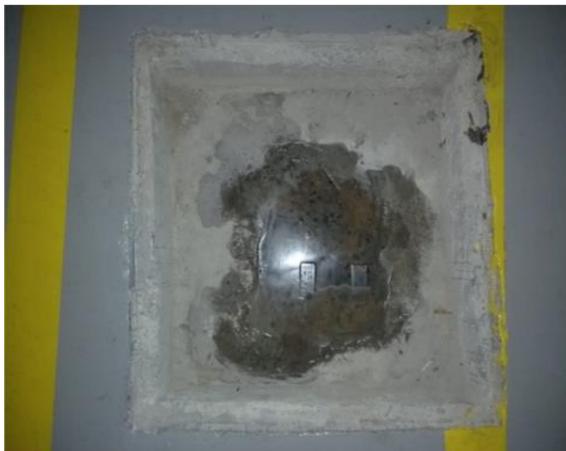
Figure 9.2: Inspection window

The inspection window was positioned to expose the largest crack in the block, shown in Figure 5.2. To do this, the bottom part of the formwork was sanded until the mortar was removed, making the crack visible (see details of the crack exposed in Figure 9.3). After removing the formwork and finishing the floor, a thin plate of glass was placed over the crack and waterproofed using epoxy resin (shown in Figure 9.2). If the block begins to expand again, the glass will crack, revealing this expansion.

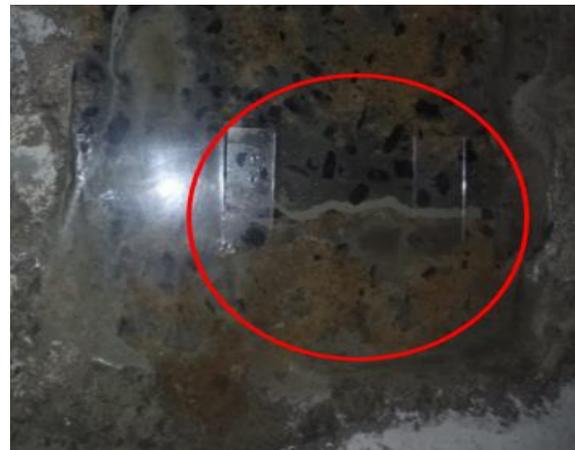
Figure 9.3: Detail of the sealed crack
