Structural behavior of Pracana dam 30 years after rehabilitation due to severe ISR-ASR damage

Keywords: Pracana dam; ISR-ASR damage; rehabilitation; monitoring; structural condition

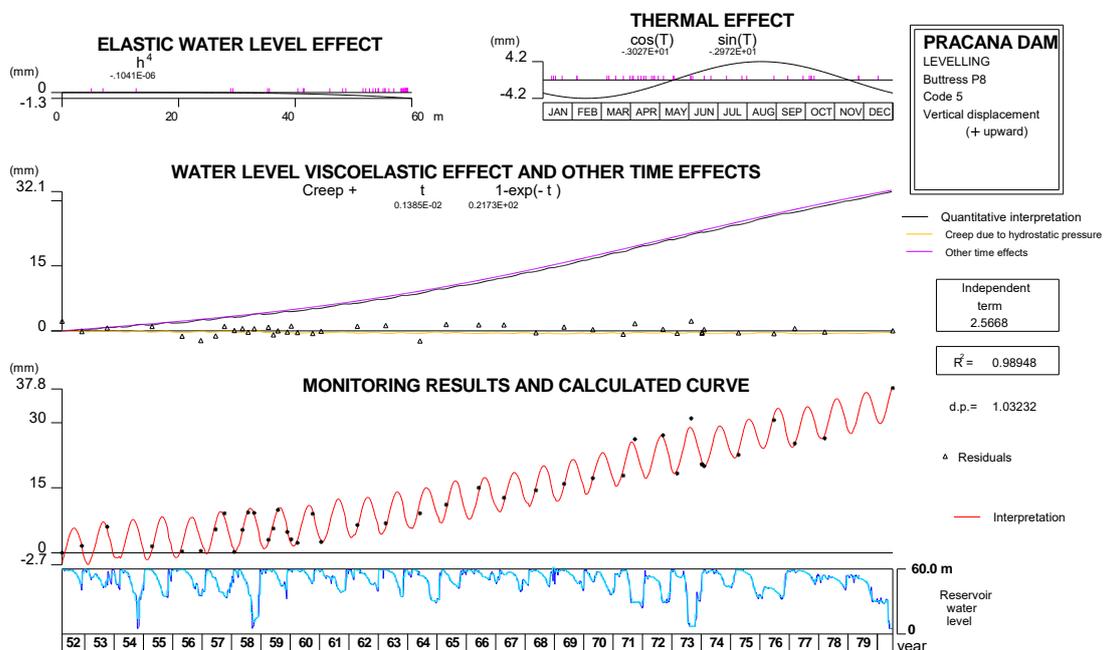
Figure 3.2: Results of statistical model application for vertical displacements measured on the top of P8 buttress since 1952 to 1980

During this period the monitoring system was based mainly on geodetic methods. The results of the monitoring campaigns allowed the detection of irreversible upward displacements and, also, downstream horizontal displacements, on the blocks B0 and B14 and on buttresses P2, P4, P6, P8, P10, P11 and P12. Just before the decision of stopping the operation and emptying the reservoir was taken, the quantitative interpretation results showed that the crest irreversible components of vertical and horizontal displacements, related to the time effect, were, very high, with average rates of 1.0 mm/year and 1.2 mm/year, respectively. Figure 3.2 shows the results of the statistical model application for vertical displacements measured on P8 buttress, since 1952 to 1980. A value of about 32 mm was computed to the irreversible vertical displacement due to the swelling process.

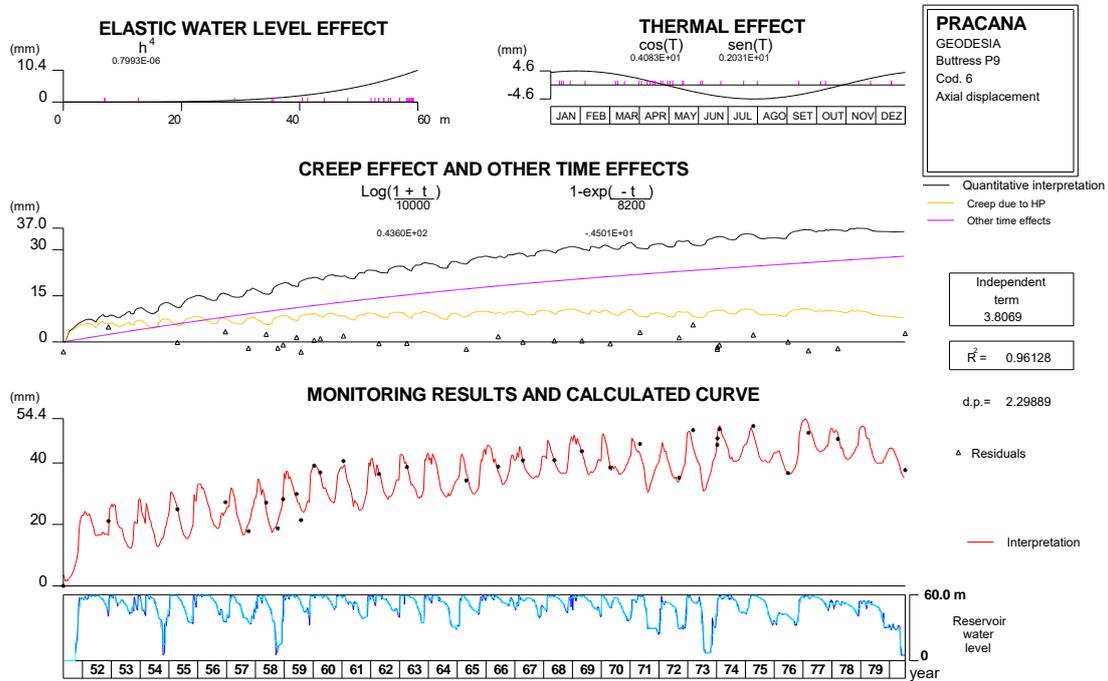
Figure 3.3: Results of statistical model application for horizontal (U-D) displacements measured on the top of P9 buttress since 1952 to 1980

In Figure 3.3 the results of statistical model application for horizontal upstream-downstream (U-D) displacements measured on the top of P9 buttress, since 1952 to 1980, are presented. Large irreversible displacements were computed in the downstream direction due to creep and swelling.

The magnitude of the computed vertical and horizontal displacements due to the swelling effects are compatible with the cracking patterns observed at that time.

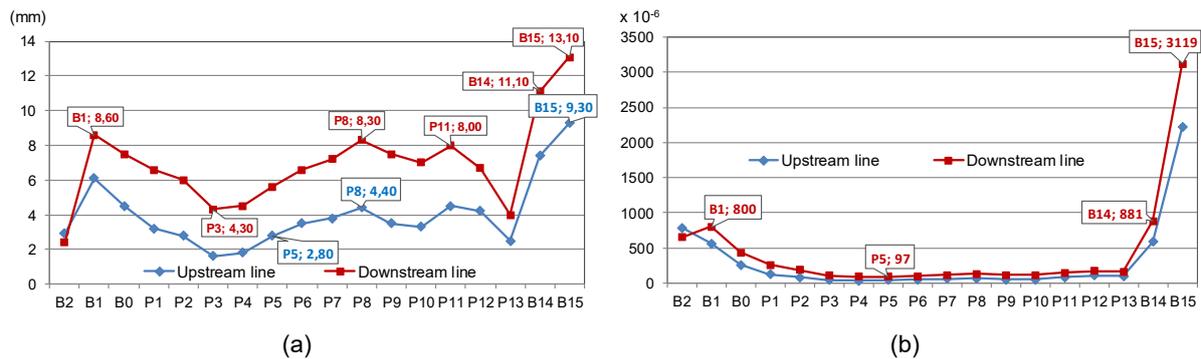
Figure 3.5: (a) Irreversible vertical displacements on levelling marks at crest and (b) accumulated vertical strains on the buttresses and side blocks.

The statistical analysis of vertical displacements for all points of the upstream and downstream precise levelling lines located at crest, which data was acquired in the 33 campaigns performed between December 1992 and January 2019, shows components due to water level variations and temperature changes compatible with these actions and reveals irreversible displacements upwards. These irreversible displacements are higher on the downstream line, with values, in the central zone of the dam, between buttresses P2 and P11, ranging from 4 mm and 8 mm and on the upstream line displacements ranging from 2 mm and 5 mm. It can also be seen that in the side blocks B1 and B0 on the right bank and B14 and B15 on the left bank the displacements are very significant. The corresponding calculated irreversible displacements correspond to vertical strain, accumulated during 27 years, that are small in the central zone of the dam, with average values below 100×10^{-6} and high deformations in the side blocks, mainly on the two blocks close to the left bank, as can be seen in Figure 3.5.

Block B15, on the left bank, is the one with the greatest irreversible deformations (it was not monitored in the first period of the dam's life).

However, vertical accumulated strain of block B15 during the second period was 2670×10^{-6} , with an annual swelling rate of $100 \times 10^{-6}/\text{year}$. This value is about 25 times higher than the expansions in the central zone, which require further investigation and, if necessary, a medium-term intervention.

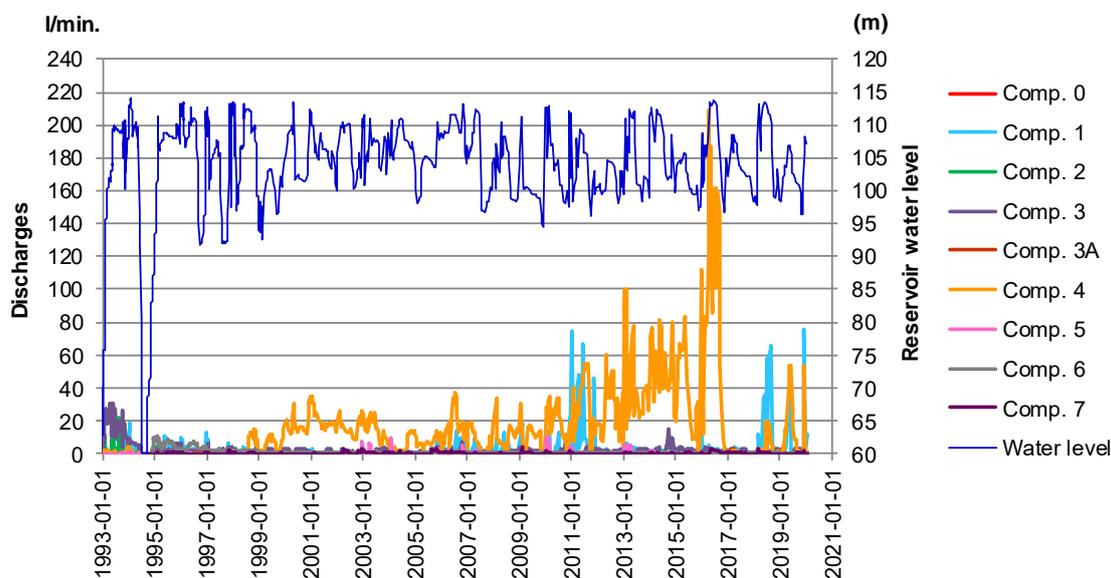
Figure 3.7: Discharges evolution in the different geomembrane compartments

Figure 3.7 shows the discharges evolution in the different geomembrane drainage compartments. As can be seen, in the compartments 1 and 4, where several membrane ruptures have occurred, the discharges were higher. In compartment 1, where the most significant ruptures occurred in 2011, 2018

and very recently (December 2019), the discharges have reached maximum values of about 75 l/min. The discharges from compartment 4 had a first increase between 2000 and 2003, with maximum values of about 65 l/min, but since 2011 to 2016 the increase was higher, reaching a maximum value of 209 l/min in April 2016. In November 2016 there was a geomembrane repair intervention that drastically reduced those discharges. However, in 2019 new rips appear to have occurred.

It should be noted that the measured values of the water level in the compartments have been systematically zero, which indicates there is no accumulated water between the geomembrane and the upstream surface of the dam, and that the compartment drains have an appropriate discharge capacity. Nevertheless, preventive actions must be taken to remove the solid material that floats in the reservoir, particularly in flooding periods, to avoid its impact on the geomembrane, which has been the cause of the rips that have occurred.

Mitigation of the swelling process proportionate by the rehabilitation works is undoubtedly a positive result to which the geomembrane installation on the upstream surface has given an important contribution. However, the long period with the reservoir emptied and the dam weather conditions, relatively warm and dry, may have also contributed to reduce the speed of the swelling process. In view of the results obtained, it is considered that the geomembrane continues to exhibit a good performance and functionality, preventing the upstream water access to the dam body. After 28 years of natural exposure, the evaluation of its physical condition must be checked frequently, which is done by carrying out visual inspections, in order to detect rips usually caused by floating woody material, especially after the occurrence of important floods. These rips are usually repaired in the following dry season.
