Prevention of ASR by use of low alkali OPC and silica fume. Field and lab studies from the Maridal culvert and the Storo bridge in Oslo, incl. assessment of residual expansion

Bård M. Pedersen ⁽¹⁾, Eva Rodum ⁽²⁾, Marit Haugen ⁽³⁾, Jan Lindgård⁽⁴⁾

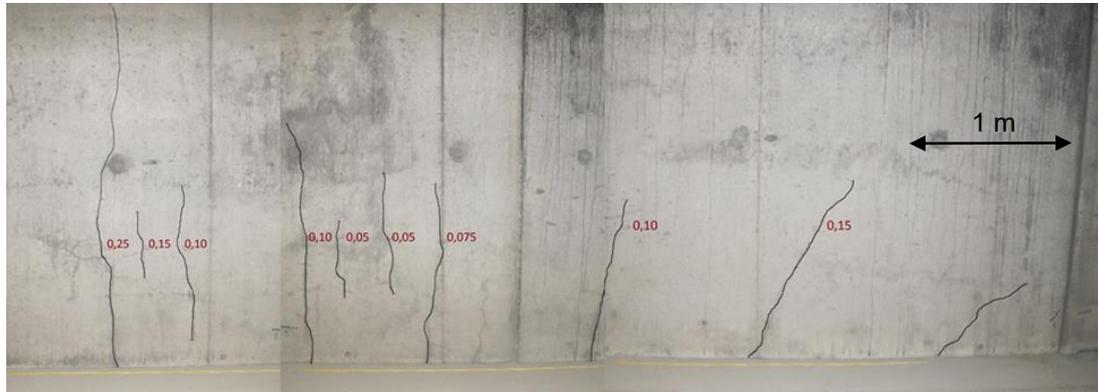
In June 2017, the Maridal culvert was visited and surveyed, and six cores were drilled from four different sections of the culvert. Typical crack patterns caused by early age hydration heat effects in a wall-on-slab structure are shown in Figures 3.1 and 3.2. Vertical cracks in the wall are caused by external restraint from the slab during the cooling phase of the wall. Cracks with crazing pattern (Figure 3.2) are caused by temperature gradients over the cross section of the (warm) wall shortly after demolding. Drying shrinkage may also produce (or further develop) the crazing, as can ASR if present. The crack

widths varied from very fine cracks 0.03 mm up to 0.45 mm. These examples are typical for the initial state of cracking of a new structure, just a week or two after casting. The origin is cement hydration and subsequent heat generation.

Figure 3.1: Visual assessment of wall in the Maridal culvert, right half of section 42. Main cracks intensified on the photo, crack widths (in mm) are drawn on the photo [11].

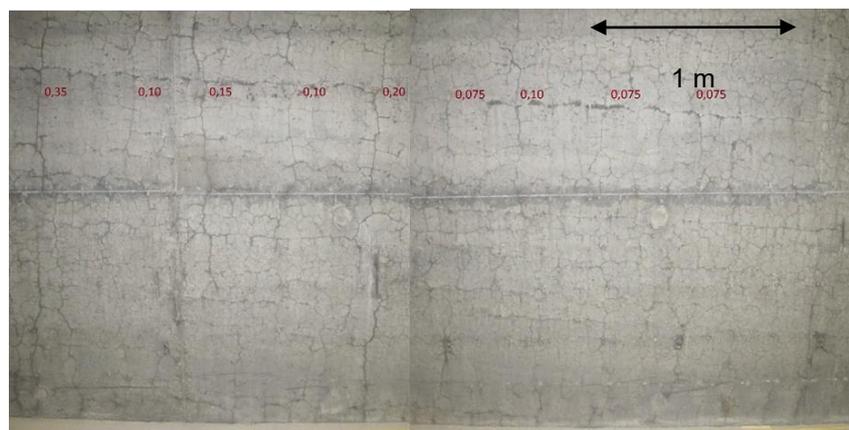
Figure 3.2: Visual assessment of wall in the Maridal culvert, part of section 38. Crack widths (in mm) are drawn on the photo [11].

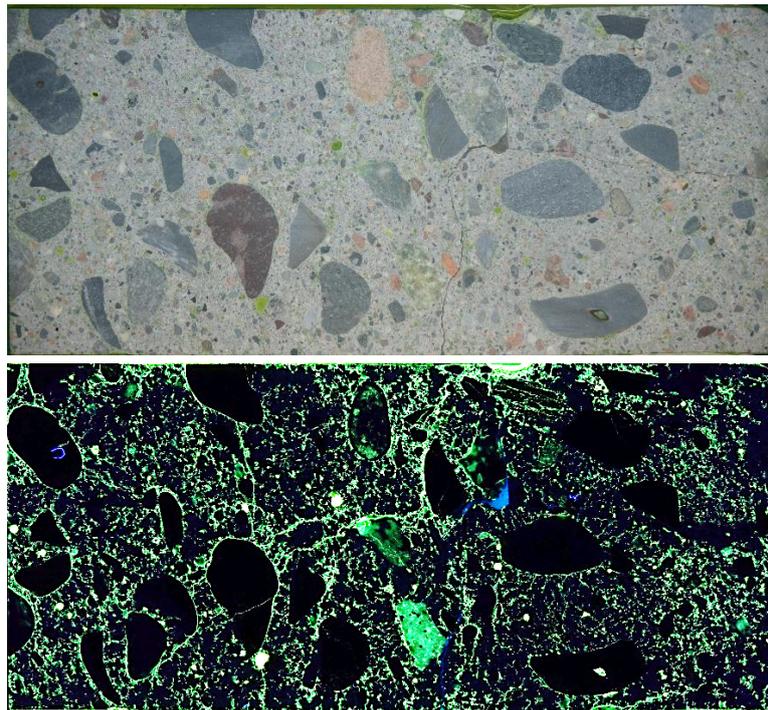
- Plane polished section (Figure 3.3): Some cracks in the cement paste, a few cracks in aggregates and very few cracks running from aggregates into the cement paste. No appreciable signs of ASR.
- Thin section (Figure 3.4): Some micro-cracking, no coarse cracks. Some ettringite and a few particles of undispersed silica fume were observed. No signs of ASR.

FIGURE 3:3: Plane polished section from wall section 42, in ordinary and UV-light. The length of the section is 200 mm, surface to the right. *Comment: The core was drilled through a crack starting at the surface (crack width 0.25 mm), then turning parallel to the surface in a depth of about 80 mm. Due to this cracking, the outer part of the core was broken during the drilling process. The core was thus glued before preparing the polished section, with a non-fluorescence epoxy. These cracks can therefore only be observed in the upper picture (but not in the lower picture).* [10].

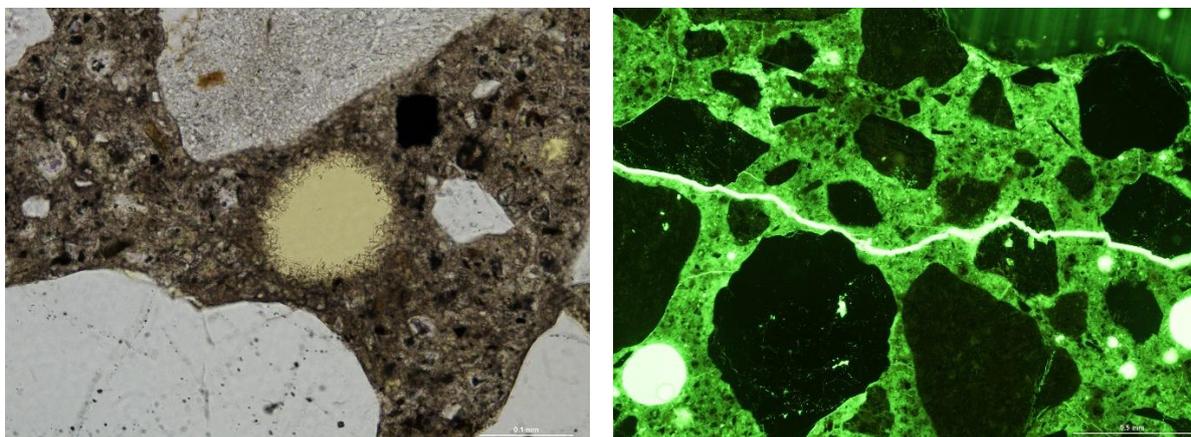
Figure 3:4: Thin section details. No signs of ASR were observed. Left: Ettringite in a small air void. Right: Crack in the cement paste. [10].

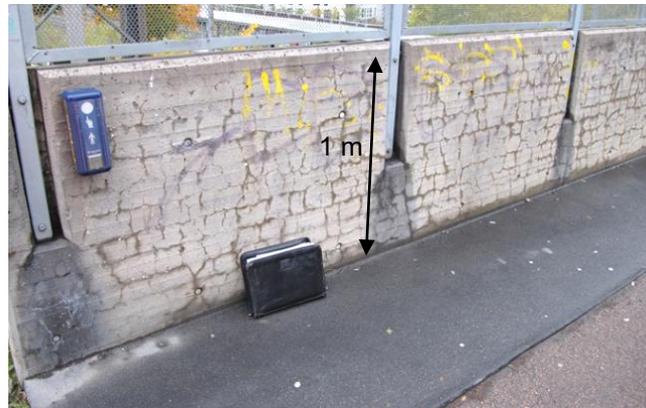
Parts of the Storo bridge in Oslo was built in 1994, including the railing structure. Due to suspected progressing ASR, this structure was visually examined in October 2016, and three cores were drilled. As can be seen in Figure 3.5 the surface cracking of the railing appears as crazing or map cracking. The crack widths varied between 0.03 and 0.15 mm. The cracking indexes, defined as “summarized crack widths along a line divided by the length” [4], varied between 0.041 and 0.062 % for the different fields of the bridge railing. The calculated indexes were evaluated to be of low degradation grade

according to a classification system developed within a Norwegian research project [12]. No significant differences between horizontal versus vertical lines were found.

Figure 3.5: Visual assessment of the railing of Storo bridge, phase to the north [4].

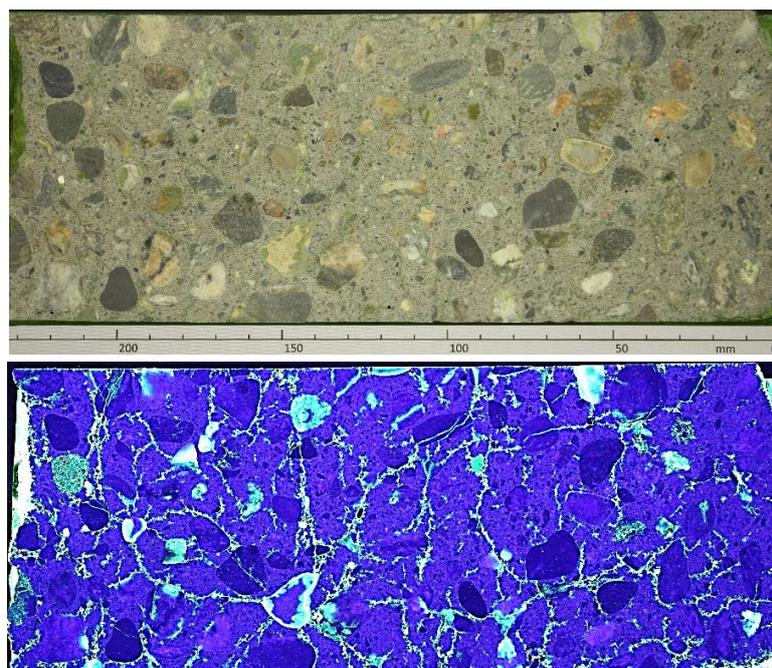
- Plane polished section (Figure 3.6): Cracks in some aggregate particles, some cracks running from the aggregate into the cement paste. A white precipitation product found in some air pores.
- Thin section (Figure 3.7): Many micro-cracks and fine cracks. Alkali-silica gel observed in several air pores and in cracks, both in the aggregate particles and in the cement paste. ASR has led to internal cracking of the concrete.

Figure 3.6: Plane polished section from Storo bridge, in ordinary and UV-light. The length of the section is 230 mm, surface to the right [10].

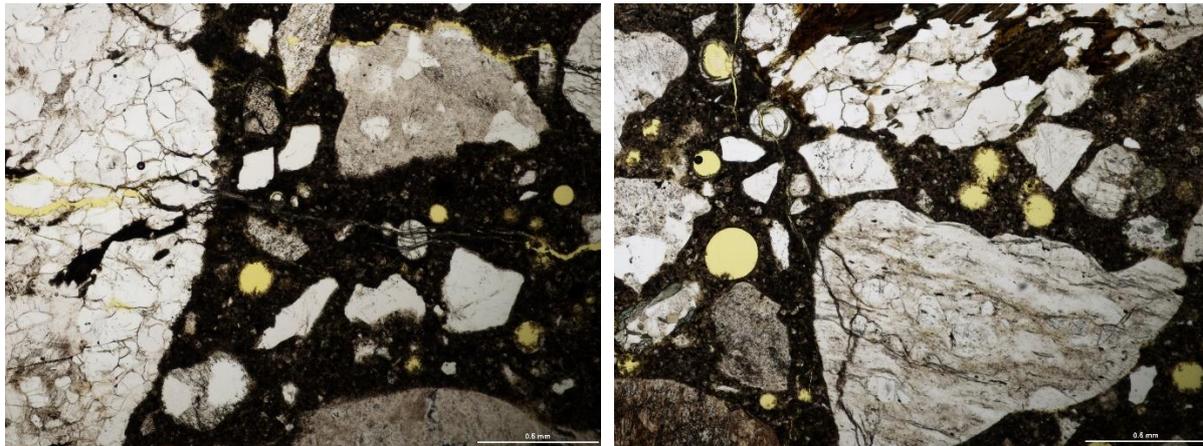
Figure 3.7: Thin section details. Left: Alkali-silica-gel in a crack running from a quartz-rich rock. Air void in crack filled with alkali-silica gel. Right: Alkali-silica gel in a crack running from a mylonite rock. Air void in crack filled with alkali-silica gel [10].

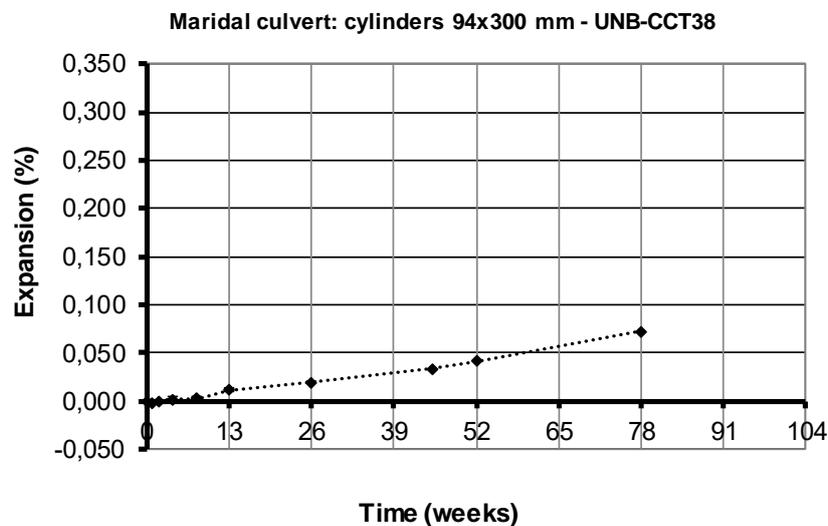
Expansion results up to 78 weeks of exposure are shown in Figure 4.1. As can be seen in the Figure, the specimens are expanding slowly at 38°C.

Figure 4.1: Residual expansion testing by the Canadian UNB-CCT test method. Mean values of three samples [12].

So, what can we learn from this plot? Should we expect that the concrete would react and expand in the long run or not? When exposed to 38°C and 100% RH there is obviously some potential for reaction. The expansion level at 52 weeks is above the border of the 0.030 % limit given by the Norwegian regulations when running performance testing by use of the concrete prism test method [8]. However, the residual expansion test method is “more aggressive” than the CPT-method since there is no leaching of alkalis (or more likely a slight ingress of alkalis from the solution surrounding the sample). The results shown in Figure 4.1 have been compared with residual expansion results from another bridge with a more reactive concrete composition, see Section 4.2.

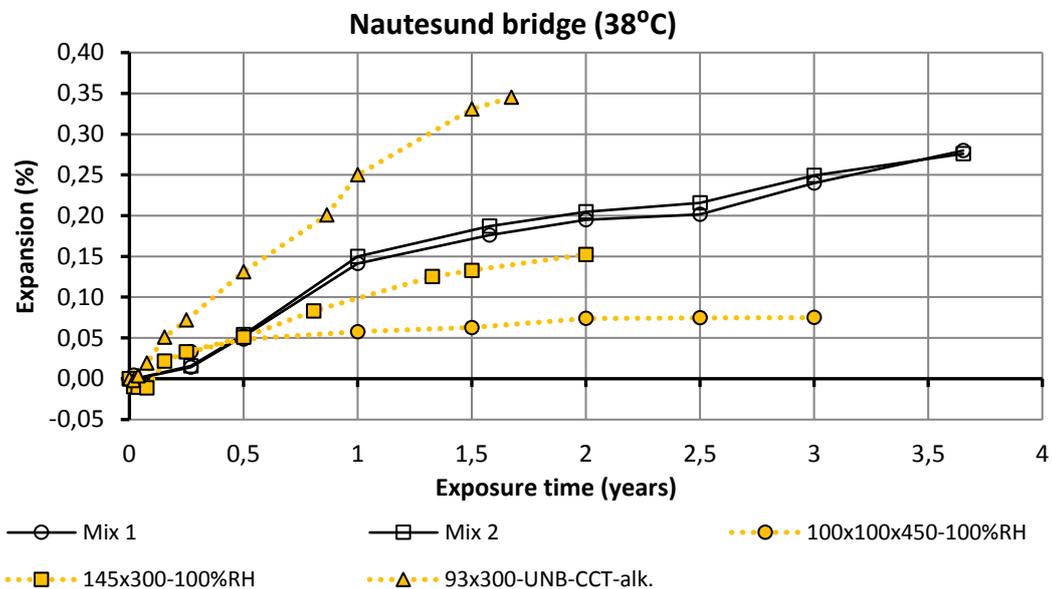
Figure 4.2: Test results from the Nautesund bridge, all samples exposed to 38 °C. Black lines show results from accelerated testing of freshly cast reconstructed concretes, yellow dotted lines show results from residual expansion testing [12].

As seen from Figure 4.2, the accelerated residual expansion of the Canadian “UNB-CCT” cylinders (labelled "93x300-UNB-CCT-alk.") is 0.25 % at 1 year and still increasing. Accelerated residual expansion of sawn 100 mm prisms (labelled "100x100x450-100%RH") and ø145 mm drilled cylinders (labelled "145x300-100%RH"), tested according to the Norwegian CPT-method, show significantly lower expansion levels at all ages. The sawn prisms (with highest area/volume-ratio) is levelling off after six months of exposure at a relatively low expansion level, most likely due to lack of alkalis caused by leaching combined with further consumption of alkalis by the ASR-gel developed during the testing. The expansion potential for the freshly cast reconstructed concrete (100 mm prisms labelled “Mix 1” and “Mix2”) is significantly higher than the residual expansion of sawn prisms of original concrete (of same prism size), but much lower than the results of the “UNB-CCT” residual method with possibility of external alkali supply. The ø145 mm drilled cylinders are still expanding after two years of exposure but are tending to level off after 1-1.5 years of exposure.

It is interesting to note that the freshly cast reconstructed concretes and the two residual expansion test series, all exposed to 100 % RH, obtain equal expansion (0.05 %) after six months of exposure. After this point in time, the access to alkalis in the concrete pore water is controlling the further ASR expansion. Since the field concrete already (during 50 years of service) had developed ASR at the time of drilling, the "starting" alkali level in the pore water is lower (due to consumption of alkalis by the ASR-gel) compared with the freshly cast concrete. This is assumed to be the main cause for the earlier levelling off for the field concrete samples.
