## Reinforcement and replacement interventions in some bridges located on Aguieira dam road network

Tiago Rodrigues <sup>(1)</sup>, Ana Rita Pereira <sup>(2)</sup>, André Martinez Costa <sup>(3)</sup>

### Abstract

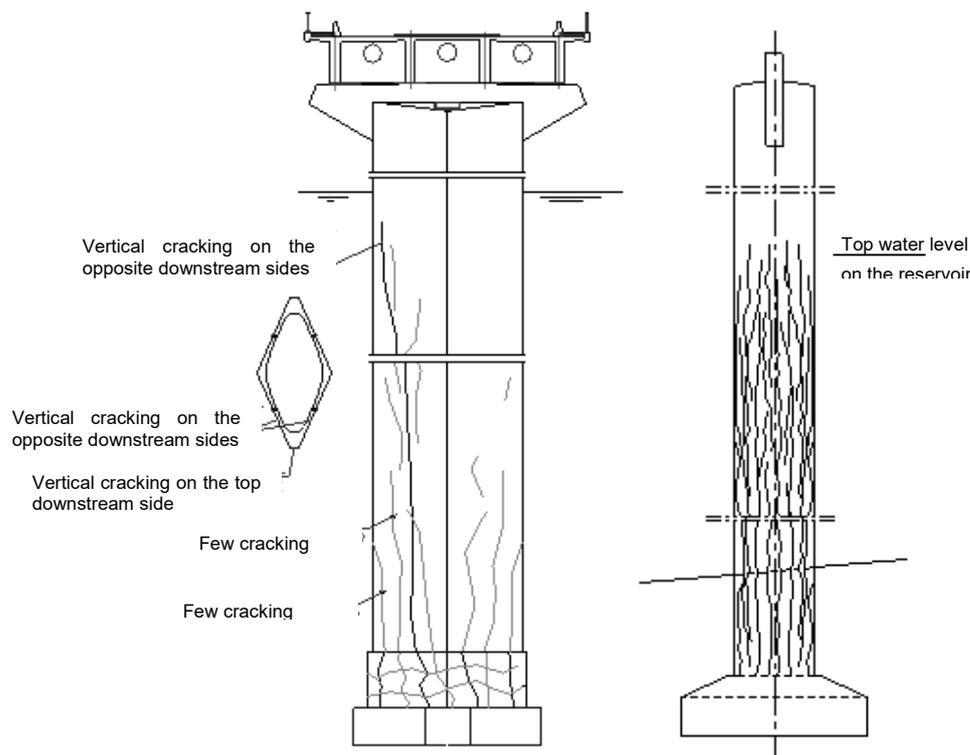
- Several cracks in piers foundation, particularly at the basement level, with random orientation, typical of swelling reactions;
- Vertical cracking, mainly in the pier/basement connection, over all the piers perimeter, with uniform spacing;
- Vertical cracking in the piers shaft, with some spot zones with steel corrosion and deficient concrete joints;

Figure 3.1: Cracking observed on Foz Dão Bridge piers [1]

The results of the studies developed by LNEC on these bridges have concluded the presence of internal swelling reactions, namely alkali-silica reaction (ASR) and internal sulphate reaction (DEF). These reactions were manifested through the cracking and deterioration of the superficial layer of the concrete, with more expression in the structural elements in contact with permanent water or water-flow.

The cracking that occurred in some sections of the pier shafts immersed on the reservoir, was predominantly oriented along the vertical direction. This situation was related to the confinement effect in this direction provided by the axial compression to which they are subjected. The development of cracking was in all submerged pier height, sometimes increasing their expression in depth.

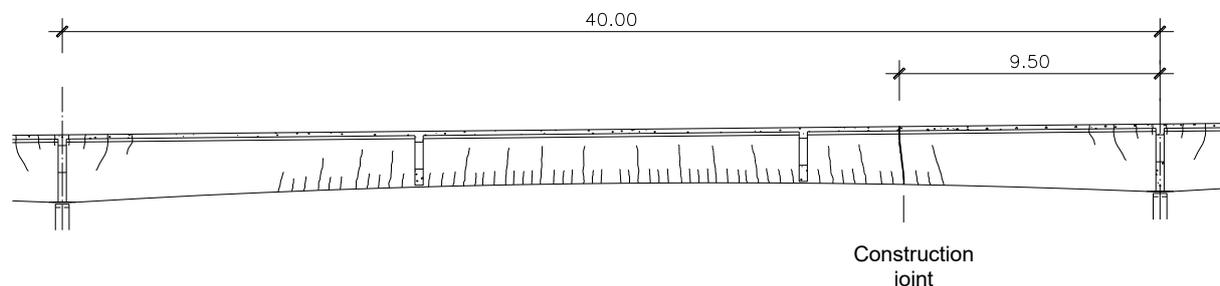
- Excessive deflection of the deck, easily observable, with values greater than 5 cm;
- Areas with concrete poorly vibrated or with poor connection between different age concrete at construction joints, with honeycombs;
- Vertical cracks on the longitudinal girders, associated with bending, resulting from the reduced compression introduced by the applied prestress;

Figure 4.1: Cracks distribution on the girders [1]

Considering the poor performance of the existing prestress, the deck was reinforced through external prestressing in the four longitudinal girders of the deck. This measure improved the service behaviour of these elements, resulting in an important increase in their performance.

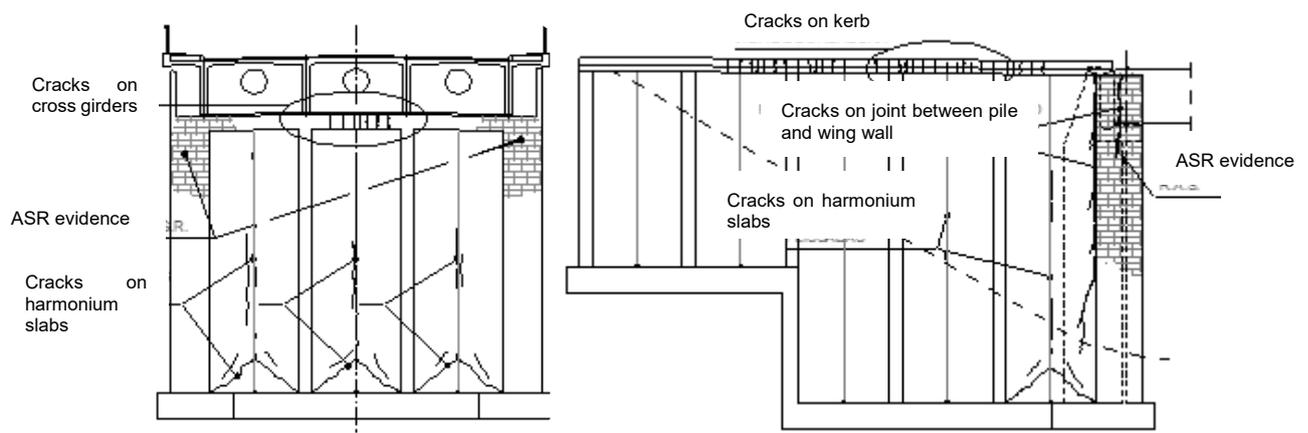
- Some transversal cracks on the deck slabs, next to the transversal girders located above the piers;
- Concrete degradation, such as delamination and rebar corrosion, associated to carbonatation effects;
- Crushed or damaged lead bearings;
- Cracks on the transversal girders located above the piers, next to the external longitudinal girders;
- Cracks on the abutments, due to the swelling reactions, and structural defects.

Figure 4.2: Anomalies detected on the front walls and wing walls of abutments [1]

- Abutments reinforcement, through the placing of a slab on the wing walls and counterforts of the existing wing walls and on an alignment of piles built along the road axis;
- Removal of the abutments interior fill until the ground level, in order to reduce the soil pressure;
- Reinforcement of the abutment bearing beams, piers and abutments transversal girders, through jacketing with new elements of reinforced concrete and prestressing application;
- Piers cap beam reinforcement through the adoption of prestressing and jacketing, in order to allow the load transfer from the bearings to the piers;
- Concrete rehabilitation and cracks injection, including coating;
- Expansion joints replacement;
- Structural bearings replacement;
- Drainage systems repair and relocation.

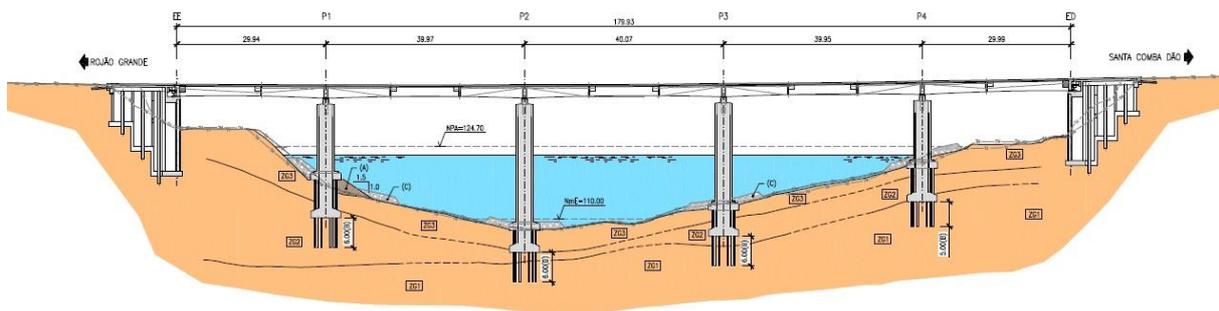
Figure 4.3: Intervention solution in the foundations of Santa Comba Dão Bridge [3]

The rehabilitation solution designed for these bridges consisted on the execution of a single shaft, on each pier, keeping the existing cap beam. The shaft cross-section geometry is a ring, which involves the existing one, founded with micro piles. The new shaft walls have a thickness of 0,30 m and an outer diameter of 3,40 m, ensuring a clearance of 0,10 m throughout the perimeter of the existing piers, in order to allow its expansion without restrictions, due to the swelling reactions that will continue to take place.

The foundation consists in a set of twelve micro piles with high load capacity, headed by a circle pile cap with an outer diameter of 6,20 m, built, as the shaft, around the existing pier. The micro piles were built from the surface, intersecting the existing footings. At the top (cap beam), the new shaft is connected to the existing one through bolts, throughout the perimeter of the shaft and at a height of about 2,0 m.

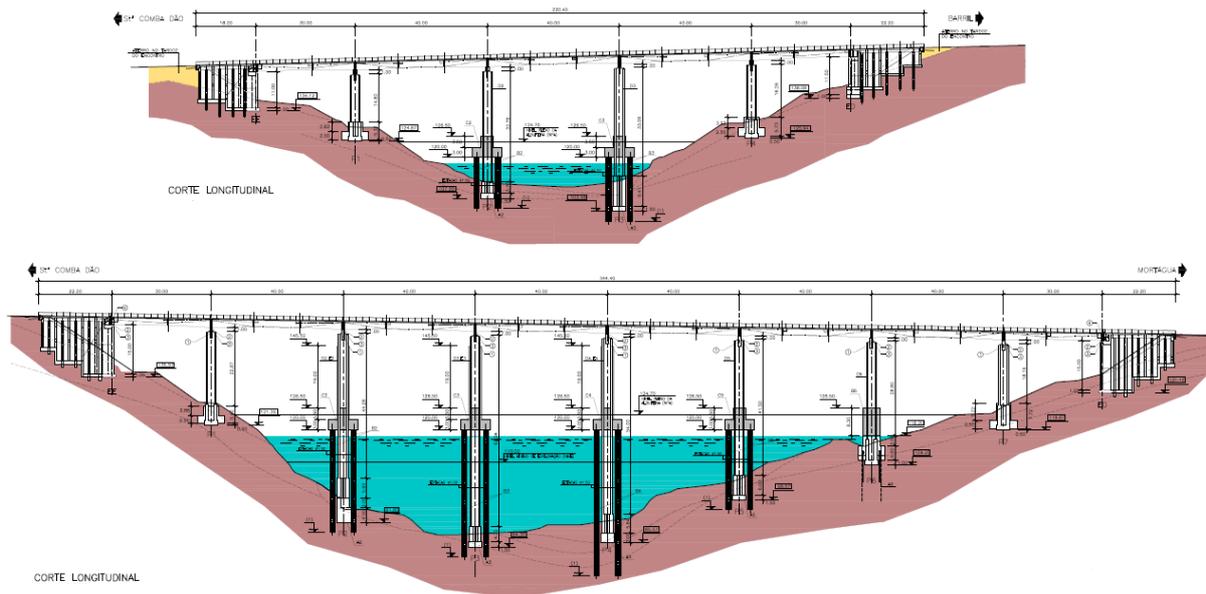
Figure 4.4: Intervention solution in the foundations of Criz I and Criz II Bridges [4]

The structural solution designed for these bridges consisted of the deactivation of existing foundations and shaft pier sections that are immersed in the reservoir, through the execution of a set of several piles with  $\phi 1,50$  m, headed by a prestressed pile cap in reinforced concrete, transferring the load from the shafts to the new foundation.

The main difficulty of these solutions was related to the execution of the piles and their caps with the use of aquatic and underwater resources, in order to ensure the perfect embedding on the bed rock. To minimize the identified difficulties, during the construction phase a system to guide and fix pile tubes was performed near the bottom, around the shaft and pier basement which also served as pier base confinement.

Additionally, in P2, P3 and P4 piers of the Criz II Bridge, it was designed the strengthening of the shaft through jacketing with reinforced concrete, above the top of the pile cap. This reinforcement was

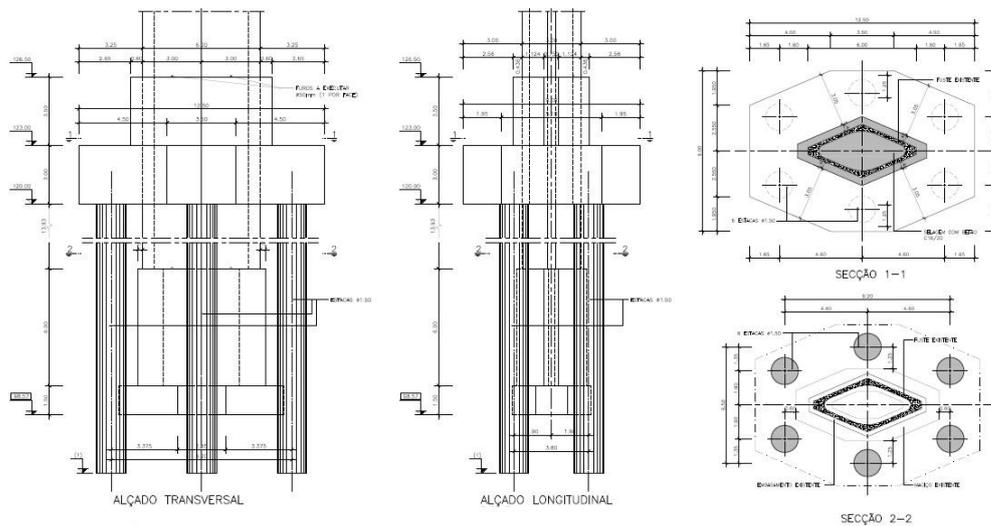
Figure 4.5: Solution type for the piers in the reservoir [4]

The reinforcement of pier basements located outside the reservoir was designed through external and internal jacketing with reinforced concrete, in order to protect these elements against water, and through prestress to confine and to able the load transfer between the pier and the new concrete element.

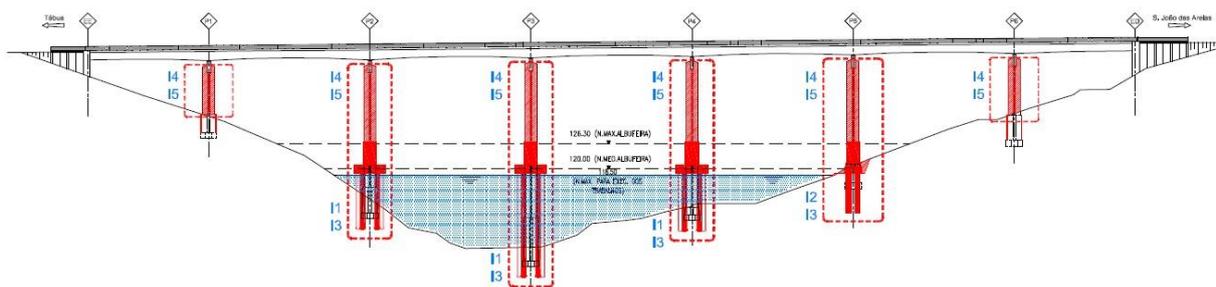
Figure 4.6: Intervention solution in the foundations of São João de Areias Bridge [5]

The P2 to P4 piers reinforcement consisted on the execution of a set of 6 piles, with  $\phi 1,20$  m, embedding on the bed rock, around the piers, linked to it through a prestressed pile cap in reinforced concrete, where the load will be transferred from the pier shaft to the new foundation in case of deterioration of the existing ones.

In the case of P5 pier, near the river bank, the reinforcement solution was carried out with micropiles around the pier, linked to it through a prestressed pile cap in reinforced concrete with 1,50 m thickness, built at the same height as the others pile cap.

Thereby, it was carried out an external jacketing solution with reinforced concrete around the pier shaft between the upper face of the prestressed pile cap and the maximum level of the reservoir, plus 0,50 m, in order to protect these elements against water and to confine them as well.

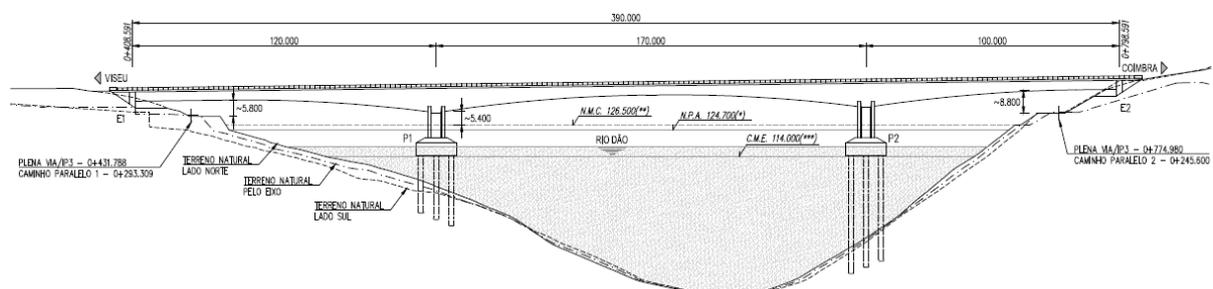
The Foz do Dão Bridge piers reinforce and rehabilitation was found to be unfeasible during the intervention design development.

Currently, 3 of the 8 piers that support the deck structure have a permanently submerged height of more than 50 m (the P5 pier is 60 m height), making it very difficult to work at these depths. It is important to underline that the elements with more evident deteriorations, caused by the swelling reactions, are the pier basements, the elements at the bottom of the piers where the shaft becomes larger. Therefore, it wasn't possible to make any reinforcement solution along the piers height (like the ones of Cunhedo, Mortágua and Santa Comba Dão bridges), once it wasn't possible to use technical and human means to execute correctly these kind of works at the mentioned depths. Another solution would be to execute the reinforcement by jacketing in half of each pier height, supported by a reinforced concrete pile cap located at the medium height of the reservoir, which in turn would be supported by a set of piles, executed with a tube, that would work like piers. This solution was also implemented on the Criz I, Criz II and São João de Areias bridge piers, and showed to be adequate where the reinforcement by jacketing along all the pier height is costly and complex because of the piers submerge height. However, given some of Foz do Rio Dão bridge foundations were very deep, it wasn't possible to guarantee the piles verticality, which makes this solution extremely complex and extremely difficult to perform.

Figure 4.7: New Foz do Dão Bridge [8]

The new bridge deck has a 15 m wide platform, with 3 spans of 120 m + 170 m + 100 m length, performing a 390 m total bridge length.

The deck consists of a monocellular box girder with variable height cross-section, made of prestressed and reinforced concrete. It was cast-in-place using the balanced cantilever method.
