CHARACTERISTIC BEHAVIOUR OF THE PORTUGUESE LARGE CONCRETE DAMS BUILT WITH GRANITE AGGREGATES AND AFFECTED BY ASR

António Lopes Batista1*, José Piteira Gomes1

¹Laboratório Nacional de Engenharia Civil (LNEC), Lisbon, PORTUGAL

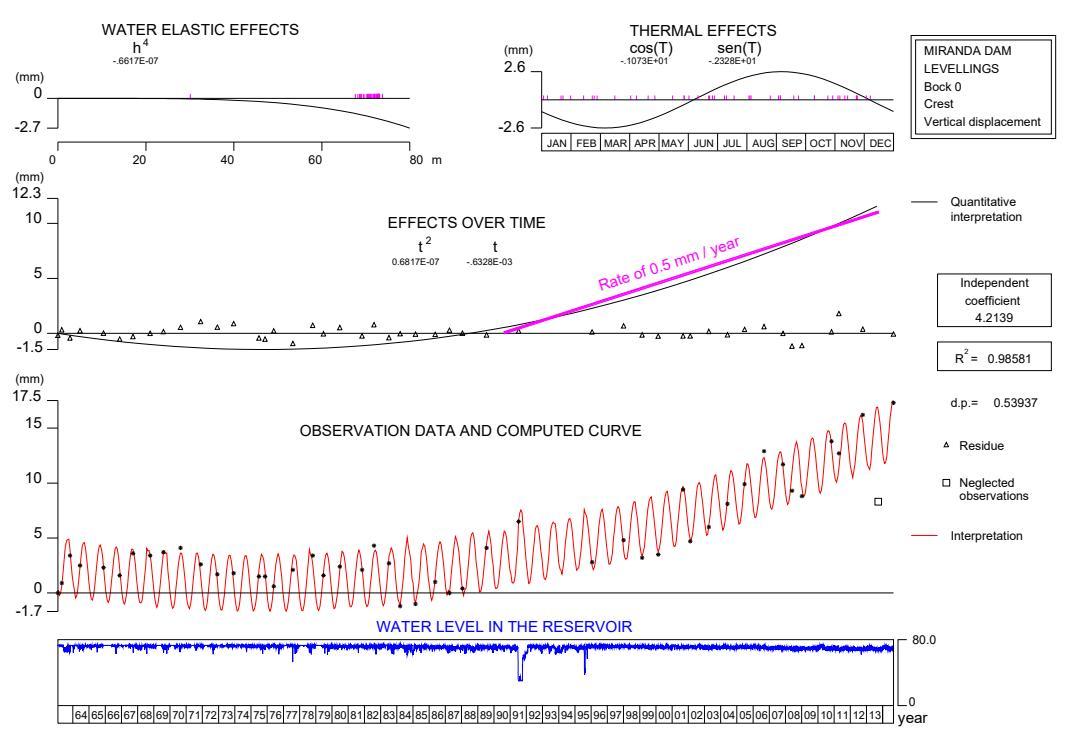
The Miranda dam is a buttress structure, 80 m high, located in the beginning of the international stretch of the Douro River (which is shared by Spain and Portugal), that is founded on a granite and schist rock mass (Figure 2). It was completed in 1961. Coarse and fine granite aggregates were used in the concrete mix. Evidences of the swelling phenomenon were identified in the eighties of the last century, about 20 years after the construction, by the detection of progressive vertical displacements upwards (Figure 3), as well as vertical sliding on the central contraction joints, near the top, and the increase of strains measured in the stress-free strain-meters. Linear and mapping cracking was detected on specific zones of the galleries and of the downstream surface. The ASR was

FIGURE 2: Miranda dam. Downstream view and buttress profile.

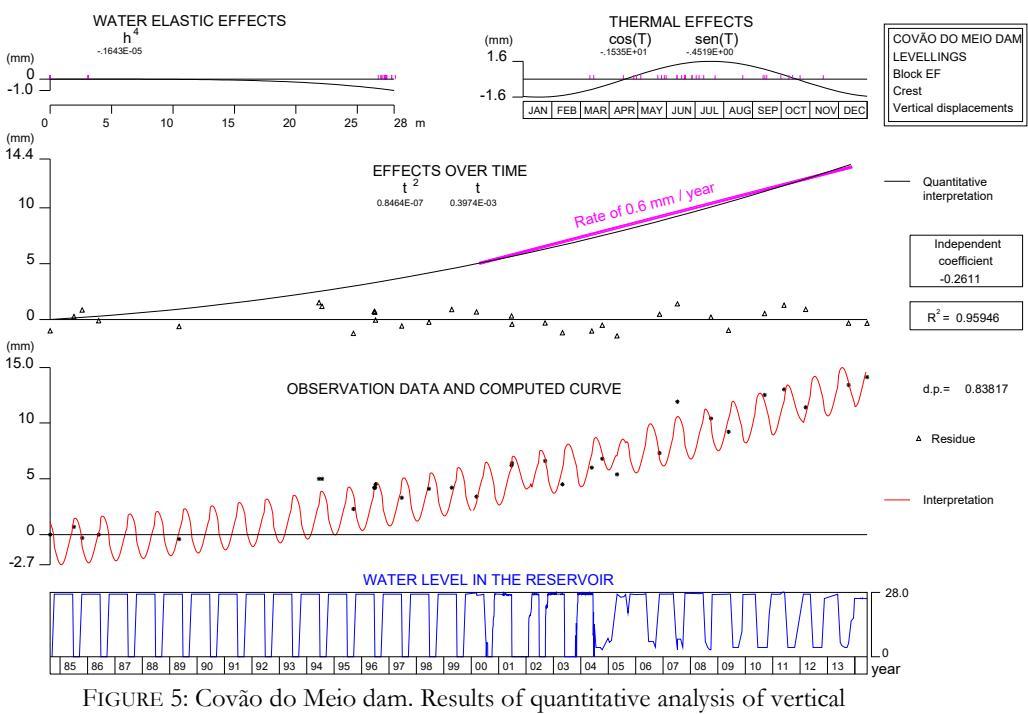
The Covão do Meio dam, located in the Estrela Mountains, at an altitude of about 1650 m, is a thin arch dam, 28 m high, founded on a granite rock mass. The spillway is formed by a gravity structure, located on the left side (Figure 4). It was completed in 1953. Coarse granite aggregates were used in the concrete composition. The first signs of the swelling phenomenon were identified in the nineties, about 40 years after the construction, by the observation of progressive displacements, vertical upwards (Figure 5) and radial upstream, obtained by the geodetic monitoring system installed in 1984. Linear cracking on the downstream surface, parallel to the foundation, was detected in the last years (Figure 4). Mechanical and chemical tests (modulus of elasticity, compressive and tensile strengths, stiffness damage test, mineralogical analysis, petrographic characterization, cement, sulphate, alkali and silica contents and residual expansion), performed on samples taken from the dam's body at the end of 2011, were concluded recently [9].

The accumulated free expansion strains and the current average free swelling rate are about 200×10^{-6} and 10×10^{-6} per year, respectively, in most of the dams. The Covão do Meio dam is a single case, in which the estimated vertical strain and the current vertical swelling rate reach about 500×10^{-6} (only in the last 30 years) and 25×10^{-6} per year, respectively. Unexpectedly, the laboratorial standard

FIGURE 4: Covão do Meio dam. Plan, general downstream view of the arch dam and detailed view of the cracks on the downstream surface, parallel to the foundation insertion.

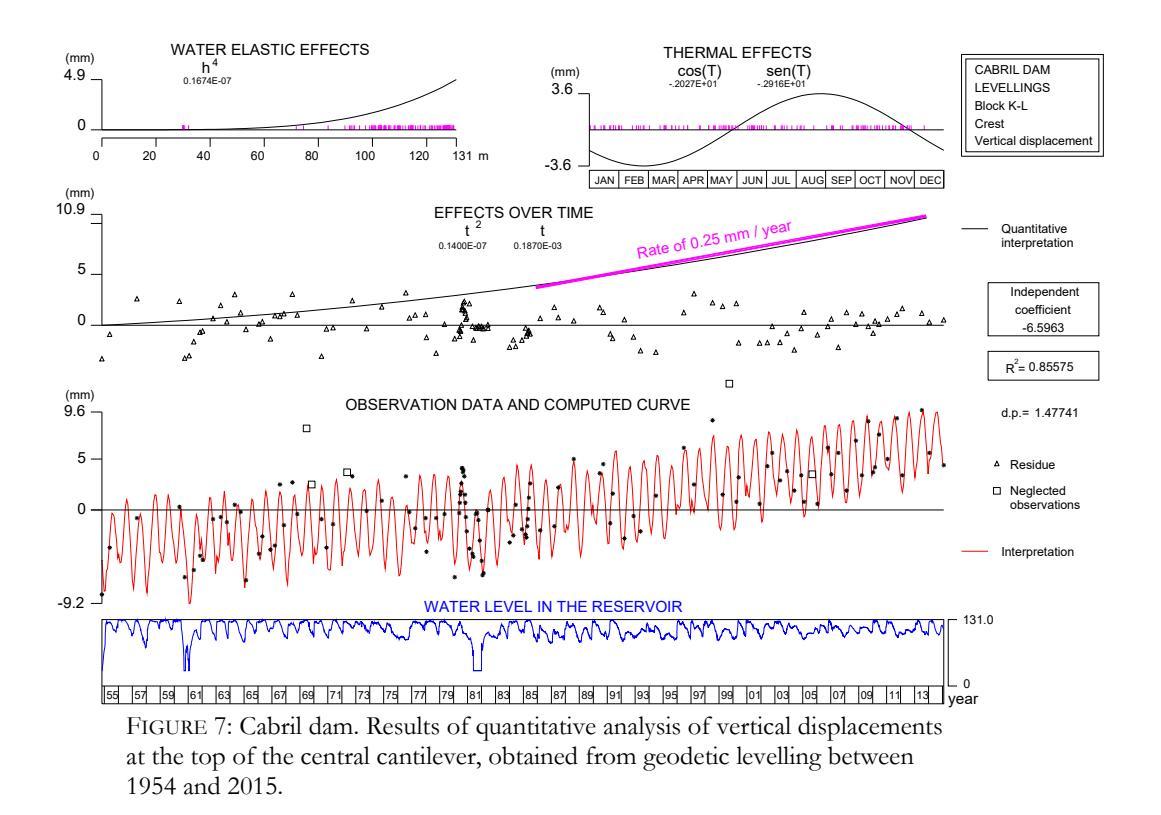
The Cabril dam, the highest in Portugal, is a thin arch structure, 132 m high, located in the Zêzere River, in a narrow V-shaped valley (Figure 5). The foundation is a granite rock mass. It was completed in 1954. Coarse granite aggregates were used in the concrete mix. Abnormal behaviour was observed during the first filling of the reservoir, characterized by horizontal cracking formation close to the top, on the downstream surface, due to the high stiffness (thickness) of the crest arch. Large scale rehabilitation works were done in the eighties, in an attempt to solve these problems. Since then, progressive displacements have been reported, vertical upwards (Figure 6) and radial upstream, as well as an increase in the strains measured by the stress-free strain-meters. Linear and mapping cracking was detected on specific zones of the galleries and on the downstream surface. The ISR and ASR were firstly confirmed by the chemical analysis of gels removed from the galleries' sidewalls. Laboratory testing for AAR evaluation, including petrographic, chemical and expansion tests, were also made [10], for better characterization of the swelling reactions.

FIGURE 6: Cabril dam. Downstream view and cross section of the central cantilever.

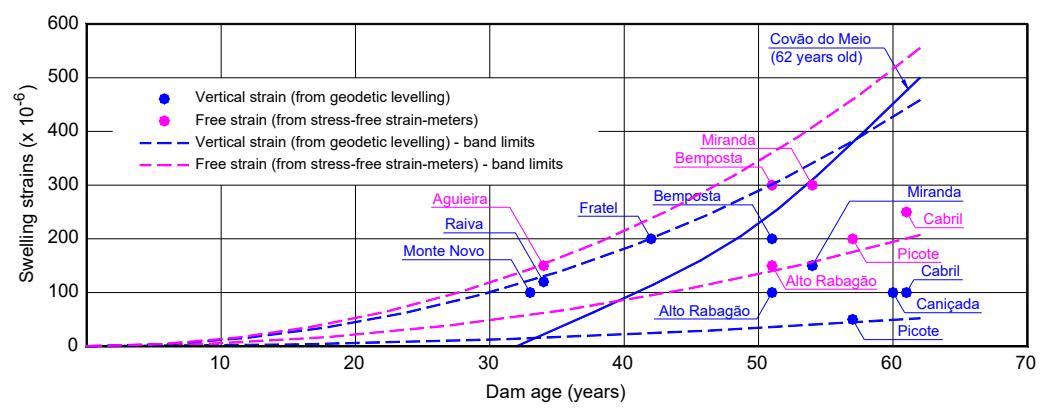
The band limits of the free and vertical expansion, represented in Figure 8, show that swelling strains greater than 500x10⁻⁶ may occur in the future, in most of these affected dams.

FIGURE 8: Portuguese dams built with granite aggregates and affected by AAR. Average values of the monitored free strains by the stress-free Carlson strainmeters and strains obtained from geodetic levelling, in function of the dam age.
