# ASR FOUND IN THAILAND AND TROPICAL REGIONS OF SOUTHEAST ASIA

A case of ASR in Thailand was analyzed. It resulted from microcrystalline quartz in granite mylonites as coarse aggregate. Although ettringite formation was accompanied in existing cracks, the mechanism of expansion was attributed to ASR judged from the texture of expansive phases in the concrete. Another important reactive mineral was identified. Fine aggregate consisted of sand-sized granite which was free of microcrystalline quartz from secondary deformation such as mylonitization. Some micas in the granite have altered into allophane and/or opal, which could be products of weathering in hot and humid climates. Similar cases were also identified in neighboring countries, where granite that has altered to bare opal was used as crushed stone. This caused numerous pop-outs on the concrete surface. These opals are common to all tropical regions, including Southeast Asia, and various weathered rocks in tropical regions could contain potentially ASR reactive aggregates.

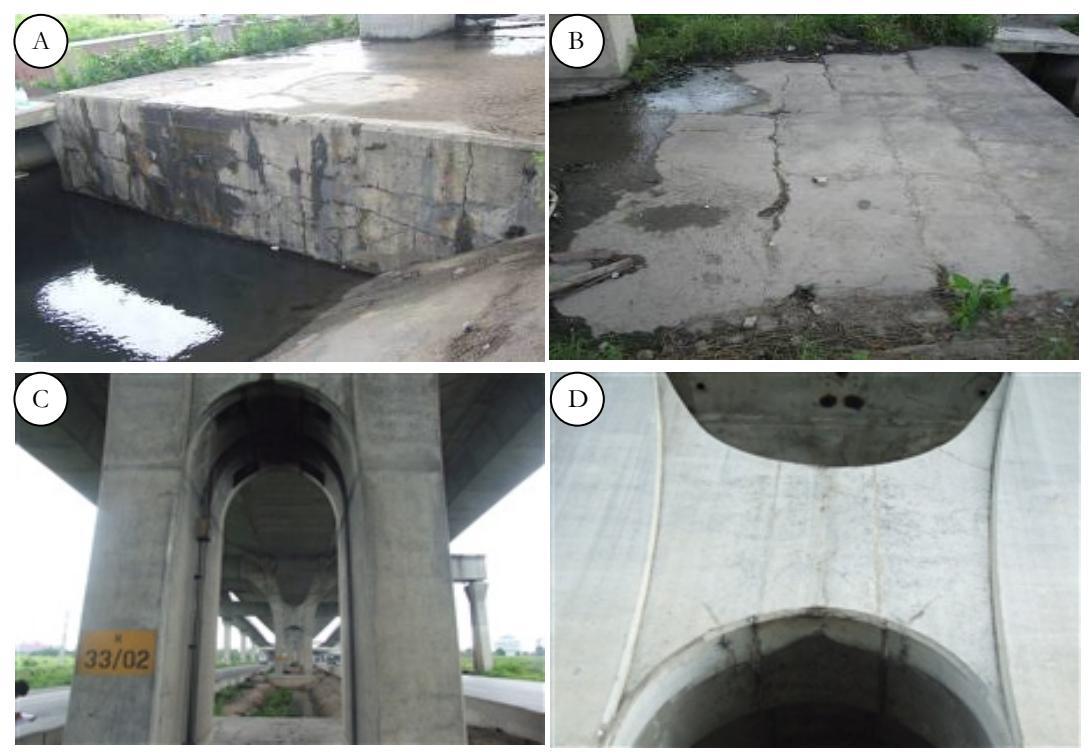
The deteriorated expressway runs from Bangkok to Chonburi, and is 55 km long (Figure 1). It was partly opened in March, 1998, and whole line in February, 2000. The deteriorated structures comprised almost half of the viaduct piers. Cracks were found in pile caps (footings) and a number of x-shaped PC piers (Figure 2). Some footings, less than 10% of the damaged ones, had notable dense cracks involving over 3 mm width openings. Cracks had been detected since 2004 and epoxy resin was used to filled cracks in some footings. However, cracks, including those already epoxy-filled continuously expanded, resulting in re-deterioration [1].

In Thailand, expressway footings were not sealed against water such as by using epoxy resin. Furthermore, some footings were submerged during rainfall due to lack of back-filling (Figure 2-A). Therefore, footings were constantly in humid conditions. On the other hand, cracks in piers were considerably slight (Figure 2-C, D). Superstructures consisted of precast members made of different type of aggregate and were not deteriorated.

FIGURE 2: Overview of ASR-deteriorated structures. A, B: Pile cap (footing). C, D: X-type PC pier.

Meanwhile, relatively rapid deterioration due to late-expansive mineral means the promotion of ASR. This suggests a more severe environment in hot and humid climate than in Japan regarding ASR, as mentioned in a previous study [3]. In addition, footings were always in humid condition due to lack of waterproofing and back filling as mentioned above. This, combined with tropical climate, also promoted ASR. Consistent waterproofing and back-filling are considered to be effective as immediate measures.

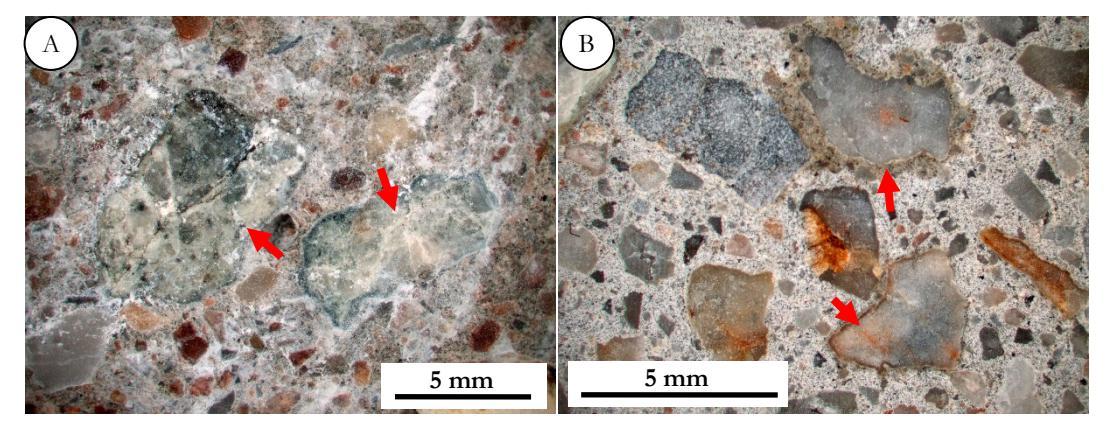
Before the polarizing microscopy, cut surfaces of concrete cores were observed with the naked eye and a stereoscopic microscope. Coarse aggregate was crushed stone with maximum size of around 20mm, and fine aggregate was natural sand. In concrete taken from much damaged footings, some particles of coarse aggregate were cracked or exuded ASR gel or had reaction rim (Figure 3-A). Meanwhile, fine aggregate did not show remarkable signs of ASR, while some particles were observed to exude ASR gel/sol, which looked wet (Figure 3-B).

FIGURE 3: Cut surface of concrete. A: Coarse aggregate with crack, ASR gel exudation and reaction rim (Footing A). B: Fine aggregate with ASR gel exudation (Footing D).

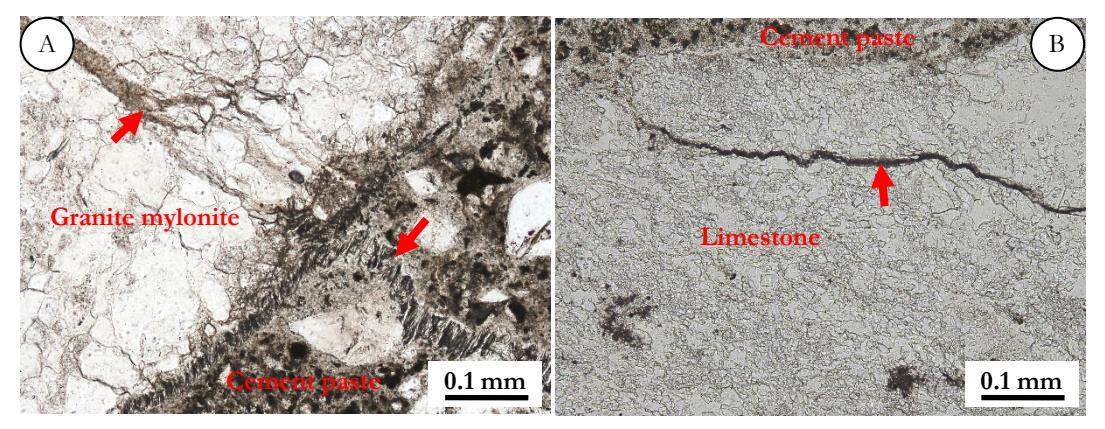
Tables 3 and 4 show results of polarizing microscopy of polished thin sections prepared from core samples. In the tables, rock types and ASR degree of each rock types and ASR degree of whole core sample are indicated. Coarse aggregate consisted of granite mylonite in certain core samples, while limestone or pelitic hornfels were abundant in the others. Among these rock types, granite mylonite was in more advanced ASR stage than others. This completely accorded with the damage levels from the visual examination of concrete structures. Figure 4 represents the texture of ASR in granite mylonite and limestone observed under polarizing microscope. ASR gel in granite mylonite produced large gel-filled cracks that extended into cement paste, while gel-filled cracks were minor and only inside of the aggregate particle in limestone. All these rocks contained as a reactive mineral microcrystalline quartz which was formed by mylonitization through fault movement in granite mylonite is shown in Figure 5. Stretched microcrystalline quartz is abundant.

FIGURE 4: Texture of ASR damaged concrete under a polarizing microscope (plane polarized light). A: Granite mylonite (Footing A). B: Limestone (Footing D).

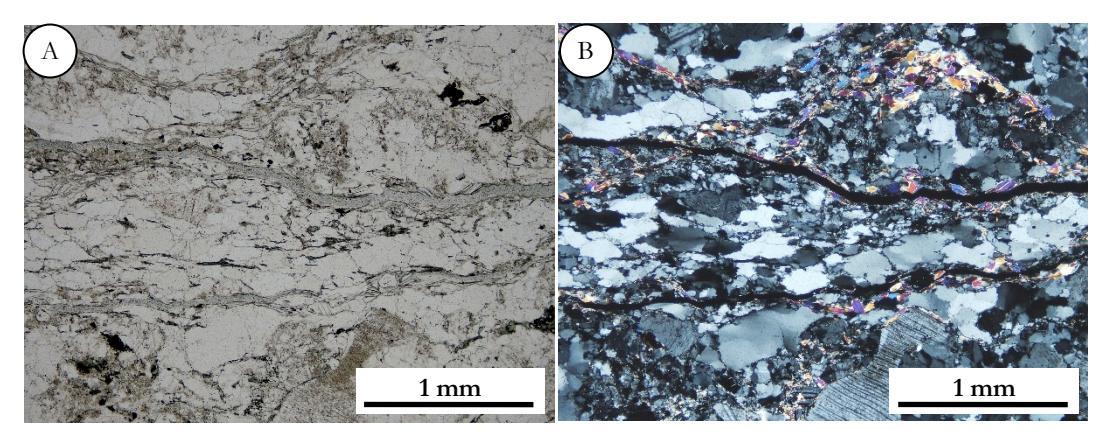
FIGURE 5: Texture of granite mylonite under a polarizing microscope. A: Plane polarized light. B: Crossed polarized light.

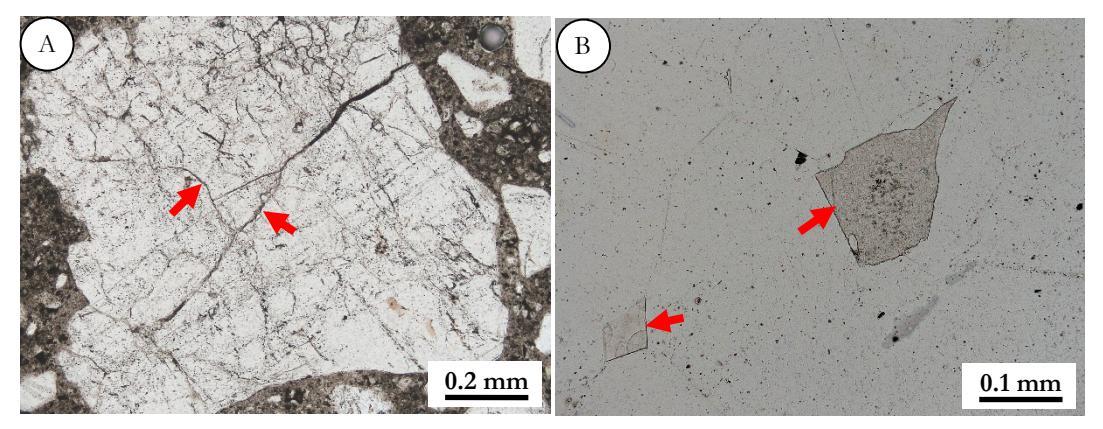
Fine aggregates in all samples were common and consisted of natural sand originating from granite. There were slight signs of ASR gel surrounding the sand, which was free of secondary deformations such as mylonitization or cataclastic deformation. In Figure 3-B, surrounding parts of white granite particles appear wet, with a darker color than other parts. ASR gel/sol bleeding from core aggregate is present in this darker part. Under a polarizing microscope, these granite particles had minute veins, which were possible cracks (Figure 6-A). Amorphous or low crystallized materials that might be altered mica were also frequently found, and supposed to be or contain allophane or opal (Figure 6-B). ASR with fine aggregate was much less than with coarse aggregate, and differences among samples did not accord with the damage levels of field structures. Therefore, fine aggregate was not believed to be related to damages in field. However, granitic rocks without microcrystalline quartz are generally assumed to be non-reactive, especially in Japan, such a case has not been reported. Thus, SEM observation was conducted for identification of minute ASR products as described below.

FIGURE 6: Granitic sand under a polarizing microscope (plane polarized light). A: Minute veins (Footing A). B: Amorphous or low crystallized materials from altered mica (Footing D).

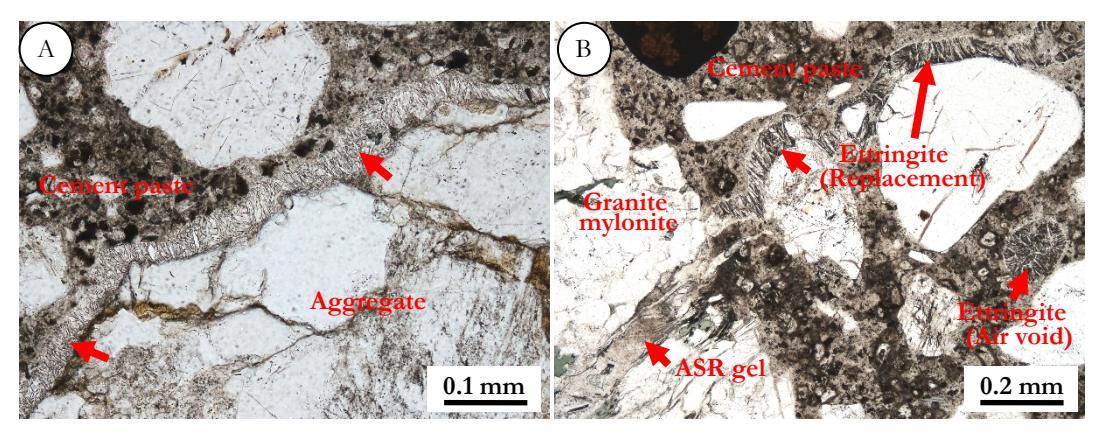
In Footings A-D (all footings), significant ettringite formation was found in air voids and aggregate-cement paste boundary, etc (Figure 7). It had frequently much formed even inside ASR-caused cracks in cement paste as replacement from ASR gel (Figure 7-B), especially in Footing A and Footing B, in which more advanced ASR was identified.

FIGURE 7: Occurrence of ettringite under a polarizing microscope (plane polarized light). A: Aggregate-cement paste boundary (Footing A). B: Replacement from ASR gel (Footing A).

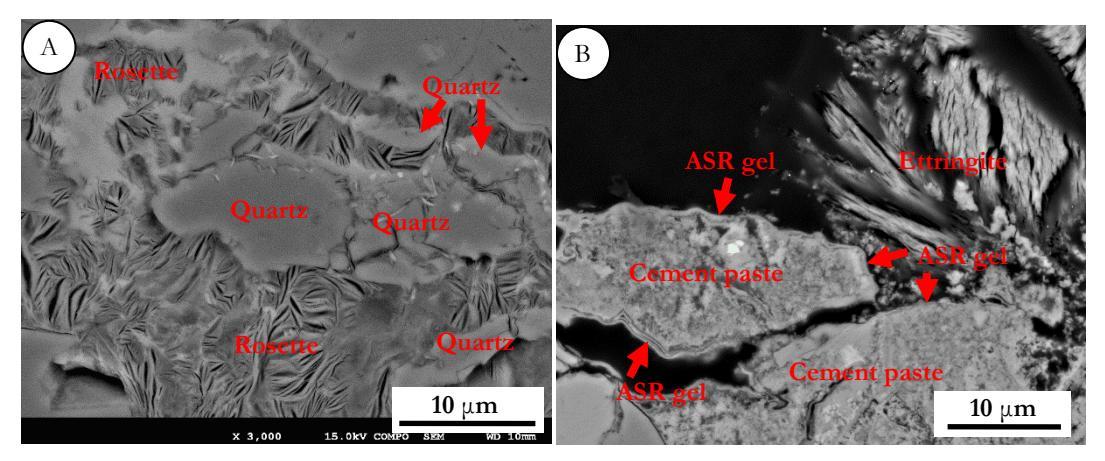
Figure 8-A shows a close-up of an ASR gel-filled crack formed inside granite mylonite. Along with ASR gel, microcrystalline quartz was present in the shape of corrosion. This means that this was a site where the reactive mineral has dissolved to form ASR gel, which has subsequently turned into rosette-like crystals.

In cement paste, most cracks concerned with ASR were presently filled with ettringite. However, the wall of the crack was partly covered with thin surviving ASR gel film, and ettringite was found to grow inside the wall, suggesting ettringite formation after ASR and replacing ASR gel (Figure 8-B).

FIGURE 8: SEM photographs. A: ASR gel-filled crack inside granite mylonite (Footing A). B: ASR gel film directly on the crack wall and inner ettringite (Footing A).

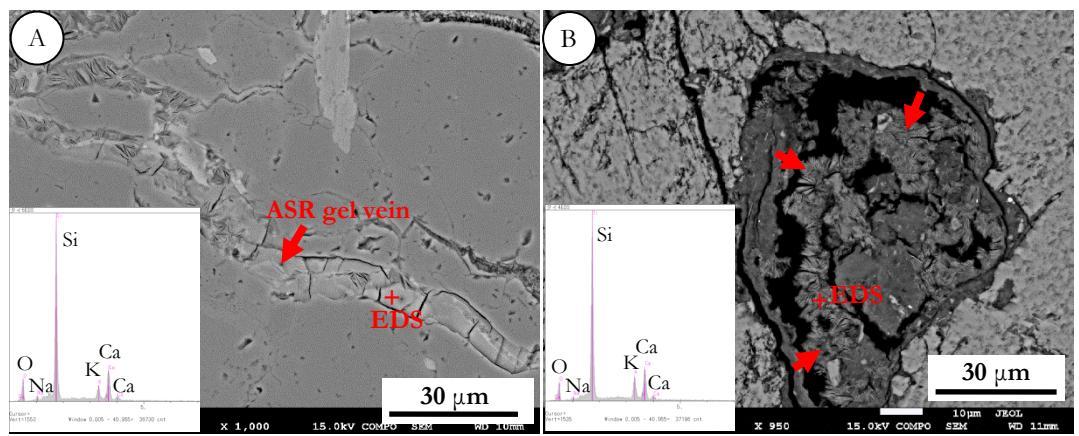
Granite particles of fine aggregate, with ASR gel/sol exudation or minute veins or amorphous to low crystallized materials possibly of altered mica as mentioned above, were analyzed by SEM-EDS. Figure 9-A shows a close-up by back scattered electron image, BEI and composition of the minute vein. Its morphology and composition represented amorphous ASR gel and suggested that most "veins" were cracks filled with ASR gel. Moreover, possible altered mica was frequently accompanied with secondary crystallized products (rosette) from ASR gel, as shown in Figure 9-B, secondary electron image, SEI and composition. Thus, it was confirmed that ASR had occurred in fine aggregate that consisted of non-deformed granite, and suggested that this ASR was attributable to altered mica.

FIGURE 9: SEM-EDS of sand-sized granite. A: Minute vein (Footing A). B: Rosette-like crystals with altered mica (Footing D).

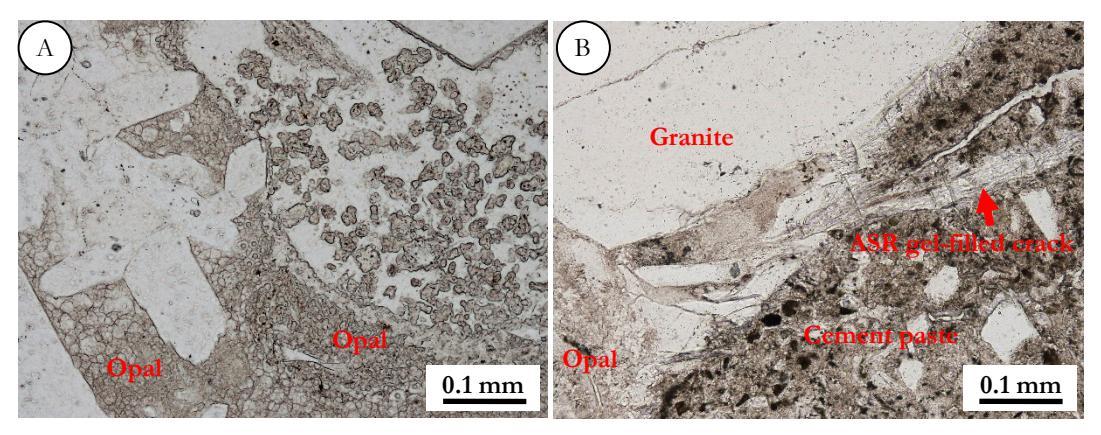
Meanwhile, within this study, ASR products in granitic fine aggregate were found along with amorphous or low crystallized substance possibly from altered mica. The identity of these substances is considered to be allophane and opal. Similar unreported cases have been also found in neighboring countries in Southeast Asia, where numerous pop-outs were produced on the surface of the concrete structures. In these cases, crushed granitic coarse aggregate had been used. Polarizing microscopy revealed that some granite particles were somewhat altered to bear aggregations of opal (Figure 10-A), which formed ASR gel-filled wide cracks that expanded into cement paste (Figure 10-B). Therefore, genesis of opal in this study is discussed as below.

FIGURE 10: A similar ASR case in Southeast Asia under a polarizing microscope (plane polarized light). A: Aggregation of opal in granite. B: ASR gel-filled crack from opal in granite into cement paste.
