ALKALI SILICA REACTION IN CONCRETE FOUNDATIONS IN THAILAND

Abstract

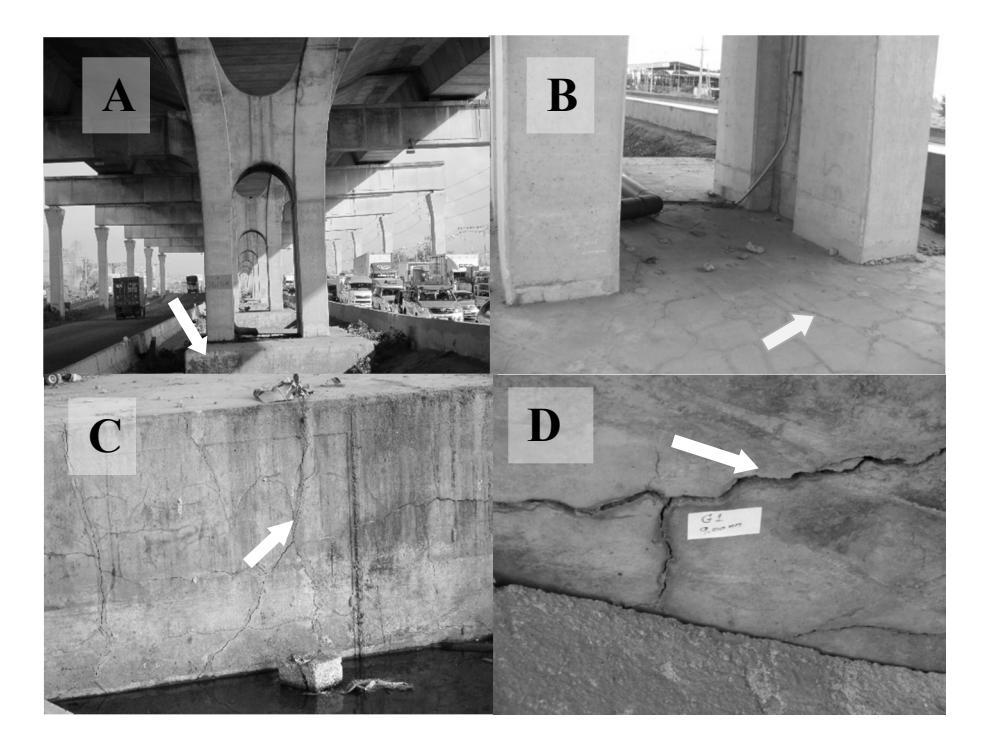
Intense mesh-like cracking in the concrete foundations was observed a few years after the construction (1998) and many foundations were repaired with epoxy. Later inspections showed that repaired cracks were still expanding and new cracks had developed, suggesting an ongoing damaging process. In addition to the mesh-like cracking, many concrete foundations contain both horizontal and vertical cracks, some measured to be 9 mm wide (see Figure 1). Field inspection in 2013 by the authors revealed beginning map cracking and fine vertical cracks in some of the box girder pillars suggesting the initiation of ASR. Microstructural analyses show occurrence of deleterious ASR caused by slow-reactive aggregates and simultaneous DEF in form of peripheral micro-cracks surrounding aggregates (gap-grading) and high amounts of ettringite in cracks. The mesh-like cracking pattern observed in foundations most likely is caused by DEF or ASR, or a combination of both mechanisms. Because ASR is due to slow-reactive aggregates, it is very likely that early cracking is caused by DEF and ongoing later cracking by ASR. In the superhighway structure, only a few concrete foundations are exposed above ground level. Most of the concrete foundations are buried below ground level and are thus not possible to inspect. The condition of buried foundations is unknown. In a separate paper the authors present and discuss the sequential appearance of ASR and DEF and the possibility that DEF might have activated slow-late reactive aggregates to be alkali reactive [5].

FIGURE 1: A: location of concrete foundations in the highway structure (arrow). B: foundation with repaired cracks (arrow). C and D: significant cracking with cracks up to 9 mm wide.

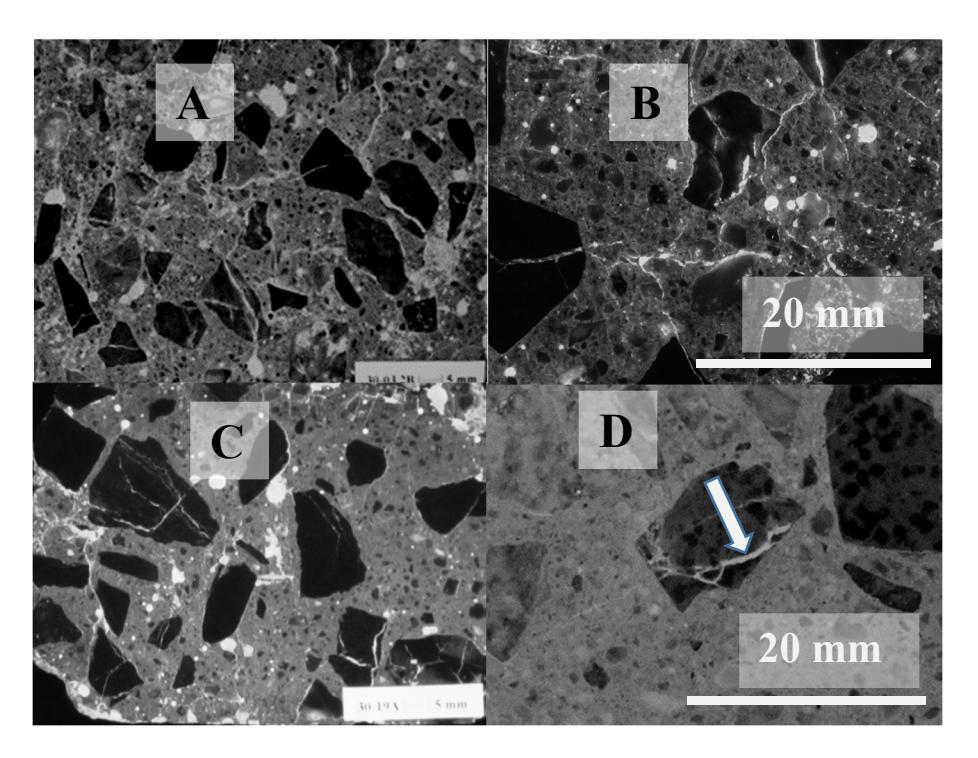
Micro-cracks appear in reacted aggregates (intergranular) and in several cases also extend into the cement paste, suggesting deleterious ASR. Micro-cracks are maximum 0.1-0.2 mm wide in thin sections. In fluorescence light some reacted particles contain a high content of intergranular micro-cracks and a dense outer zone as sometimes observed in reacted slow reactive aggregates. Micro-cracks, which extend into the cement paste and connect other reacted particles, suggest that deleterious ASR is at an advanced stage. Micro-cracks in the cement paste are abundant and several coarser aggregates (and some finer) are surrounded by peripheral micro-cracks filled with ettringite. Peripheral micro-cracks are more pronounced in sample 30-XA and less in sample 30-XB.

Figure 2 shows micrographs of cracks on polished fluorescence impregnated polished slabs photographed in UV light.

FIGURE 2 : A and B: (30-XB) cracks in aggregate (quartzite and granite) and cement paste. C: (30-XA): cracks in aggregate and cement paste (sericite rock). D: white reaction product (arrow) in intergranular crack in quartzite (30-XB). Photo A. B and C in fluorescence light.

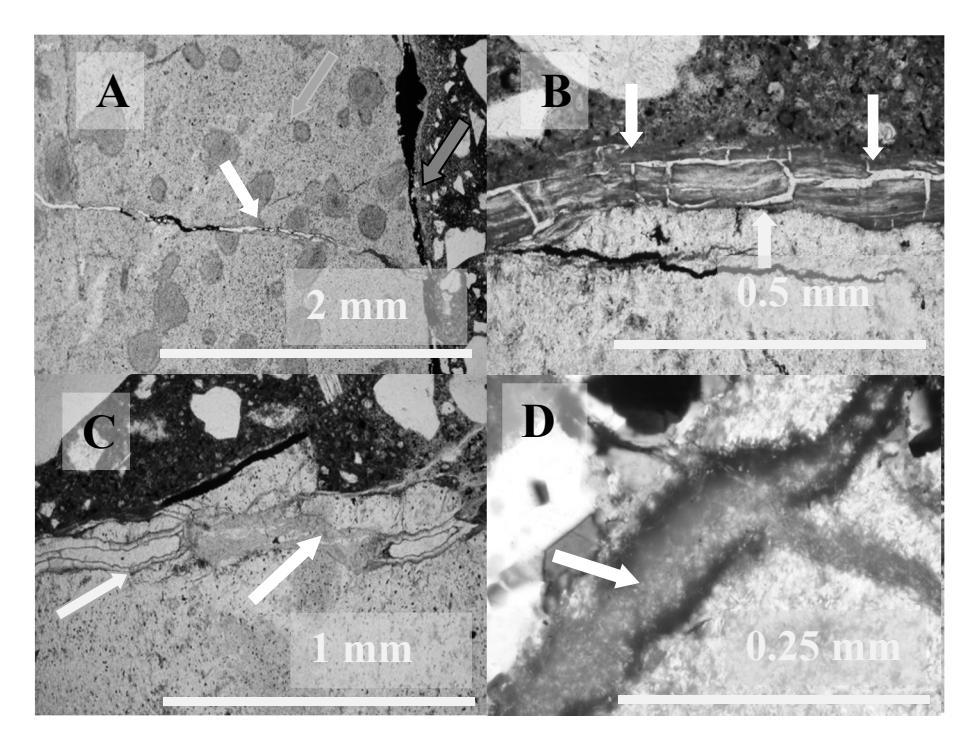
Figure 3 show reaction signs and reaction products from reacted sericite rock (sample 30-XA). Figure 4 shows reaction signs and reaction products from reacted granite and quartzite (sample 30-XB). Figure 4 B shows inter granular micro cracking and dense outer rim in reacted granite under fluorescence light.

FIGURE 3: sample 30-XA photos of sericite rock: A: pseudomorph in sericite rock and cracks due to ASR (arrow). B: laminated amorphous gel in contact zone aggregate-cement paste. (arrow). C: gel and cryptocrystalline reaction product in sericite rock near interface to cement paste (arrow). D: cryptocrystalline reaction products in sericite rock. polarizing light (arrow).

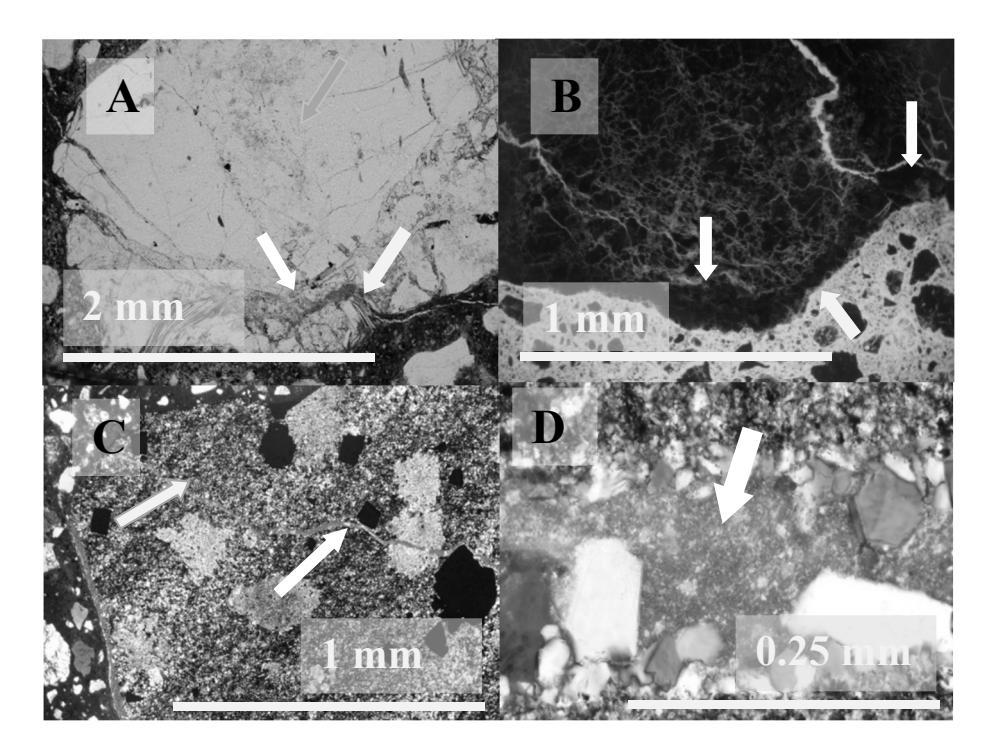
FIGURE 4 (sample 30-XB):A: reacted granite with cryptocrystalline reaction products in crack (arrows). B: reacted granite in fluorescence light. Note significant intergranular cracking and dense outer zone due to ASR (arrows). C: reacted quartzite in polarizing light. Note crack due to ASR (arrow) and pseudomorphs and opaque phases. D: quartzite in polarizing light; note cryptocrystalline reaction products in crack (arrow and salt and pepper texture) in cryptocrystalline reaction products.

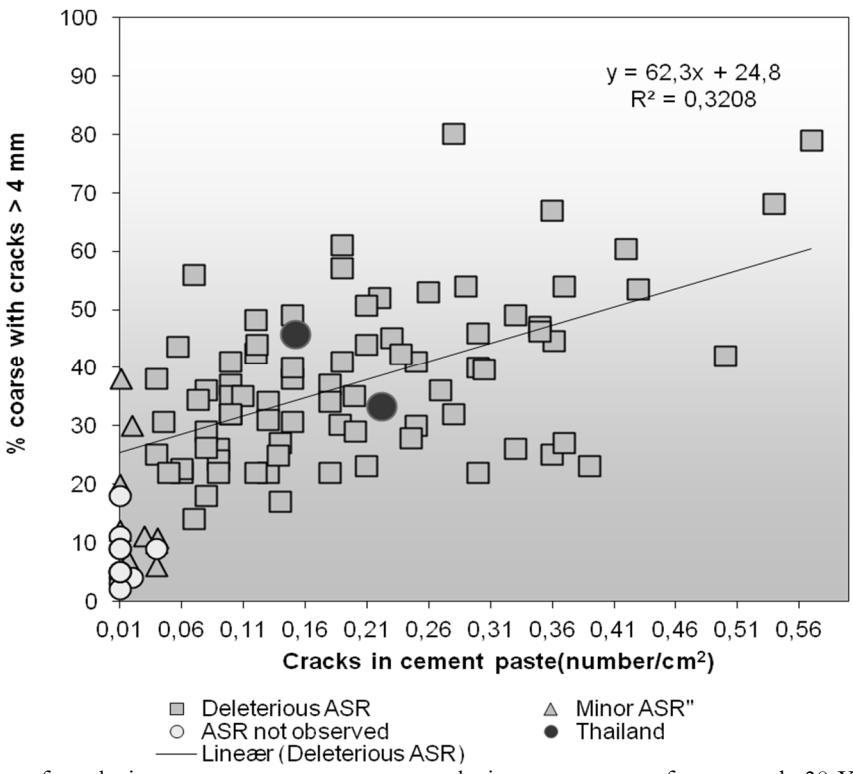
The results from counting Thai concretes in addition to a calculated crack index is given in Table 4 [17], [18]. Note that ASR is assessed deleterious reaction types 5 where cracks due to ASR extends into the cement paste and connects reacted particles [16]. The Norwegian crack index classifies Thai concretes to be "moderate to severe ASR" (samples 30-XA) and "small to moderate ASR" (sample 30-XB), or generally as "moderate ASR". A graphical plot of the number of cracks in the cement paste versus the percentage of coarse particles with cracks is plotted together with Norwegian structures damaged by ASR [16], including results from the NBTL laboratory over several years, see Figure 5. Note that sample 30-XA and 30-XB from Thailand plots in the same "cluster" as Norwegian structures damaged by deleterious ASR.

Quantification of micro-cracks by the "Norwegian method" plots the Thai concretes into the same "cluster of damage" as many Norwegian structures. The Norwegian crack index classifies Thai concretes to be "moderate ASR". Thai cores are smaller than normally examined in Norway and therefore less representative. However, the result gives a more or less correct estimate of the damages in the concretes.

FIGURE 5: Plot of cracks in coarse aggregates versus cracks in cement paste, from sample 30-XA and 30-XB plotted together with Norwegian structures damaged by ASR
